# **Seabrook Station Feedwater Reg Valve Internal Erosion OR17 – Fall 2015**

**Jim Johnson**

**Feedwater System Engineer**

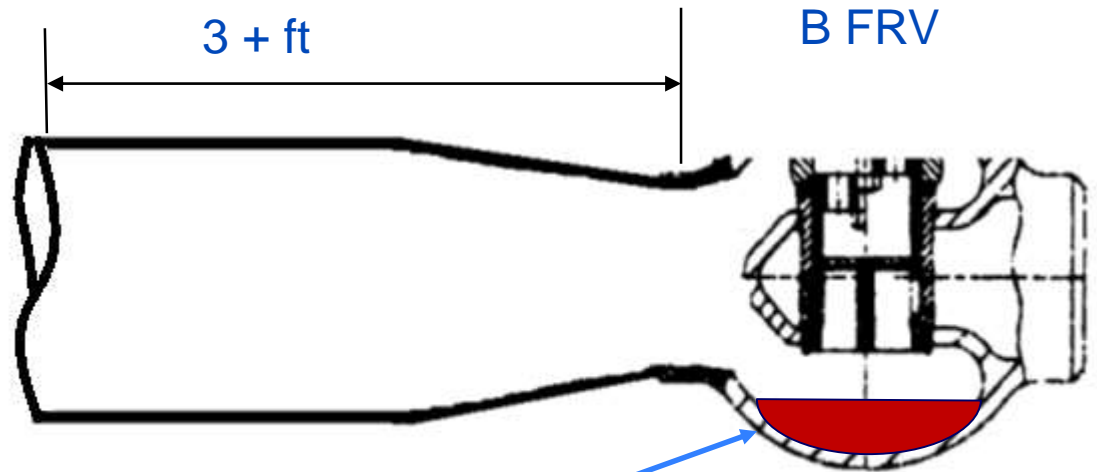
Water pocket left in in low spot of valve body – rusty water could not see through.

Maintenance Supervisor asked for water to be pumped out for before signing off final FME closeout

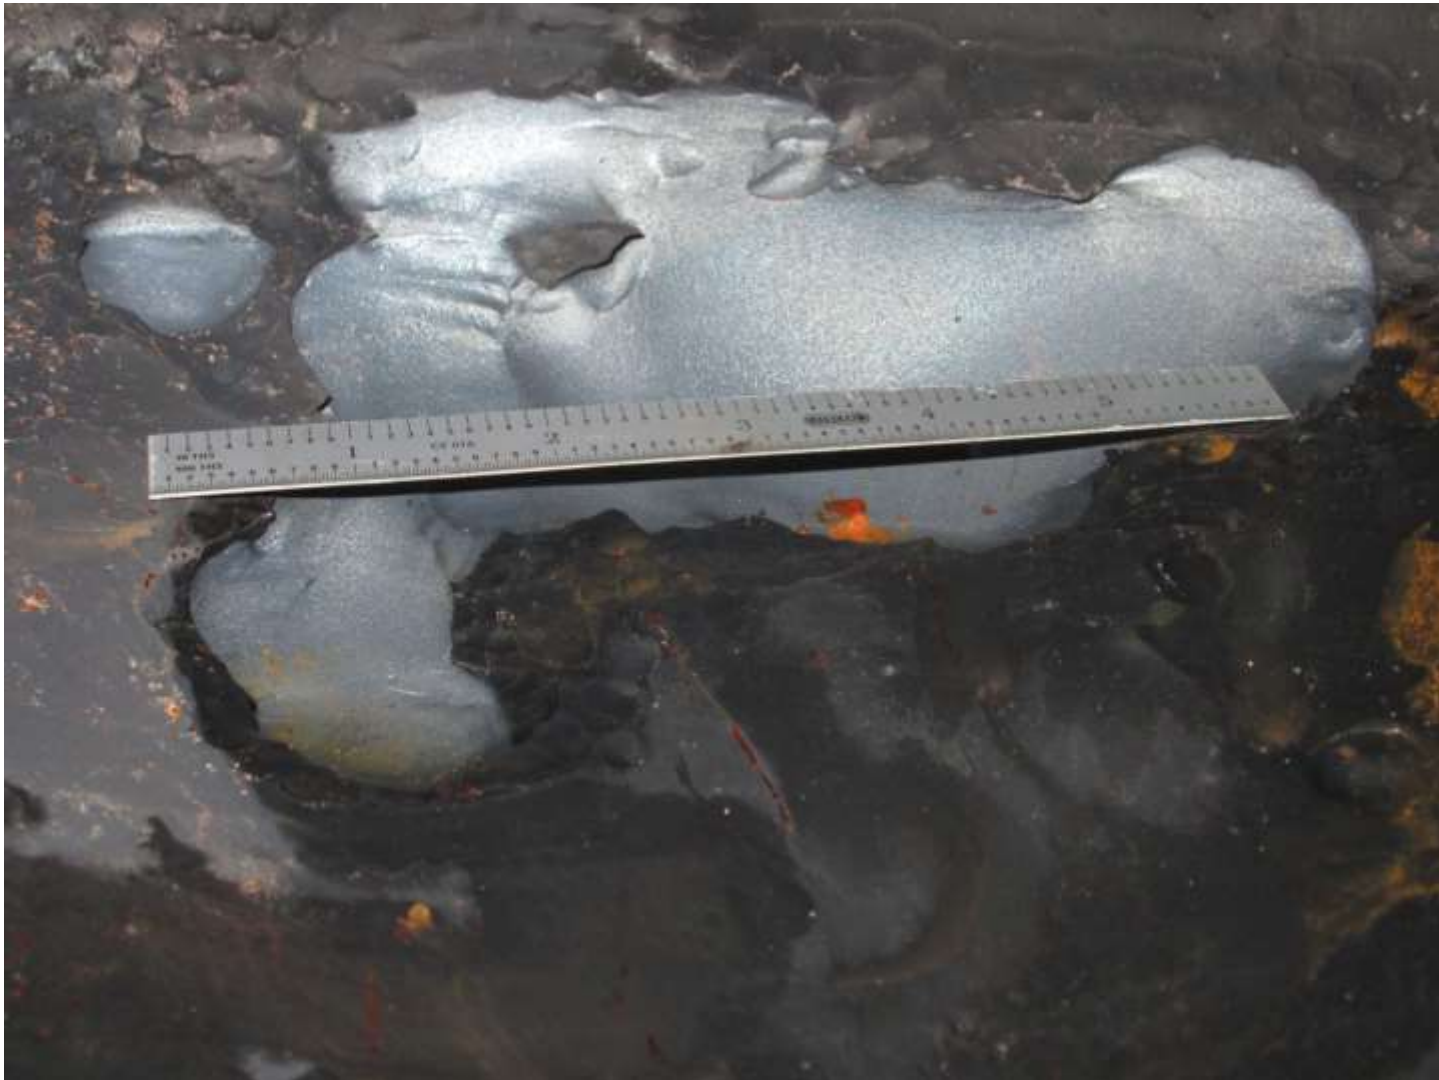
## D FRV – View of Largest Flaw

- **Need to determine wall remaining and wall required**
- **External UT – rough surface, off angles, poor material – no results**
- **Miller pipeline – Internal UT, Contour Gauge Readings**
  - Not able to get readings in all locations.
- **Contacted OEM (Copes-Vulcan, now SPX) to determine minimum wall required on valve body**
- **OE from Beaver Valley – not similar.**
- **EOC – A and C FRV?**
  - Cut 4 inch bypass line and used borescope to inspect.
  - Similar overall, but not able to measure wall loss.

- B and D FRV had a 0.25 inch weld overlay applied to lower valve body based on results of internal inspections.
- A and C FRV had a 0.5 inch weld overlay to allow for uncertainty.

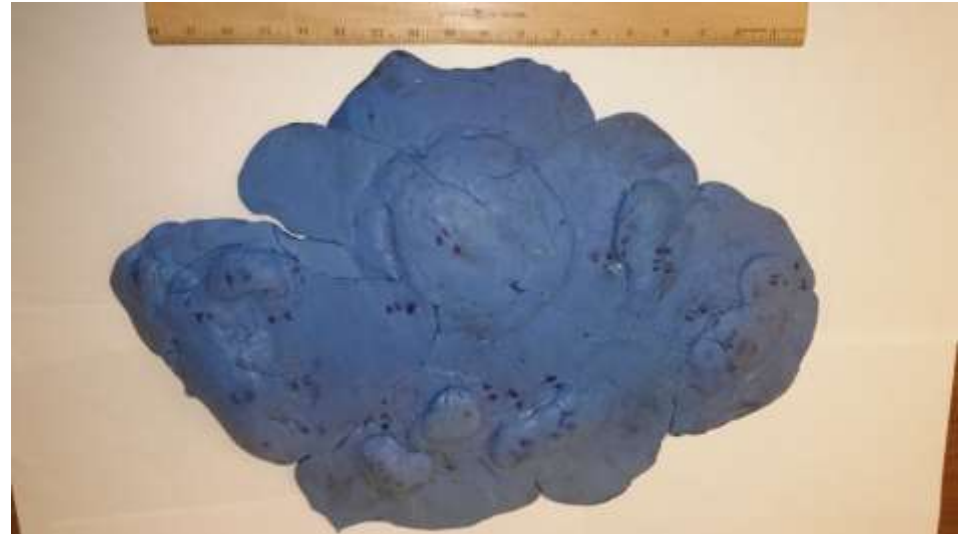
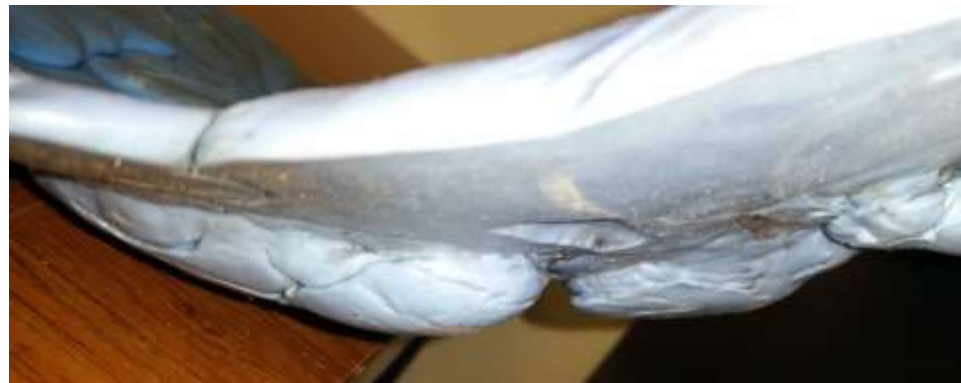
- Used a two part quick setting plastic modeling compound to fill and measure erosion locations.
- Provided information on size of erosion sites, but not a measurement of wall thickness remaining.
- Used nominal wall thickness to get maximum possible wall loss

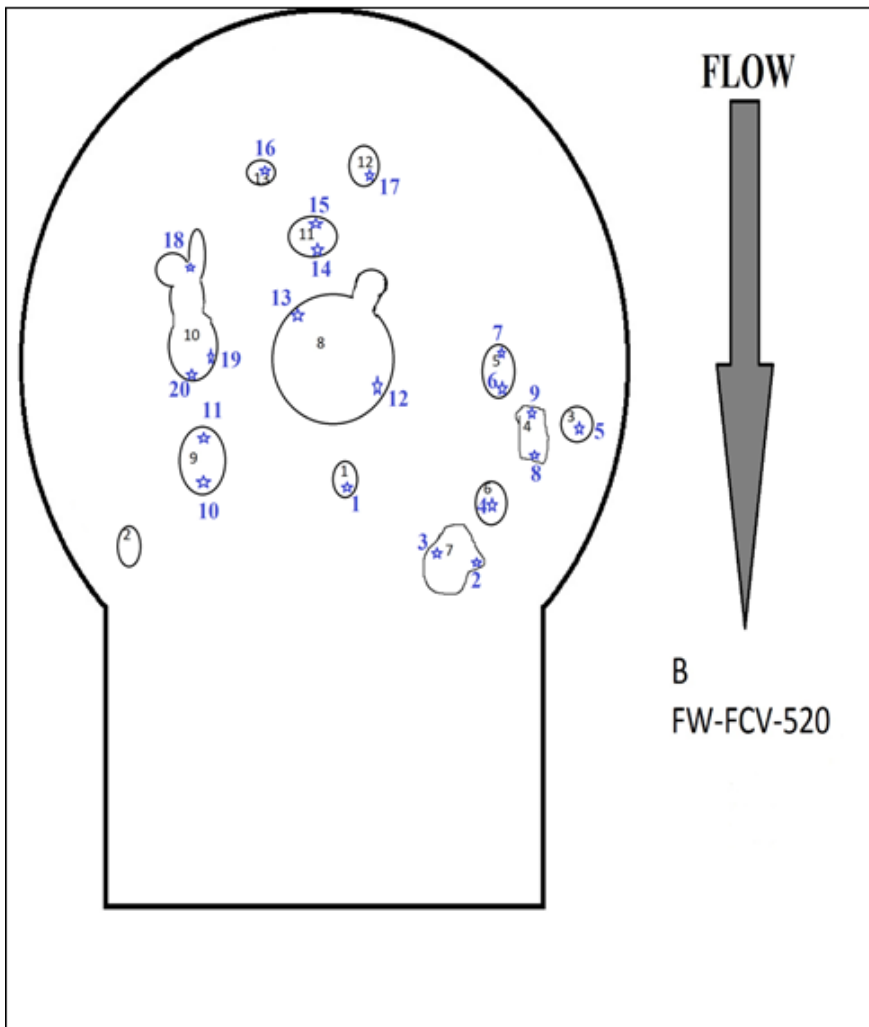
# Results

Putty Indications are blue numbers and stars for measurement points.

Location	Mold Measurement #	Depth from Mold Measurement (inch)	Remaining Wall Thickness Based on Putty and OEM Min wall.  OEM Min wall for valve is 1.56 inches.  These results are bounding but , potentially over conservative.	UT, inch, in Base Metal	Base Metal UT minus Mold Measurement  Due to limited locations for UTs and poor reference point for mold indications these number may be non-conservative.
1	13	0.45	1.11	2.29	1.84
	14	0.51	1.06		1.79
2	11	0.25	1.31	1.94	1.69
	12	0.32	1.24		1.62
3	8	0.37	1.19	1.96	1.59
	9	0.34	1.22		1.62
4	7	0.44	1.12	1.96	1.52
	6	0.54	1.02		1.47
5	5	0.67	0.89	2.01	1.34
	1	0.47	1.09		1.32
6	2	0.27	1.29	1.80	1.53
	3	0.71	0.86		1.09
	4	0.33	1.23		1.47
7	10	0.12	1.44	No parallel surface for UT readings	N/A
8	Could not be reached for measurement. Visually looked to be less than 3/16 <sup>th</sup> inch erosion.

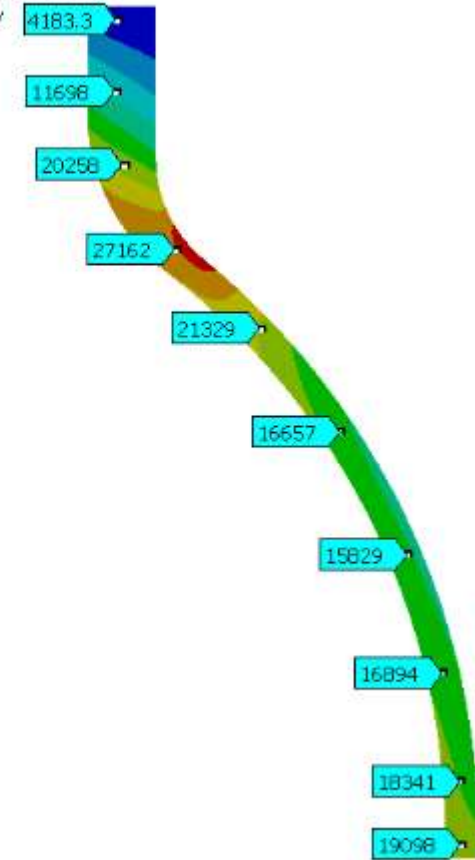
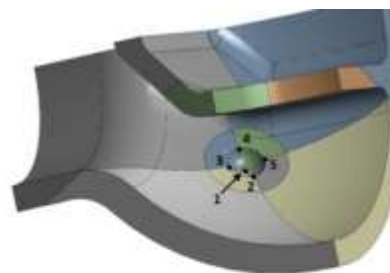
Path Lines and Location of Eroded Area

J: Case B - .76" bowl, 1.56" port, P=1505 psig

Case		1	2	3	4	5
internal pressure	psig	1505	1505	1505	1505	1505
end load	lbf	225692	225692	225692	225692	225692
sphere diameter	in	2.50	2.50	2.50	2.50	2.50
original wall at eroded area	in					
minimum wall at eroded area	in	1.9472	0.94224	0.83724	0.89224	
erosion penetration depth	in					
diameter of eroded area	in	2.3519	2.42899	2.477	2.4545	
membrane stress at 1 (center)	psi	7564.8	7564	7627.3	7772.5	
membrane stress at 2	psi	<b>10954</b>	11289	11652	11949	
membrane stress at 3	psi	7970.4	7814	7695.8	7605.1	
membrane stress at 4	psi	70612	<b>11411</b>	<b>12091</b>	<b>12982</b>	
membrane stress at 5	psi	6091.6	6472.5	6340.2	6298.3
