This Pressure Switch Is Giving Me Bad Vibes

MFWP Suction Pressure Switch Failure Leads to
SCRAM.

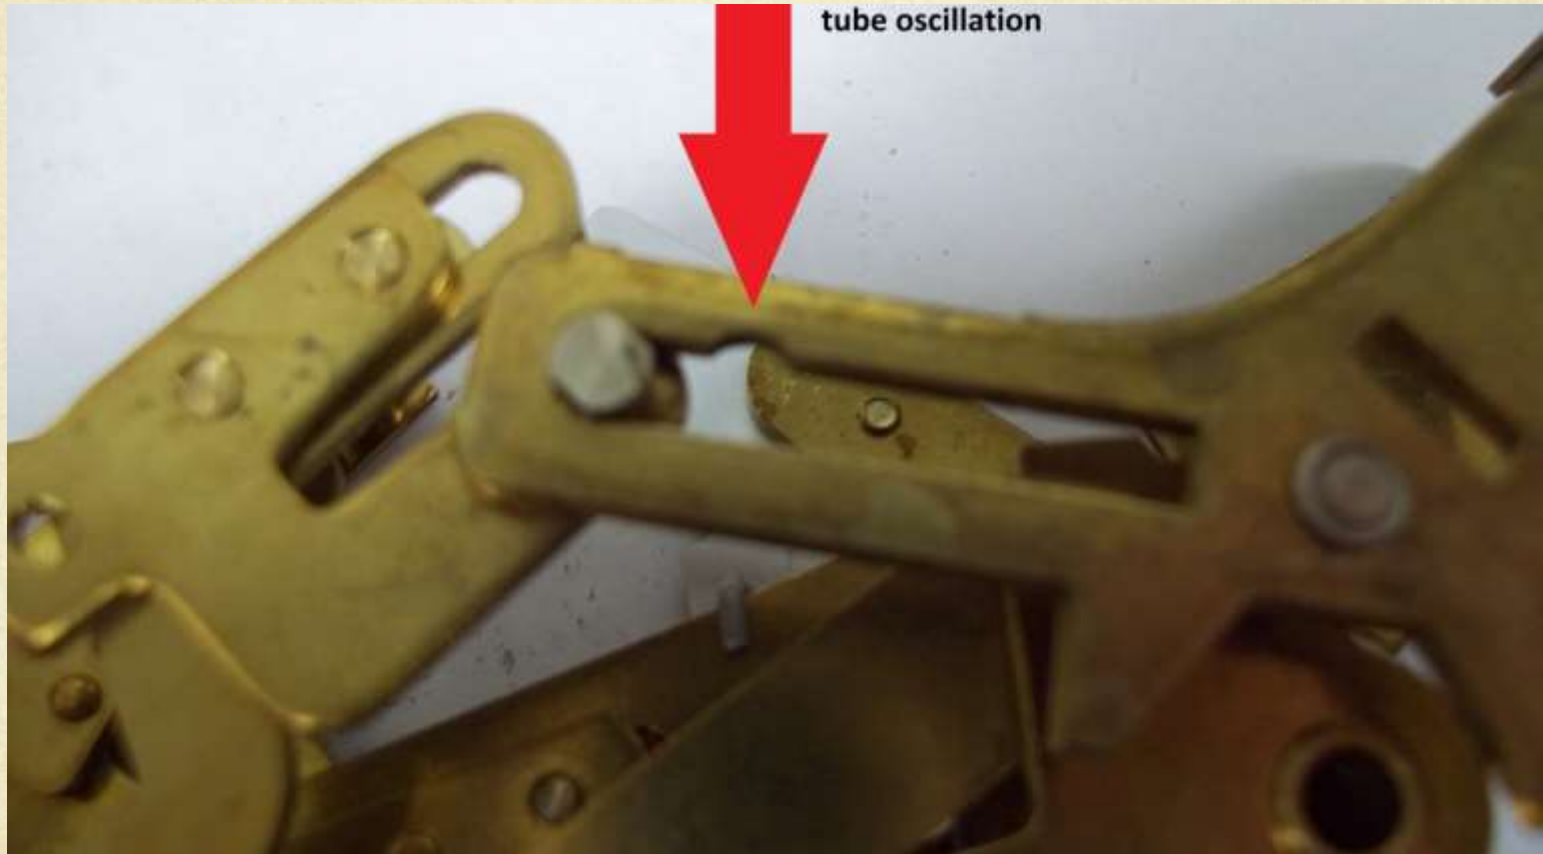
Mercoïd DSW-7223-153S1-10S

- Original Pressure Switch Replace 25 MAY 2010
 - Original replaced due to failure after 38 years.
 - Original failure resulted in SCRAM.
- Replacement Switch Failed 0652 03 APR 2015
- Manual Rx SCRAM Due To FWP Lockout 23s Later
- 3,000 MWh lost.

- Why FWP Trip?
 - Disconnected Linkage
- Why Linkage Became Disconnected?
 - C-Clip Mechanical Wear Resulting in Failure
- Why C-Clip Fell Off?
 - Vibration-Induced Oscillations of Bourdon Tube

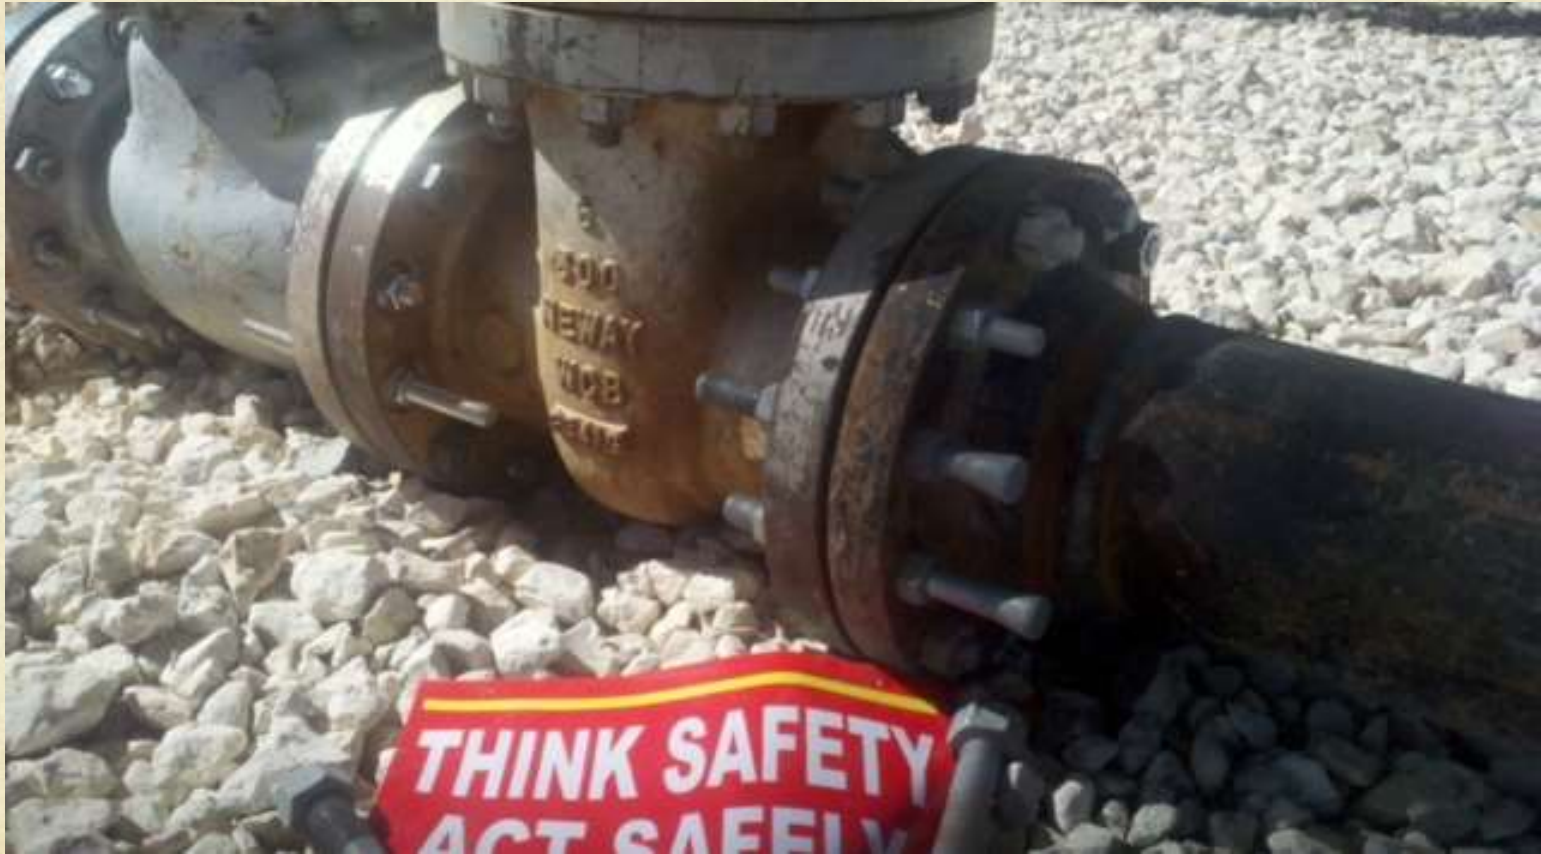
Hairy Eyeball

- Focused Observations of Newly-Installed Equipment
- QUESTIONS?
- Jeremiah Smith
 - Prairie Island Nuclear Generation Plant
 - Jeremiah.Smith@xenuclear.com
 - (651)-267-6378
