Manual Trip Entering 2RF15

Inability to Control Steam Generator
2-03 Level Due to Unresponsive
2-FCV-0530

Main Feed Pump Turbine (MFPT)

1-A Trip due to Loss of Axial Position Probes

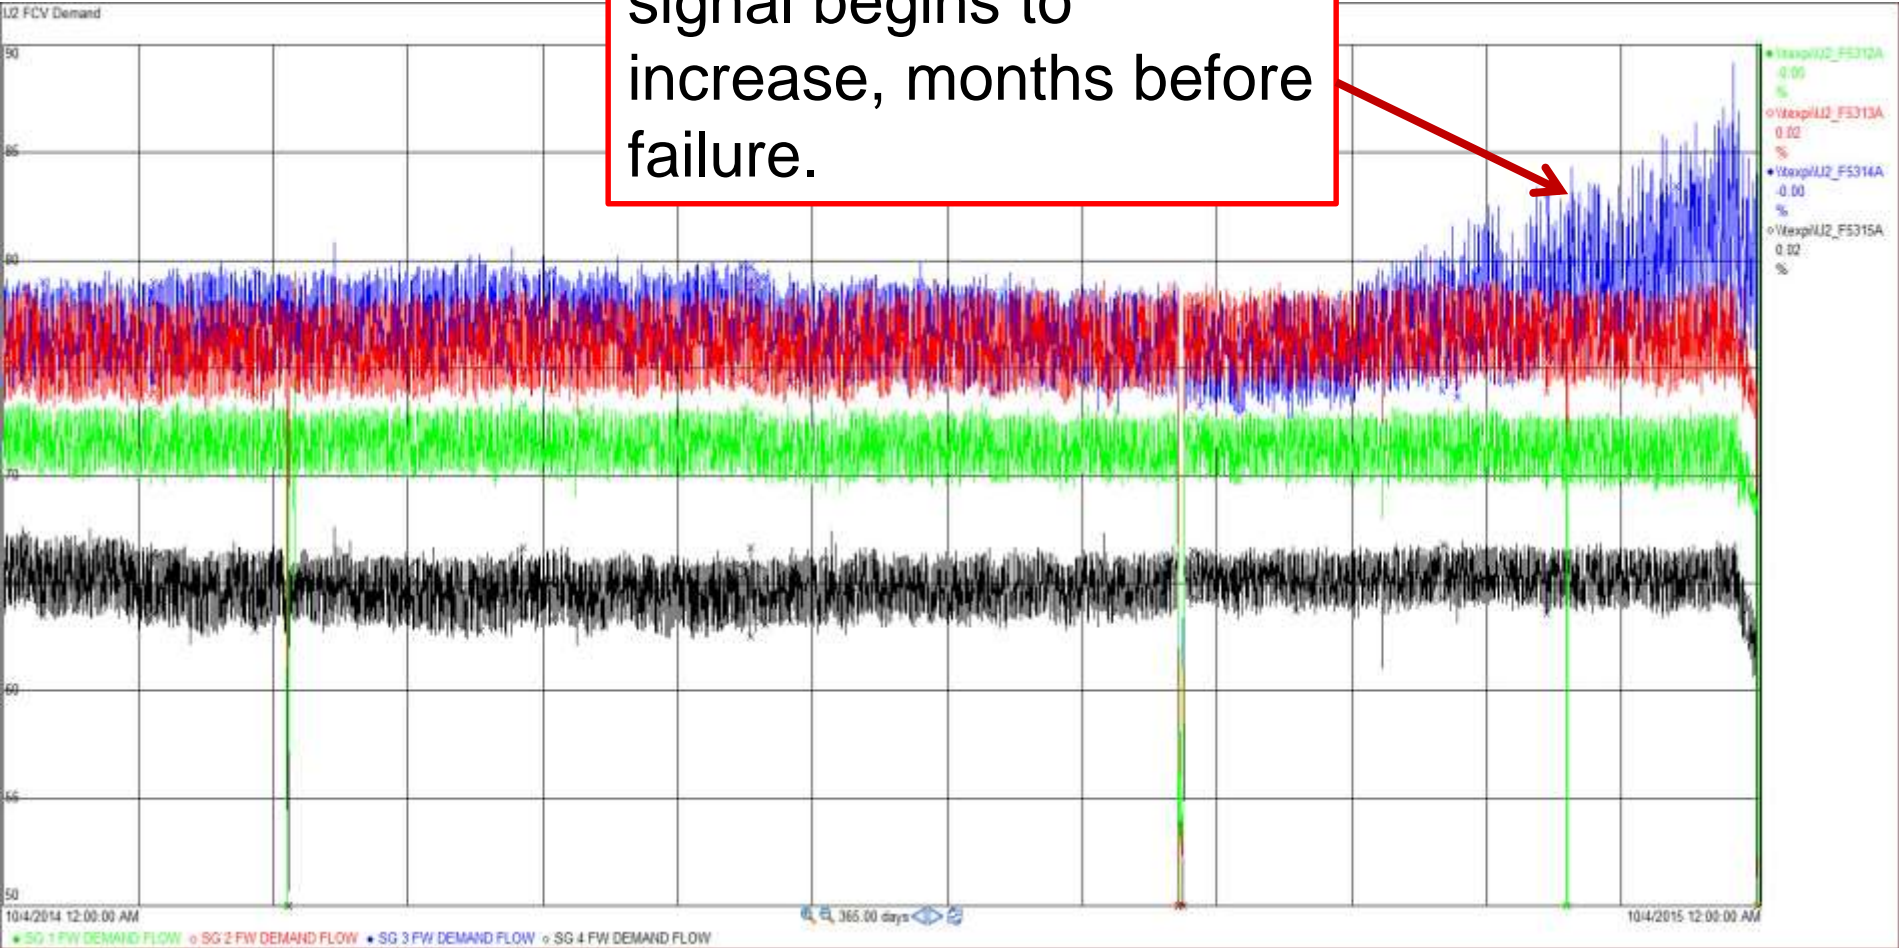
The valve demand signal begins to increase, months before failure.

- All four Unit 2 positioners were replaced.
- An EOC review was performed for the Unit 1 positioners to determine if any adverse SG FW demand flow trends were present.
- Trends of the Unit-1 components show no abnormalities.
- The System Monitoring Plan has been modified to identify the this trend potential (System Engineering).
- POC has modified their trending plan to assist with the identification and site notification of this trend.

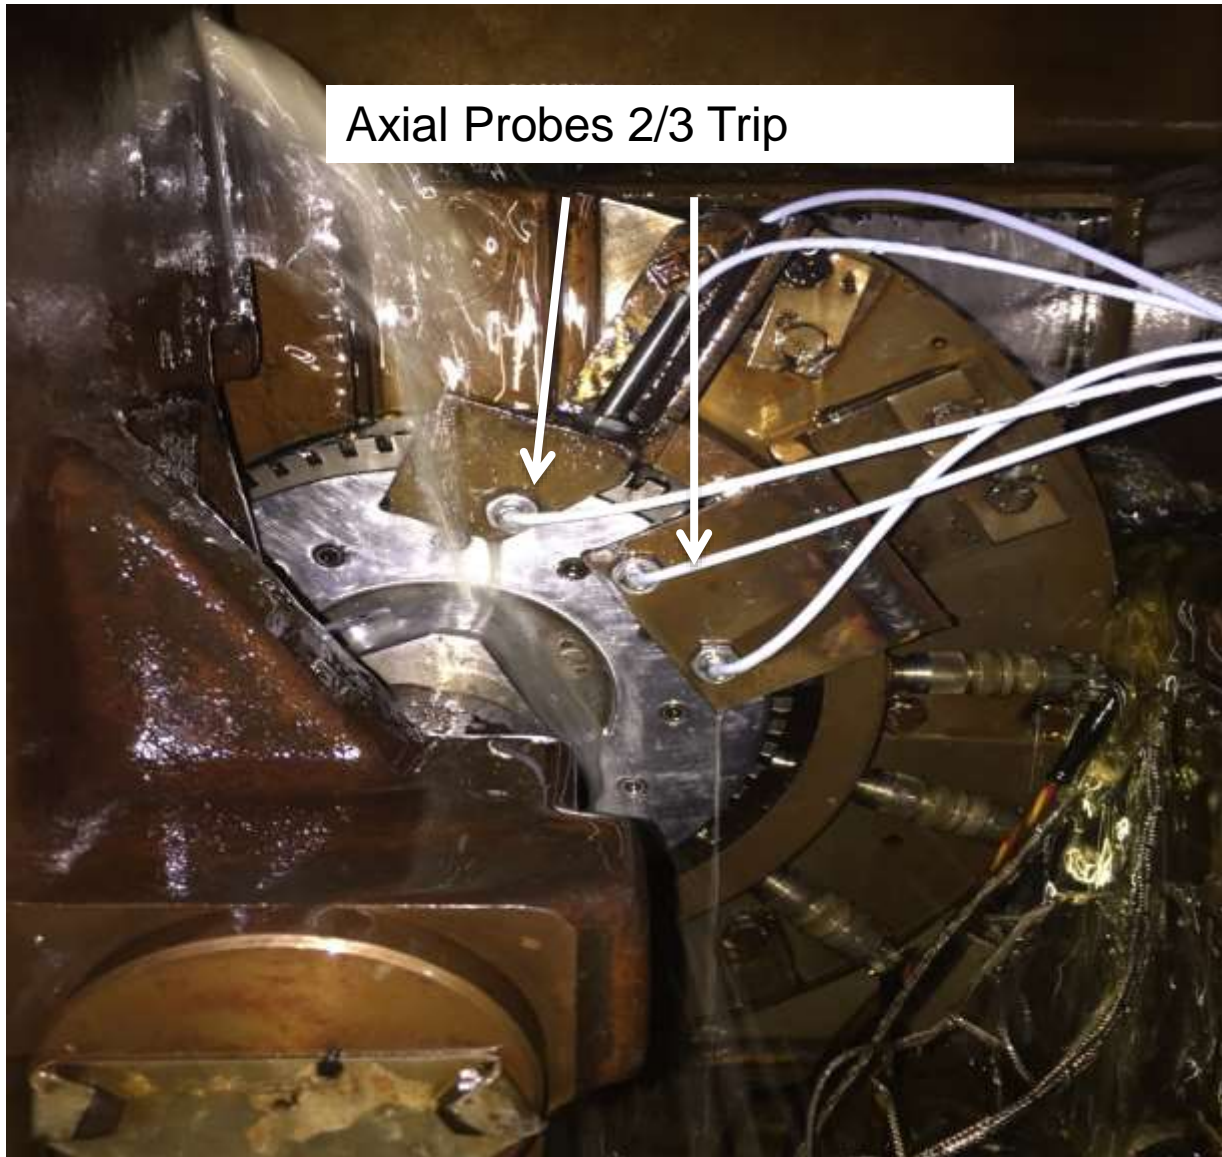
Normal configuration of axial position probes

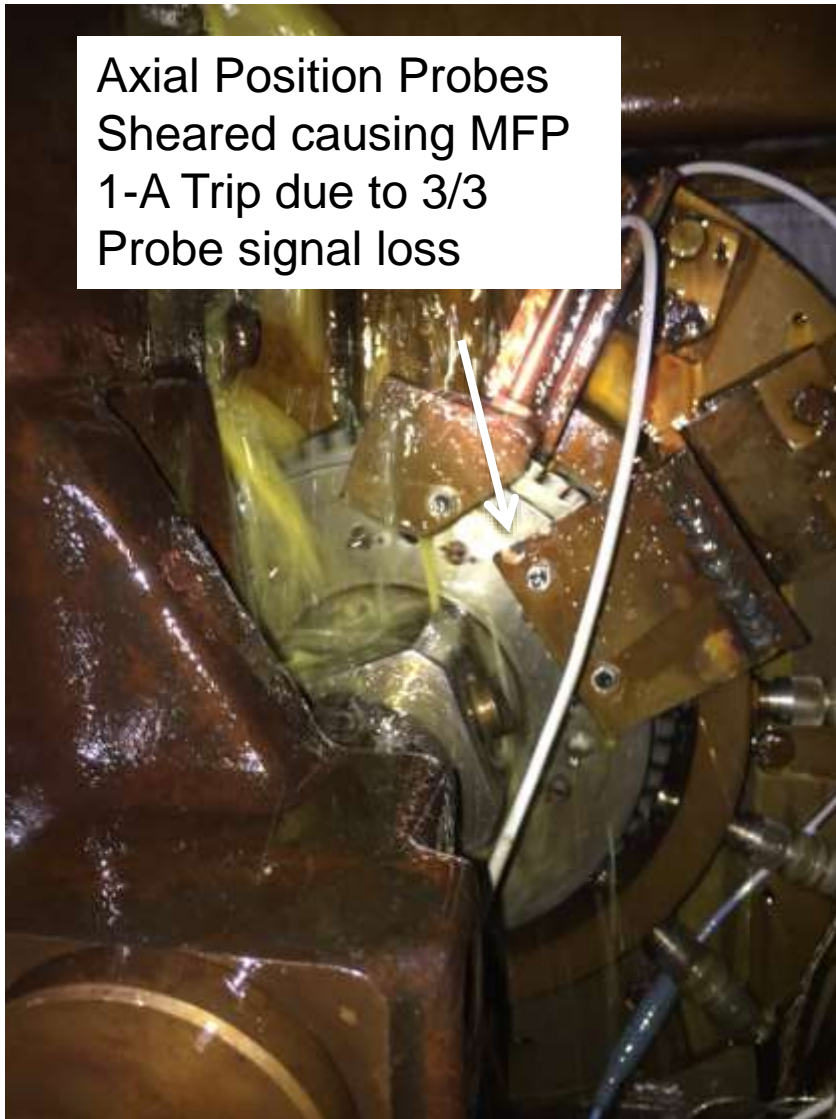
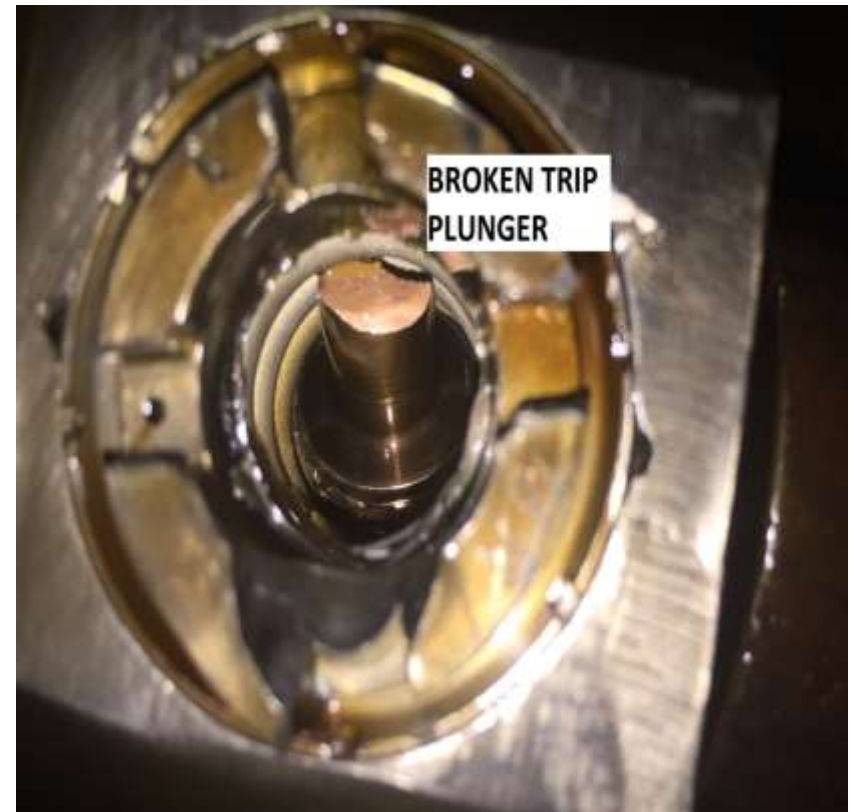
As Found condition of Axial Position Probes

- The Emergency Governor Plunger experienced a fatigue failure of the perforated disk that holds the plunger in place by a spring. This fatigue failure caused the bolt to be no longer restrained within the trip housing, shearing off the proximity probes. The fatigue failure was enabled due to a failed solenoid that did not allow the Reset/Trip Piston to fall which allowed excessive contact to the trip trigger during overspeed testing.

- CA1 (CAPR): Create PM to replace SV-8 during major teardown inspection (~7-1/2 yr) For 1/2-MSTDFP-01/02
- CA2: Revise ETP-302 series procedures to include the following:
 - 1. Add a Note or a Caution concerning the instantaneous trip of the device that should occur during this PM.
 - 2. Add abort criteria and additional monitoring instructions for conduct of the PM.
 - 3. Reinstitute the <900 MWe

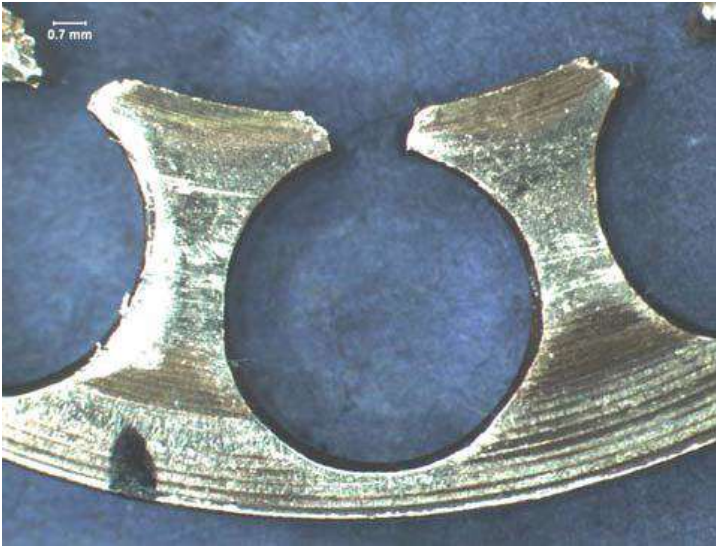
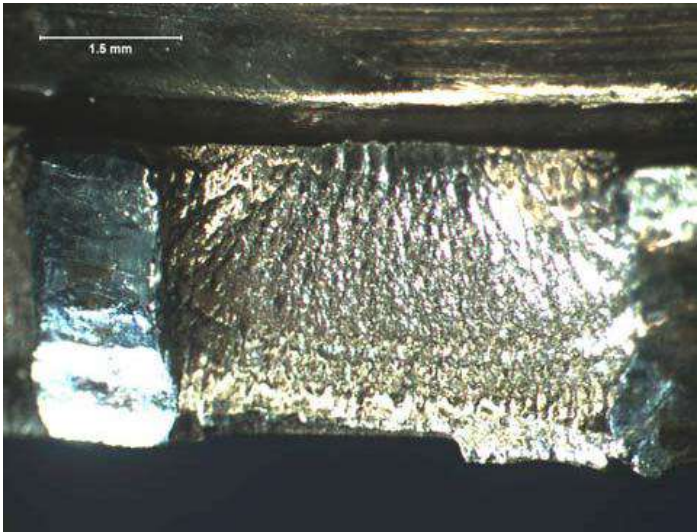
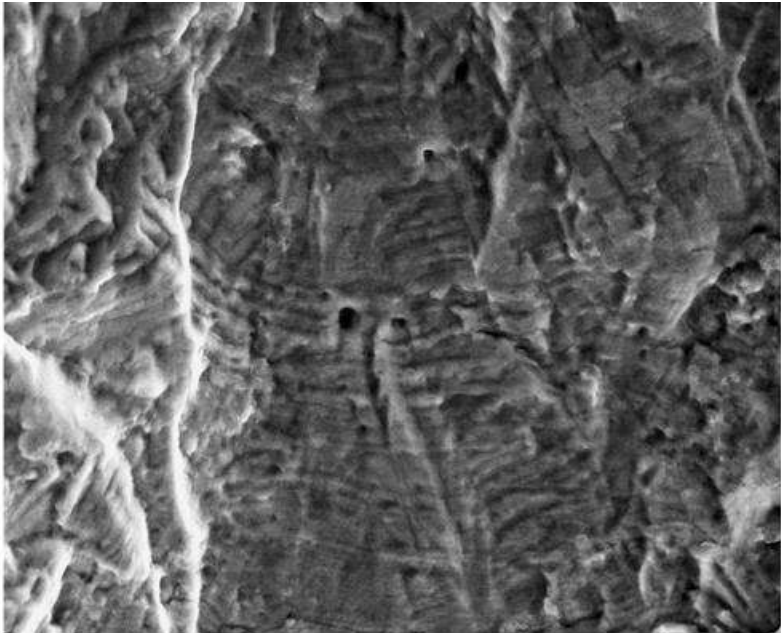
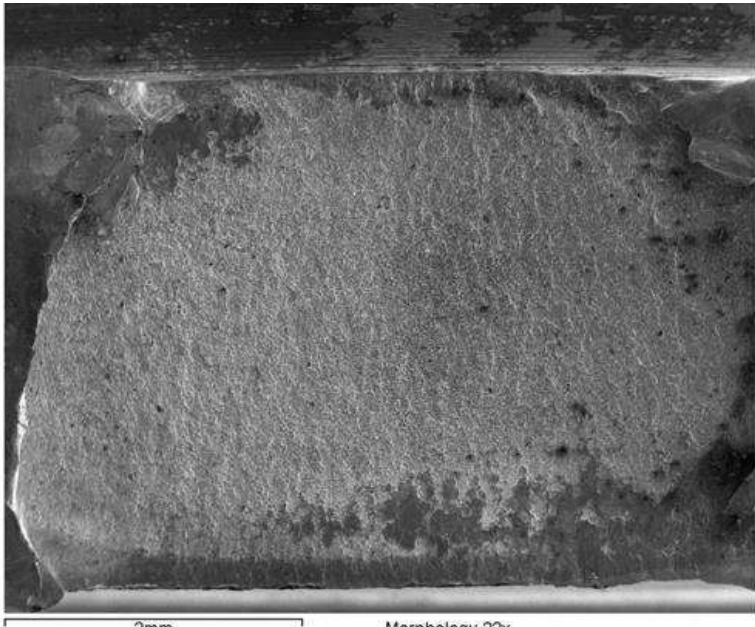
- Failure analysis found that the trip plunger experienced fatigue failure from the tens of thousands of impacts it experienced from holding the trip exercise down for that amount of time. The cause of the MFP not tripping on demand was the reset solenoid was mechanically stuck in the reset position preventing the trip cylinder from falling

Fatigue Failure

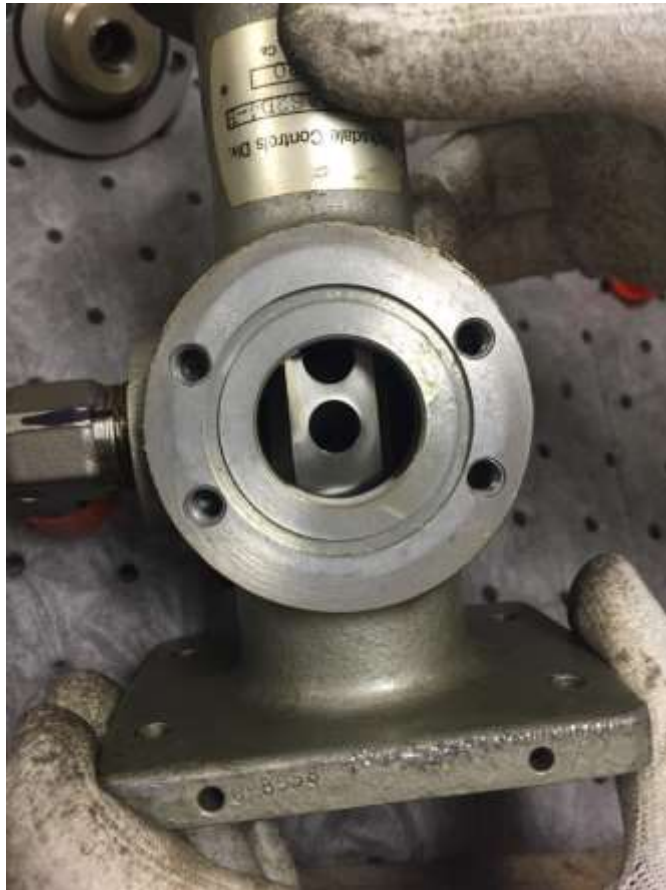
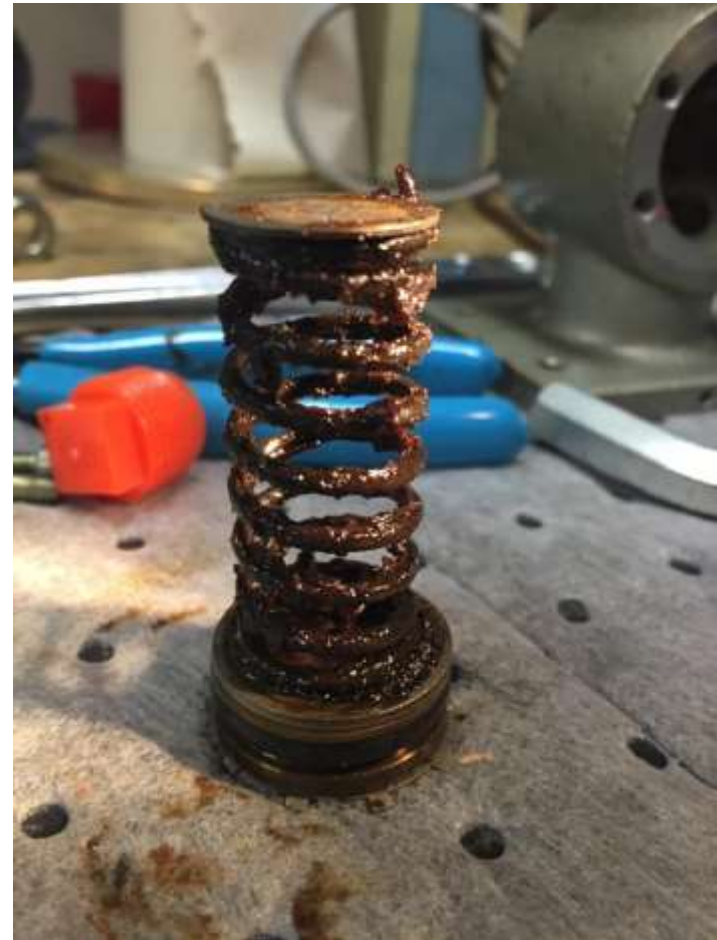
- The Reset Solenoid failed in the energized state and did not have a PM
- (Non-Crit RTF)
