MSR Drain Tank Level Control Valve Positioner Failure

Paul Bott – Brunswick Nuclear Plant

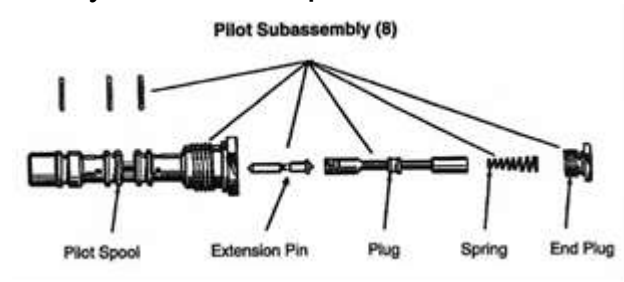
- A copy of the pilot subassembly schematic provided in the Vendor Technical Manual provided with the spool valve.

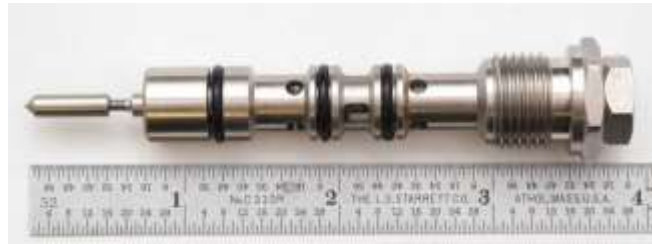
- A digital photograph of the spool valve in the as-received condition.

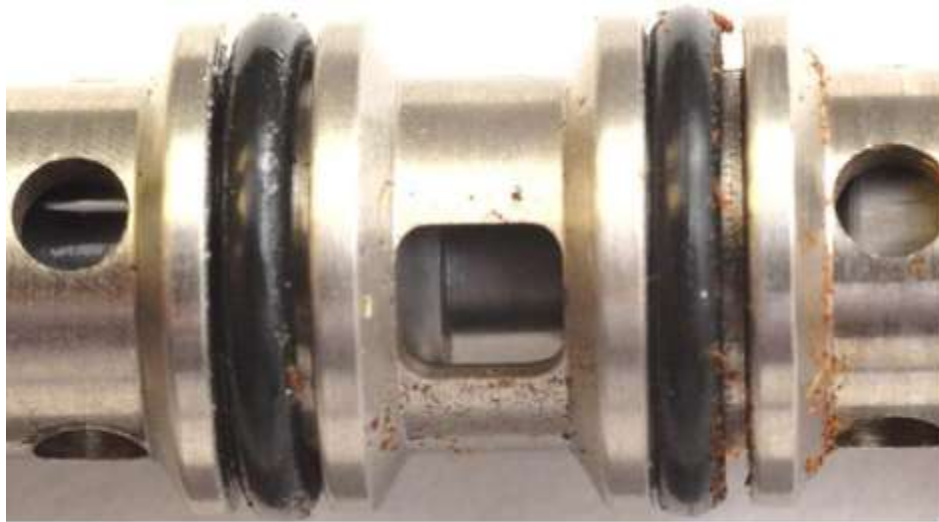
- Close-up digital photographs of the spool valve in the as-received condition showing the debris observed on the exterior surfaces of spool.

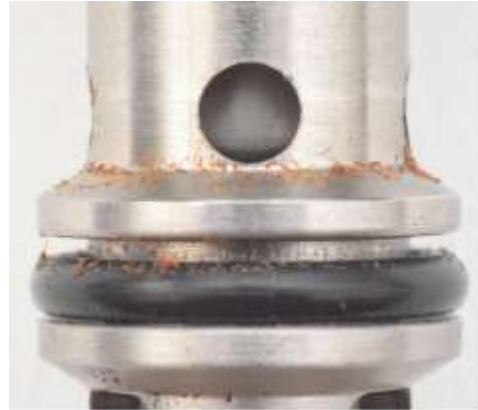
- A close-up digital photograph of the spool valve in the as-received condition showing the O-ring condition and an enhanced view of the fibrous debris.

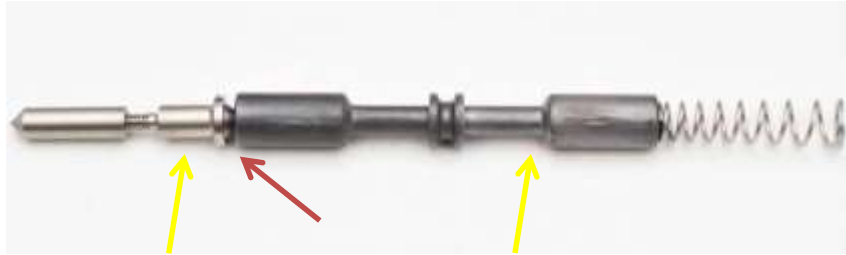
- A close-up digital photograph of the spool subassembly showing the extension pin, plug, and spring after being removed from the spool. The yellow arrows indicate degraded areas observed on the surfaces of the cylindrical portions of the plug and the red arrow indicates a gray colored deposit observed on the chamfered edge of the cylinder.

- Galling of the positioner pilot subassembly is attributed to normal service wear over an extended service life.

- WO 1344969-11 replaced the positioner's pilot valve and the positioner was restored to service.
- The removed pilot subassembly was sent to Duke Energy Metallurgy Services for evaluation.

- At time of the failure there was no PM for replacement.
- EPRI recommendations Critical positioners should have a PM replacement frequency of 10Y, or 5R.
- The failed positioner was in service for 9 years.
- Brunswick decided to have a PM replacement frequency of 6Y or 3R.

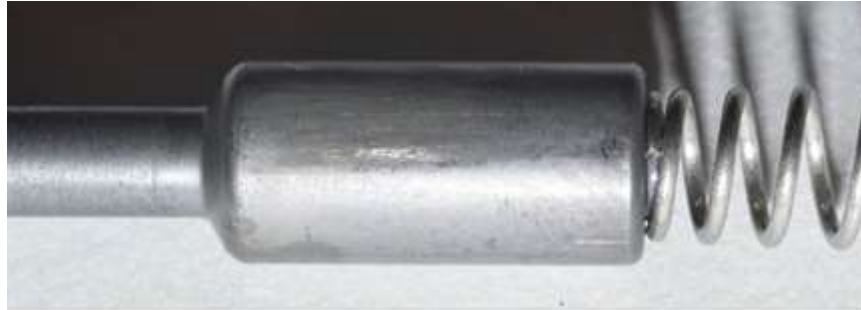
- A digital photograph of the end-plug side cylinder where the most severe degradation was observed.

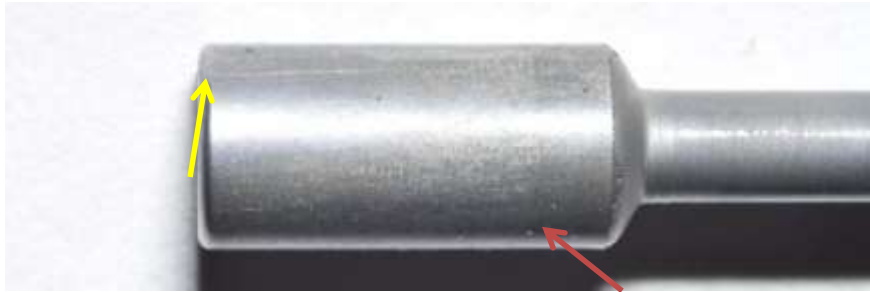
- A digital photograph of the extension pin side cylinder with a red arrow indicating the deposit observed and a yellow arrow indicating the degraded area of the cylinder.
