# August 20-21 FWHLC BWROG

## Dresden 2015 FWLC Scrams & 2014 Turbine Trip due to MSDT LT failure

Dave Kijowski  
Feedwater Heater System Engineer  
Dresden Station

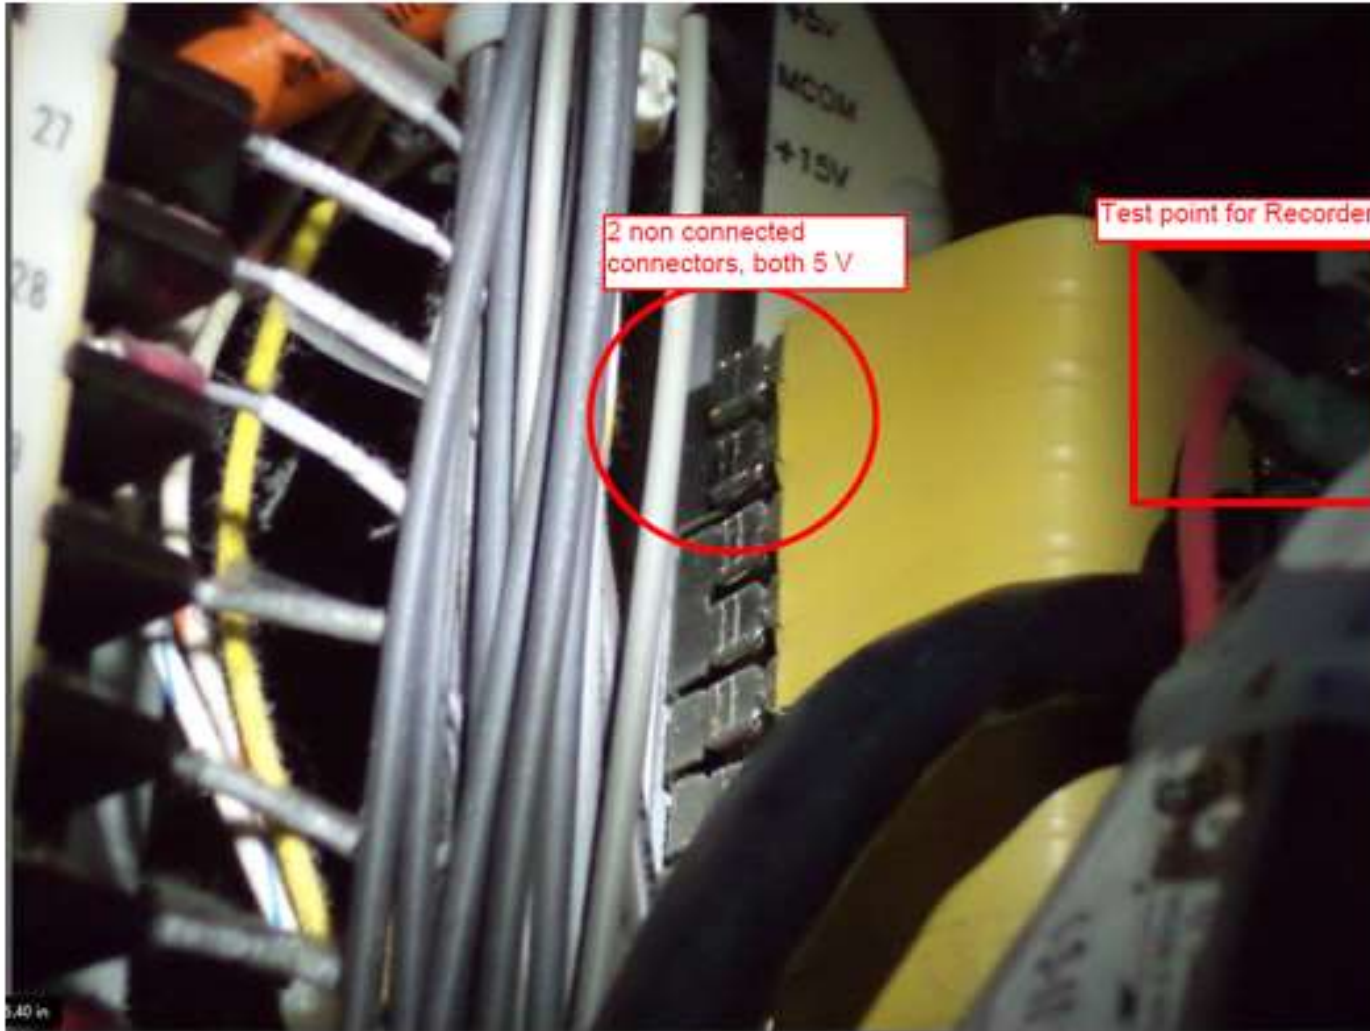
A root cause of both the manual scram initiated on Unit 2 on 01/13/15 and the scram on 02/06/15, is a spurious power interruption on a historically **improperly landed power supply ribbon cable** connection for the digital FWLC system, which caused a momentary 5Vdc power supply loss to the FWLC Multi-Function Processors (MFP).

Unit 2 FWLC System Power Supply Ribbon Cable with faulty connection:

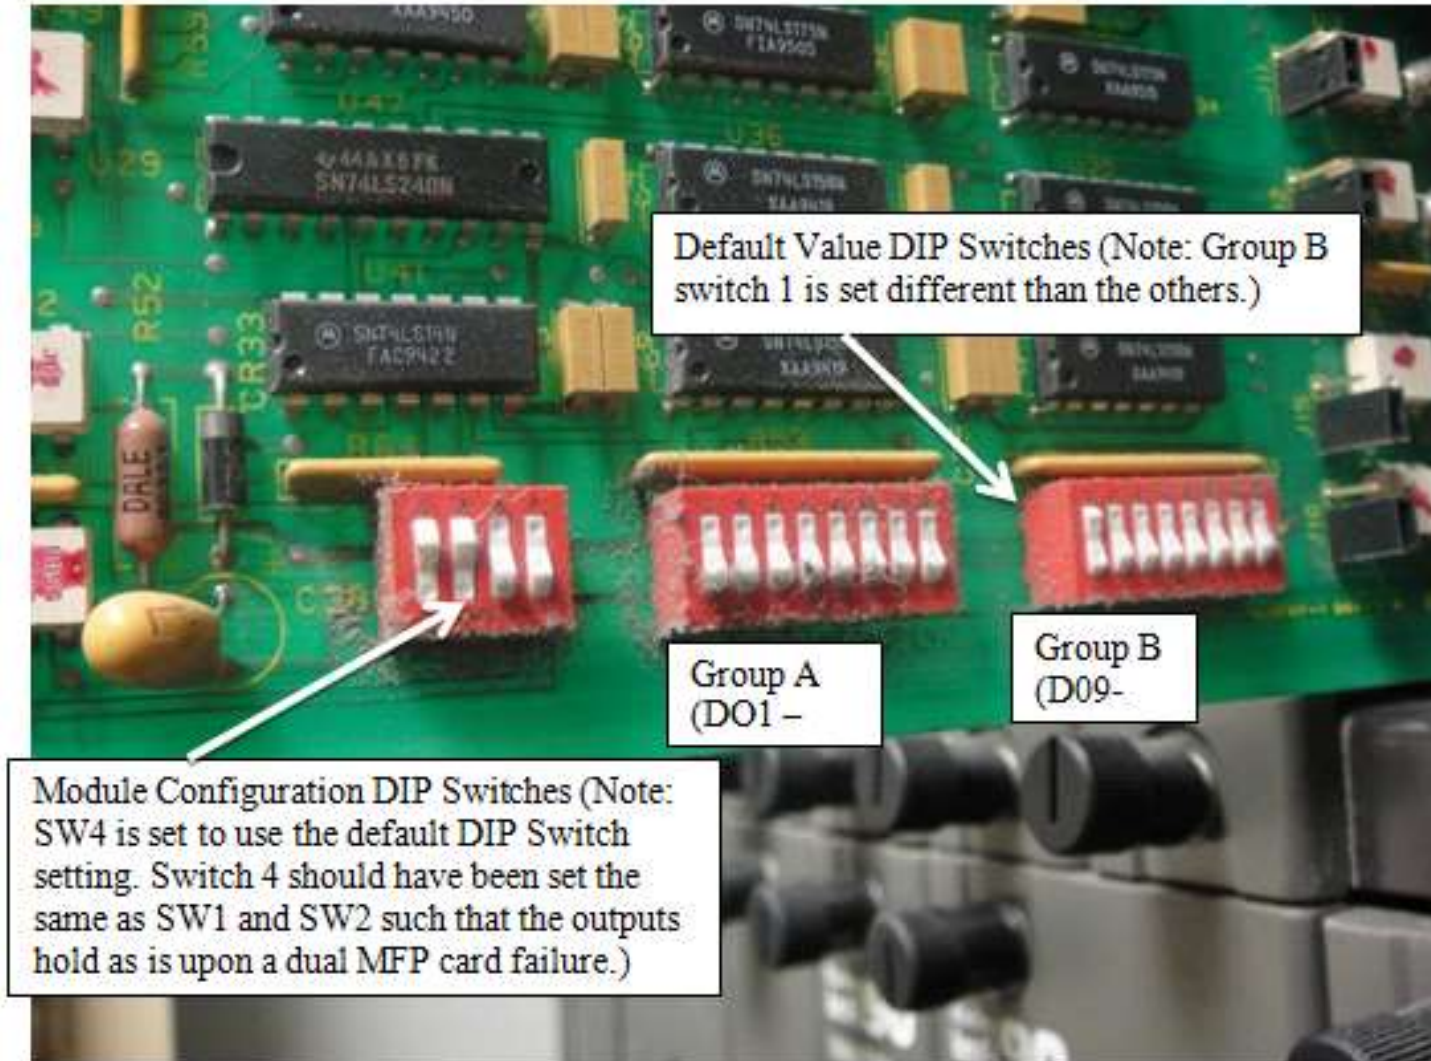
## Digital I/O Slave Module (IMDSM05) DIP Switches:

Design Engineering Electrical identifies to members of the troubleshooting team and root cause team that the previously observed spurious 2A RR pump runback could be due to an incorrect DIP switch configuration on the Bailey I/O circuit cards. (Actions to check the DIP switch positions were to be included in the original root cause report, but Unit 2 scrambled two days later on 02/06/15 before the root cause report was complete and any actions were initiated).

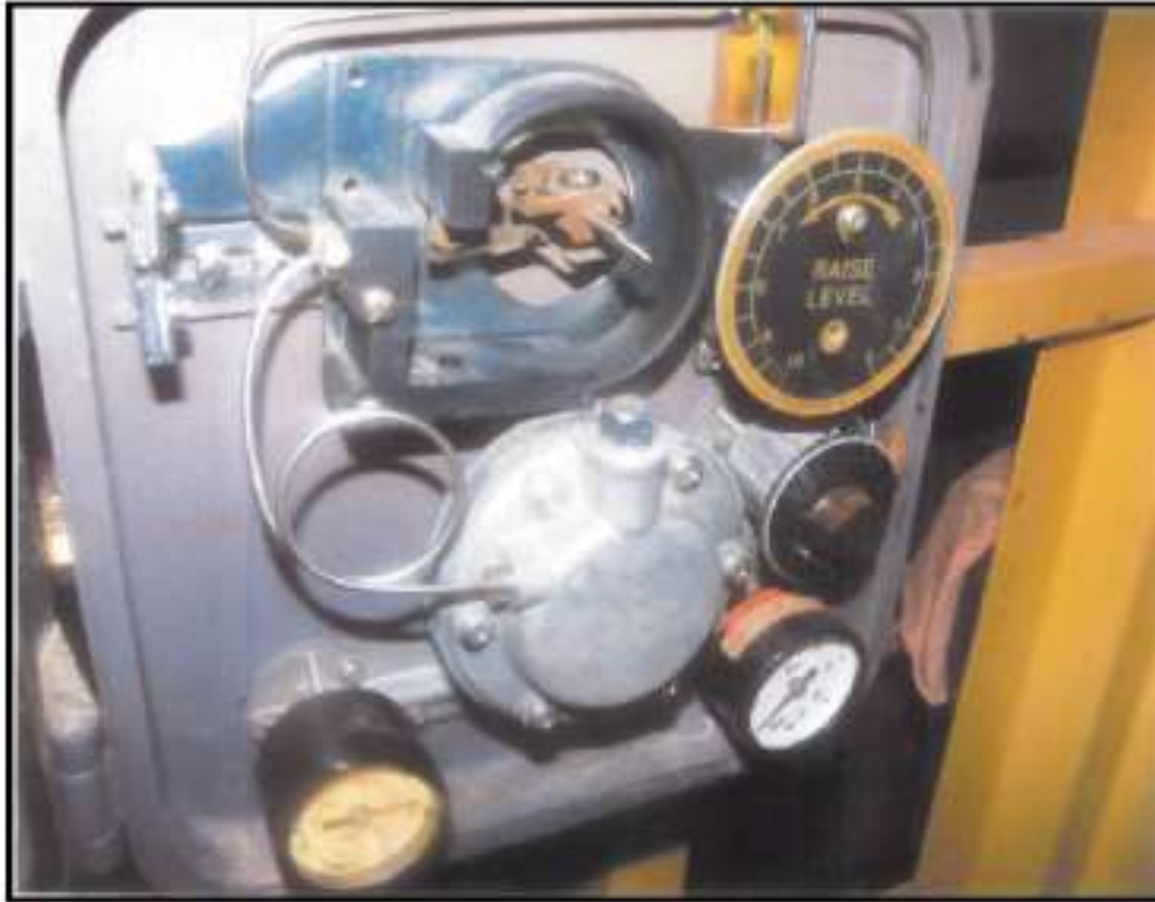
Failed Zero Adjustment on the 2B Normal LT discovered in May 2014

**Photograph 1**  
**Field Photograph of the Actual Controller/Transmitter**  
**Note: Level Set Adjustment Handle was Out of Place (Found Behind Dial)**

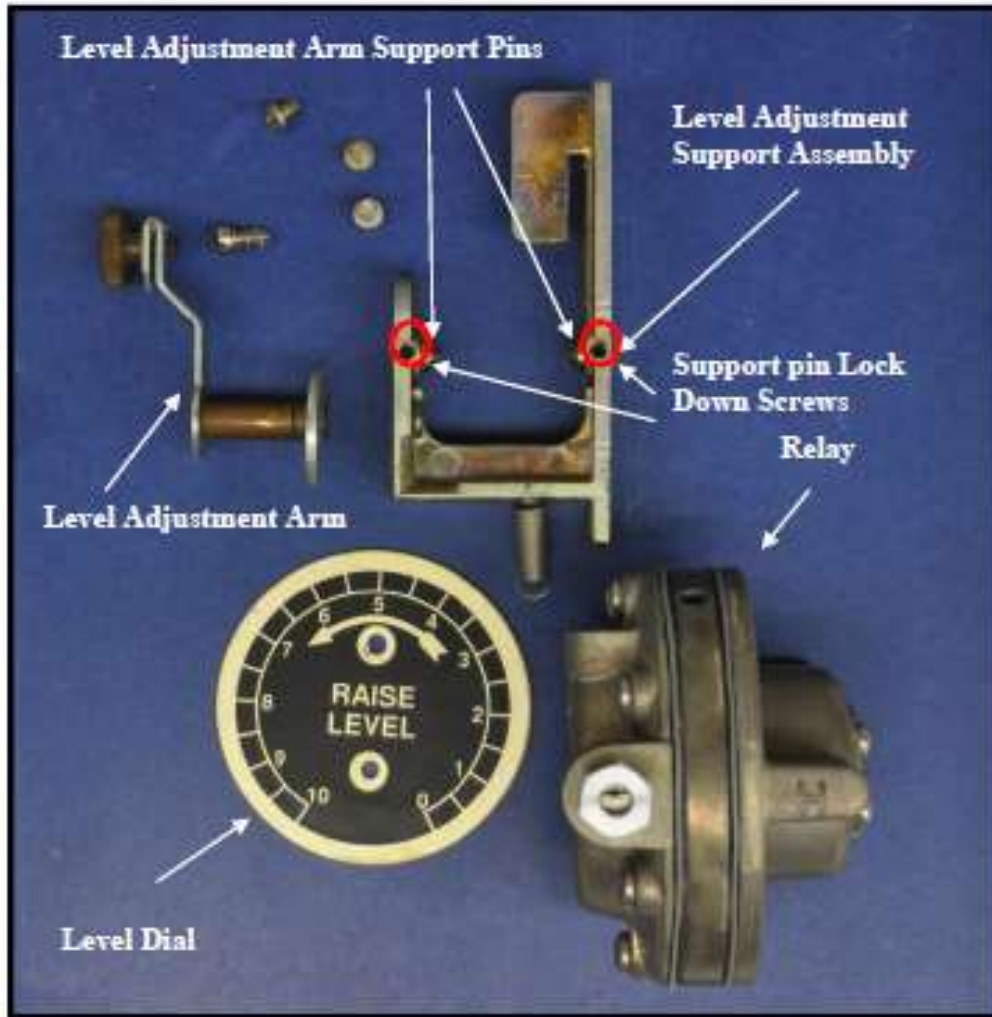
**Failed Zero Adjustment & Pneumatic Relay from the 2B Normal LT, replaced in May 2014**

**Photograph 2**  
Components Submitted for Analysis

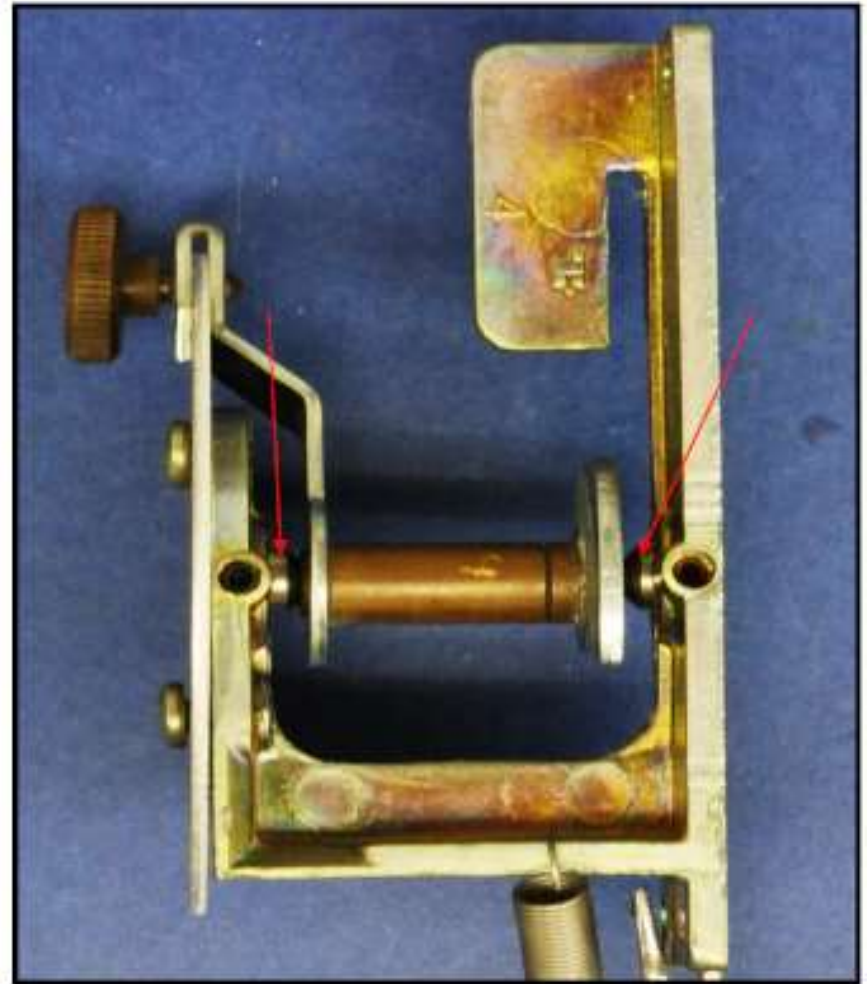
In order to determine how the level adjustment lever became dislodged from the level adjustment support assembly, the support screws were tested for tightness. It was noticed that both of the support pins that hold the adjustment lever in place could be moved by hand pressure, which would explain why the lever fell out during service. When pins were moved back to their original positions, the set screws were found to be loose.

Photograph 3  
Level Adjustment Assembly Shown Assembled  
Note: Pins that Support the Adjustment Arm

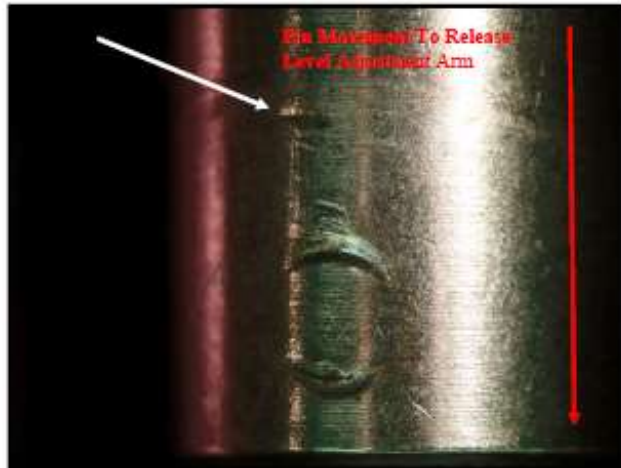
Photograph 4  
Front Support Pin Showing Initial Indent from Screw being Tightened Down and Score Mark from Screw Moving, Arrow Indicates Where Screw May Have Settled After the pin Moved

The set screws were fully loosened and the pins were extracted and examined further under light microscopy. Both of the pins showed deep indents where the set screws were originally tightened down. However, both pins also contained additional set screw marks which indicated that the pins had slightly moved from their original positions. The small axial movements of the pins would have allowed the adjustment lever to fall out. The front support pin also contained a shallow scratch/score mark which confirmed that the pin had moved during service.

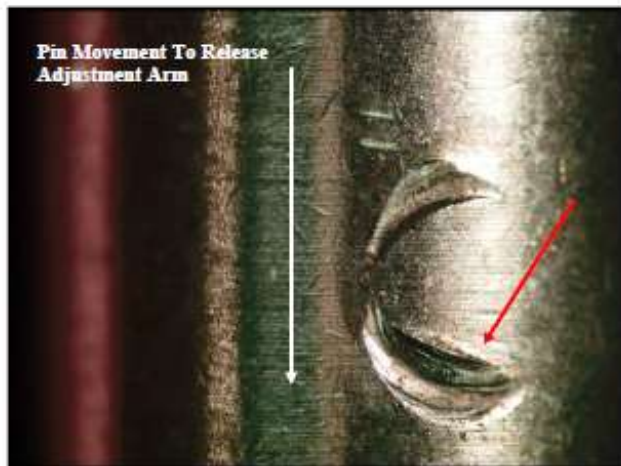
Photograph 5  
Rear Support Pin Showing Indent Mark from Screw  
Note: Rolled up Material At Edge Possible Indicating that When Screw was Loose the Pin was Forced Backward Upsetting the Metal

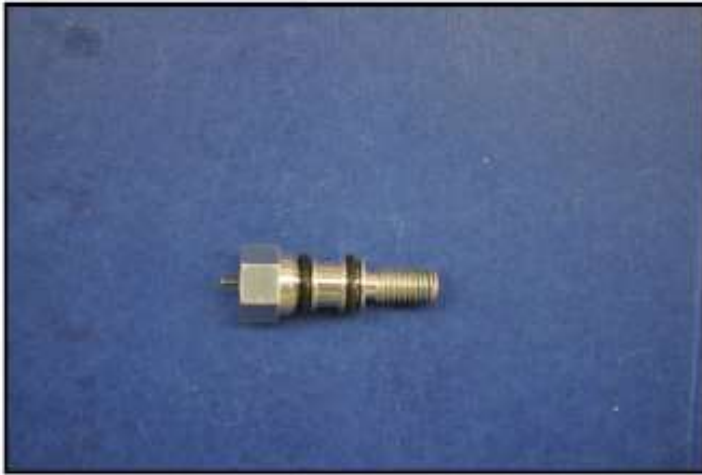
Photograph 6  
Orifice Fitting Removed from Relay

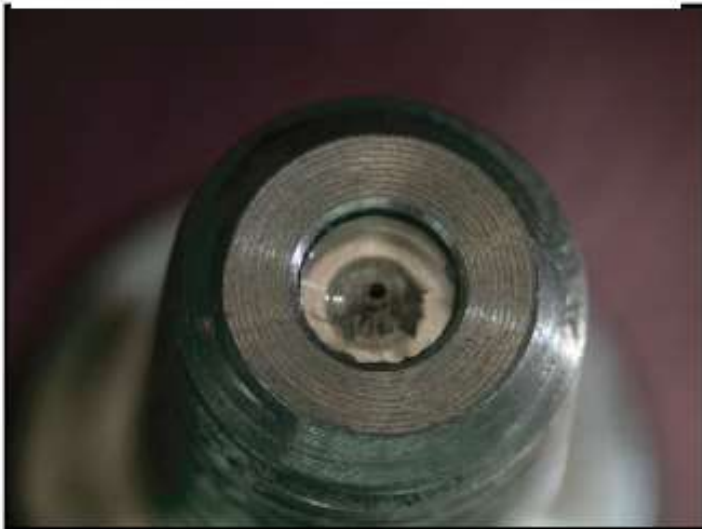
Photograph 7  
Orifice Hole After the Piece of Foreign Material had been Dislodged

- Orifice found blocked
- However when the piece blocking the orifice was attempted to be recovered, the piece was dislodged and lost so no additional evaluations could be performed.
- Further examination of the relay was performed by dismantling and inspecting the different chambers.
- When the chamber dead space was examined, there appeared to be small cast material flakes that could easily be dislodged.
- It is possible that one of these flakes was the source of the blockage.

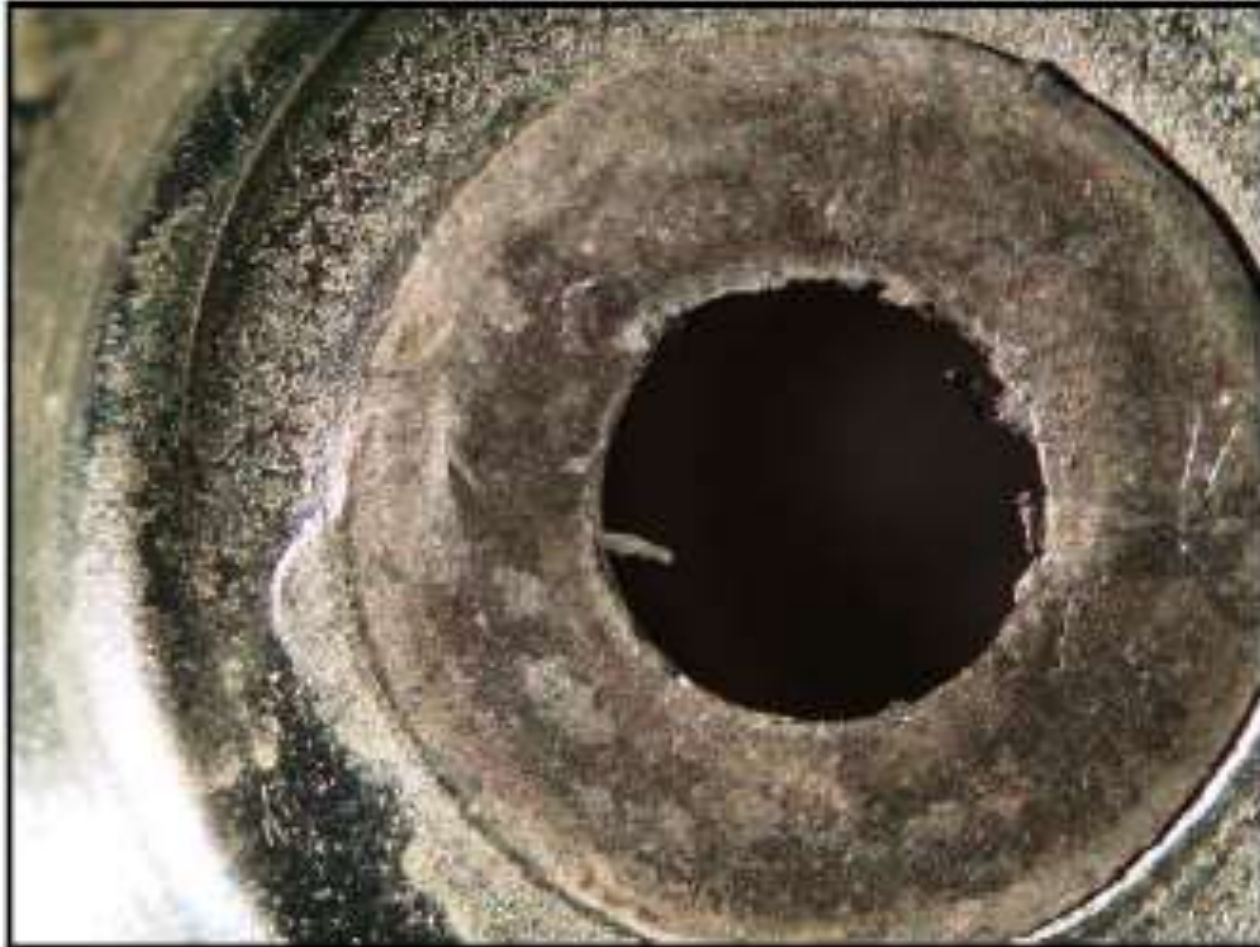
**Photograph 8**  
**Dead Space on one of the End Plates Showing Small Cast Material Flakes that Could Easily be Dislodged**
