PLANT HATCH FEEDWATER SYSTEM OPERATING EXPERIENCE

Significant events from 2015

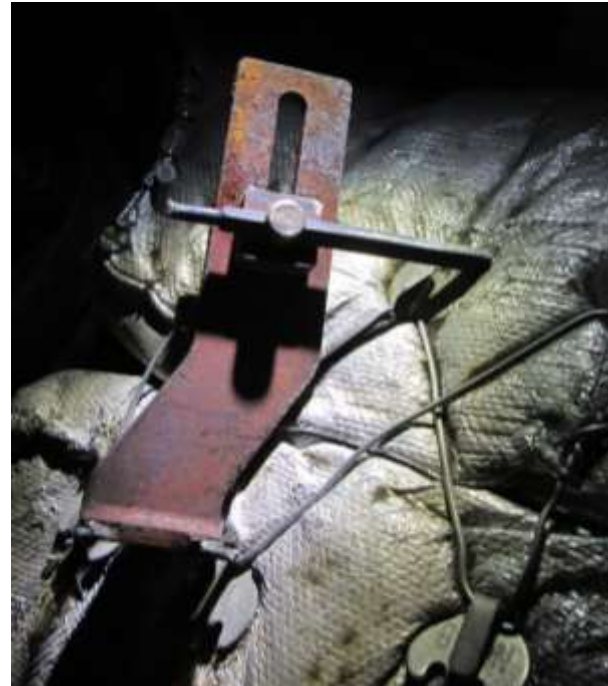
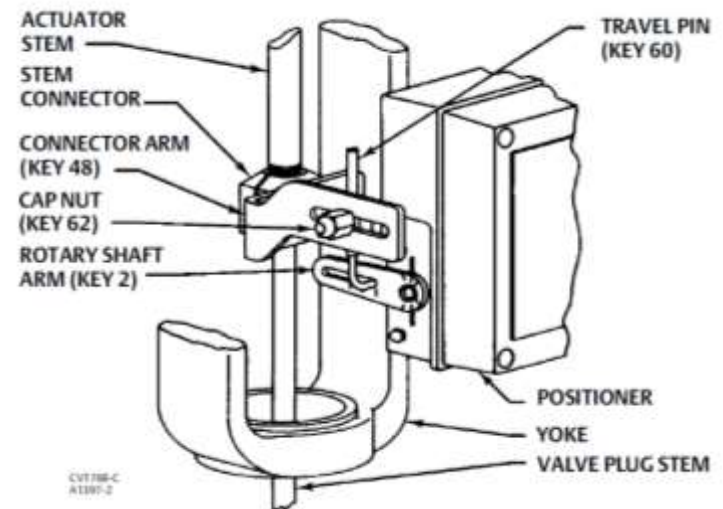
Valve Failure

- AOV Positioner stem connector arm broke & detached
- Valve control was lost
- FWHLC system oscillations occurred
- 8th stage B FWH isolated on high level

Causes

- Actuator stem was loose and could rotate freely
- Rotation caused wearing of the positioner stem connector, and its eventual failure
- Wearing identified during previous refueling outage (2014), but no investigation was done. (parts replaced only)
- 8th stage B FWH level indicator (Yarway) had drifted out of calibration low.
 - Caused erroneous low level alarms
 - Level was raised in FWH to prevent alarms, reducing margin to high level isolation

Corrective Actions/Lessons Learned

- Rebuilt valve actuator
- Revised maintenance procedure to include checking actuator stem for rotation
- Reevaluated PM frequencies & scope
 - BOP AOV PM “project”
- Increased priority placed on digital FWHLC upgrade project
 - Evaluating use of no-contact positioners

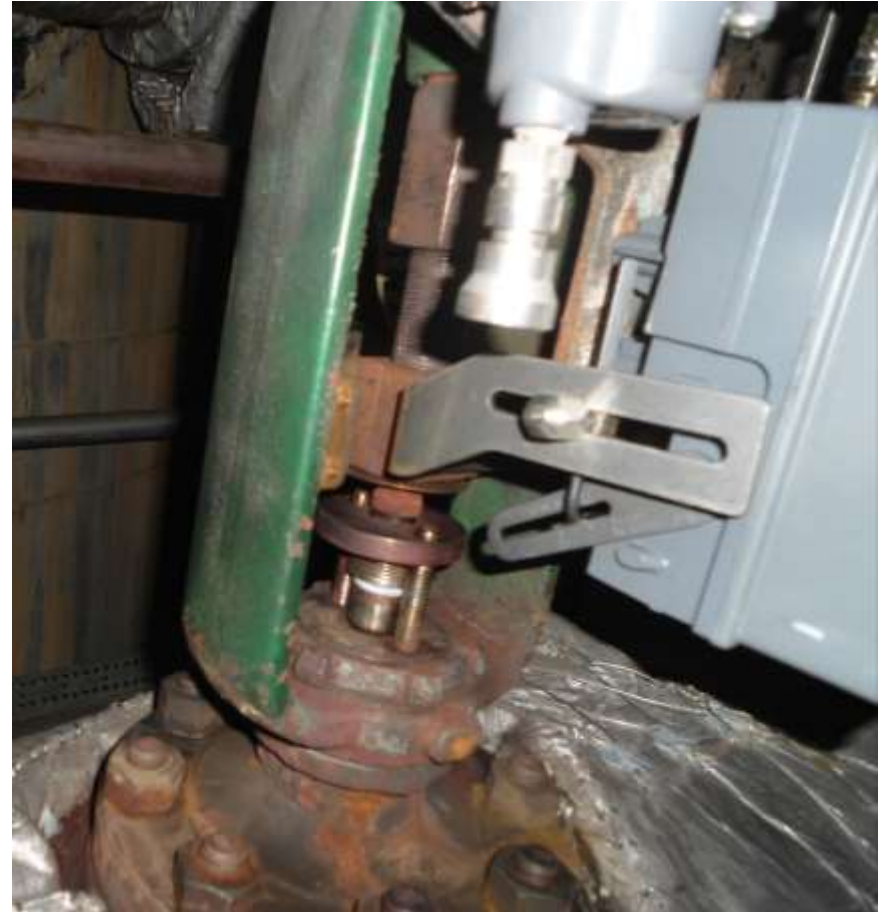
Valve Packing Failure

- Packing nuts backed off
- Packing was ejected out from the valve
- Resulted in large steam leak

- Sudden steam leak relieved system pressure
 - Condensate in the drain tank flashed
 - High level switch actuated
 - 2nd stage MSR steam supply isolated
- Reactor pressure increased
 - Main Turbine Bypass valve #1 opened ~15%
- Reactor power reduced manually 0.5% via recirc
- Repairs required Unit 1 downpower to 17% and Main Turbine Tripped
 - Unable to isolate leak, High Temperature, High dose

- Vibration induced nut loosening
- Vulnerable design
 - Multiple pipe elbows & elevation changes
- System not upgraded for EPU
- Inadequate pneumatic control system
- Proposed digital upgrade not implemented
- CCI drag valves used for high level dumps
 - CCI valves installed in 2012
 - Snap acting relay results in actuation from 0-17% open instantly before controlling
 - Closes fully from 17% open
 - Causes water hammer

- Add second packing nut to the 2nd stage drain tank valves
- Further emphasis on digital FWHLC system
- System study performed to identify vulnerabilities and recommend system improvements

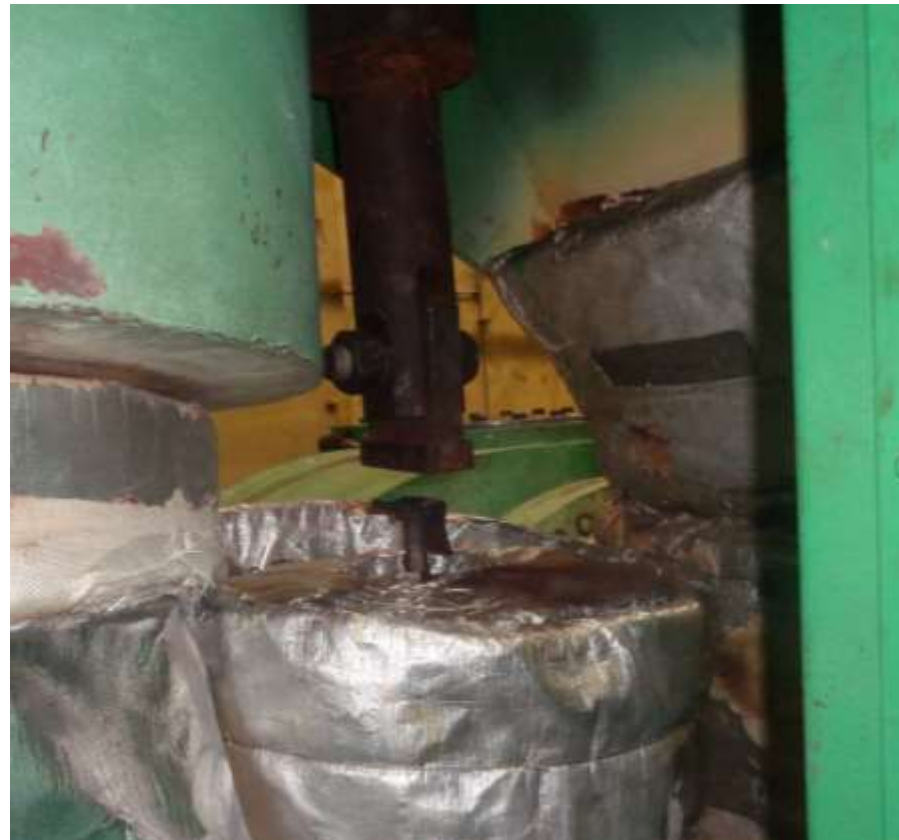
Valve Stem Failure

- The valve stem for the HP control valve failed, preventing the valve plug from lifting when demanded

- As the 1B RFPT was being removed from service, the 1A RFPT attempted to increase speed to maintain feedwater flow.
- The LP steam at reduced power was insufficient
- Controls demanded HP steam
- HP steam was not supplied, 1A RFPT speed did not increase as much as required
- Reactor water level decreased
- Reactor Recirc Pump runback on low level
- ~20% power reduction (unplanned)

- Improved maintenance procedures
 - Added requirement to use lock tabs
- Updated vendor drawings in GEK documents
- Include this item in Pre-Outage Turbine Team briefings

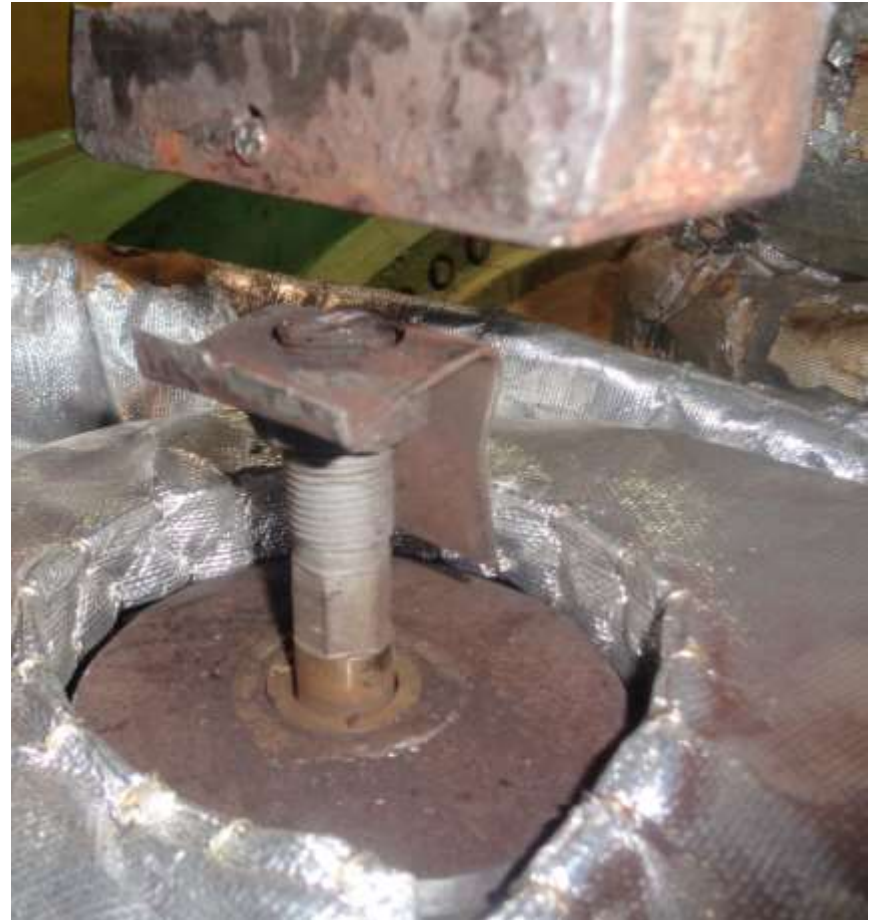
- HP valve stem was drilled twice
 - Each hole was 90 degrees from each other
 - Valve stem cross sectional area was reduced
- Inadequate Vendor Oversight
- Overreliance on vendor drawings
- Not utilizing maintenance procedures properly
