# EHC Fluid Contamination D.C. Cook – Unit 2

# EHC Fluid Contamination Background

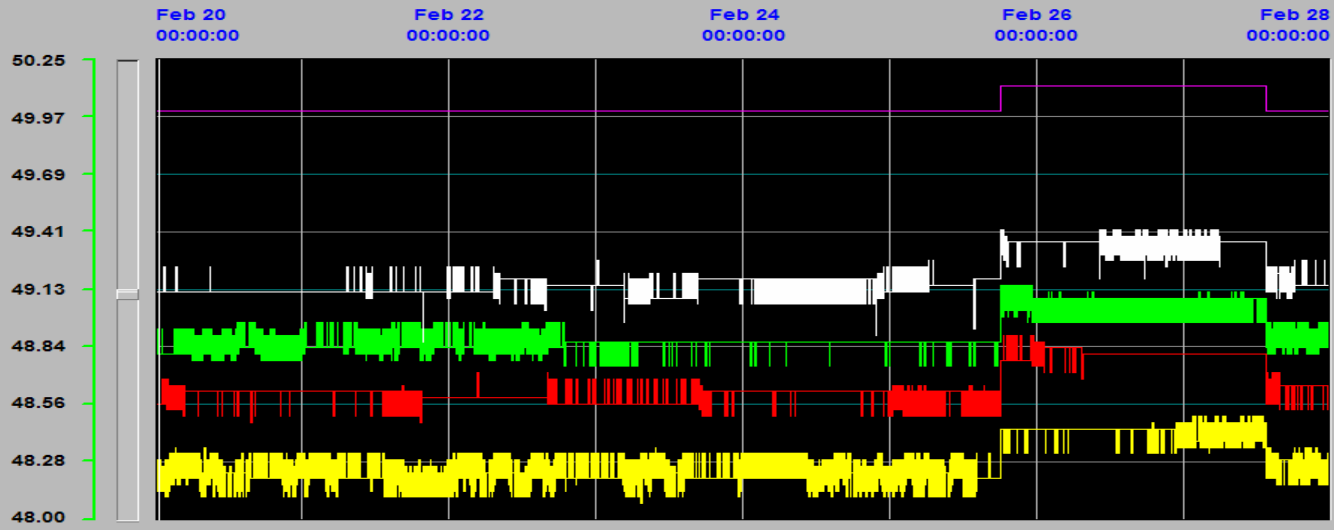
## Pre-U2C22 Operation

### Main Turbine Historical Trending

- a2\_OME90\_LI\_CV\_POSA *i*  
48.81 48.93
- a2\_OME90\_LO\_CV\_POSA *i*  
48.57 48.66
- a2\_OME90\_RI\_CV\_POSA *i*  
48.26 48.32
- a2\_OME90\_RO\_CV\_POSA *i*  
49.11 49.15
- \_\_\_\_\_ *i*
- r2\_CVA\_SPCA\_OUT *i*  
50.00 50.00
- FALSE *i*  
Unavail Unavail
- FALSE *i*  
Unavail Unavail

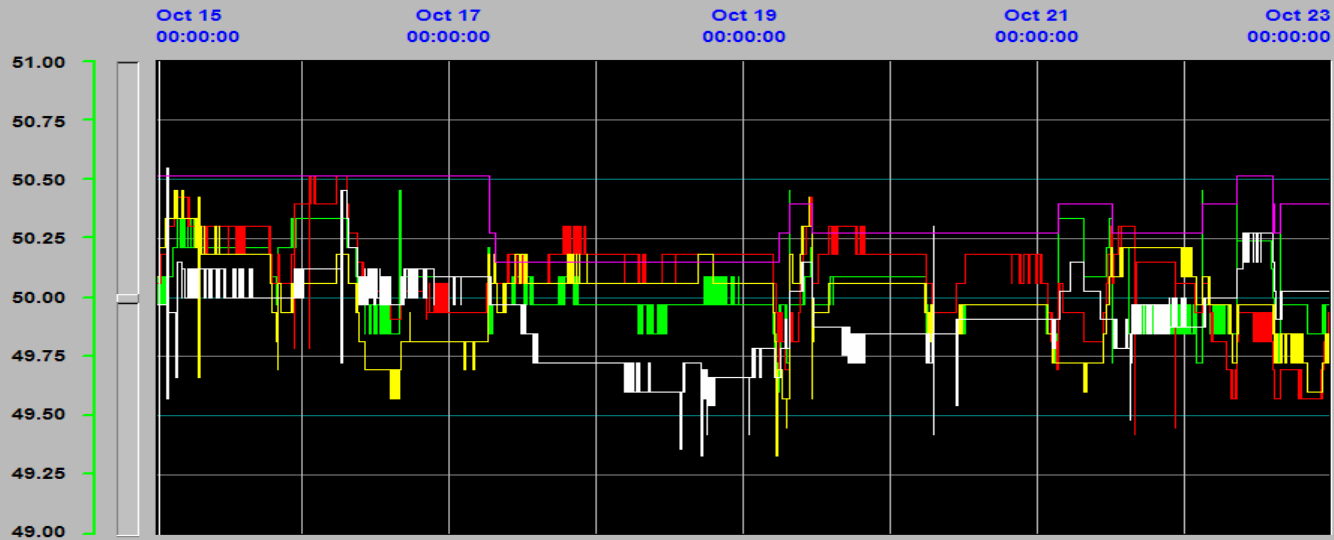
## Post-U2C22 Operation

### Main Turbine Historical Trending

- 51%
  - a2\_OME90\_LL\_CV\_POSA *i*  
50.01 49.97
  - a2\_OME90\_LO\_CV\_POSA *i*  
50.06 49.94
  - a2\_OME90\_RI\_CV\_POSA *i*  
50.21 49.73
  - a2\_OME90\_RO\_CV\_POSA *i*  
49.97 50.03
  - \_\_\_\_\_ *i*
  - r2\_CVA\_SPCA\_OUT *i*  
50.52 50.40
  - FALSE *i*  
Unavail Unavail
  - FALSE *i*  
Unavail Unavail
- 49%

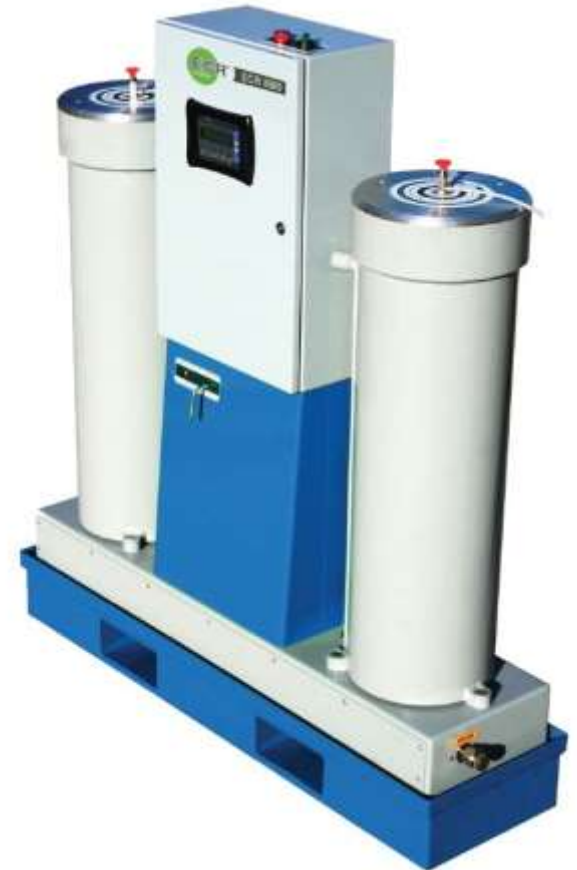
# ECR Skid

- Electrostatic Contamination Removal
- Removes sub-micron insoluble material
- improves resistive & air release properties.
