# Watts Bar Unit 1 A2 Feedwater Heater Partition Plate Weld Failure

# Watts Bar Unit 1 Feedwater Heating Overview

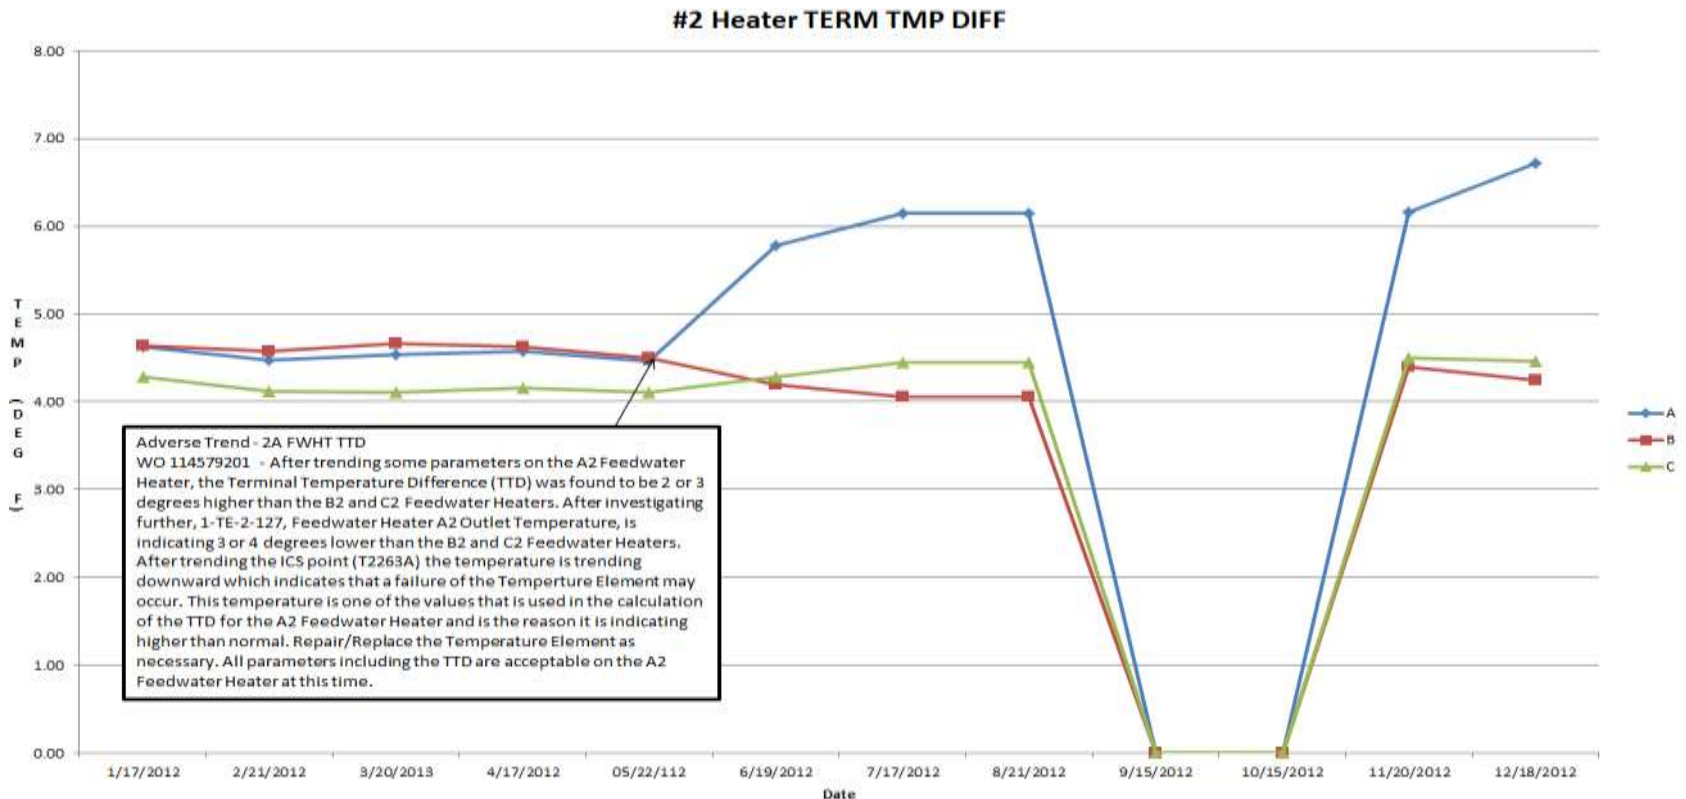
# Initial Event Discovery Information for 1A2 Feedwater Heater

- System Monitoring/Trending identified an adverse trend in the TTD associated with the 1A2 Feedwater Heater (Began in May 2012 when values increased to approximately 6 Deg F)
- Initial thoughts were the Thermocouple measuring Feedwater Outlet Temperature was failing

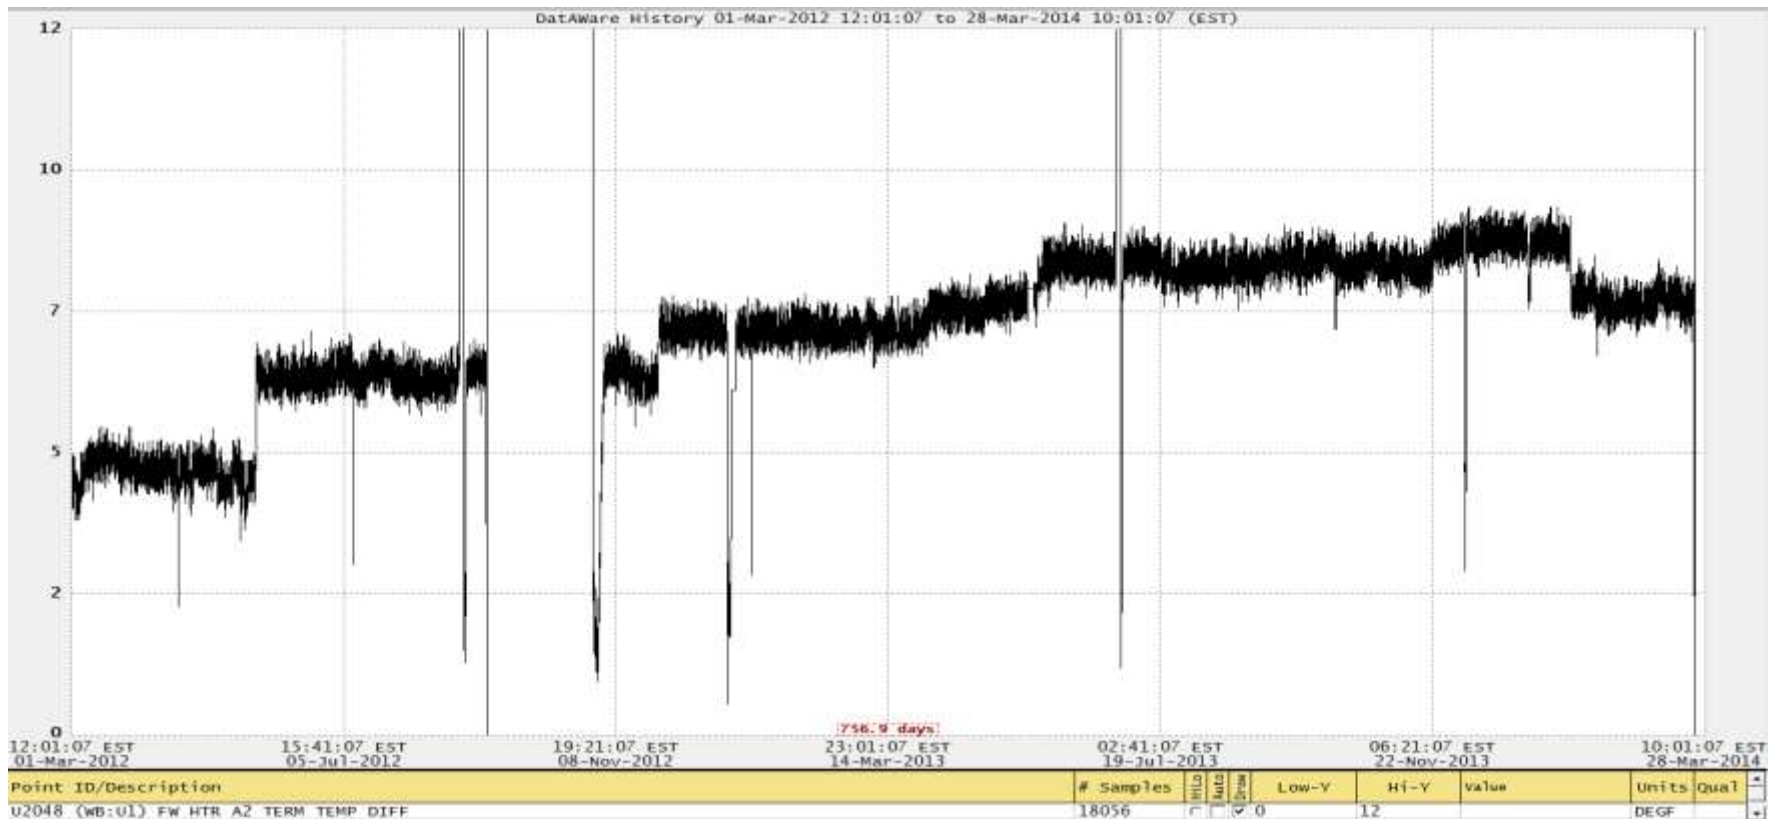
# Troubleshooting and Additional Findings

- Adverse Trend in TTD continued to worsen to approximately 8.5 Deg F (January 2014)
- Feedwater Outlet Thermocouple was replaced and the condition did not change (March 2014)
- Eddy Current Testing scheduled for WBN U1C12 Refueling Outage (Spring 2014)

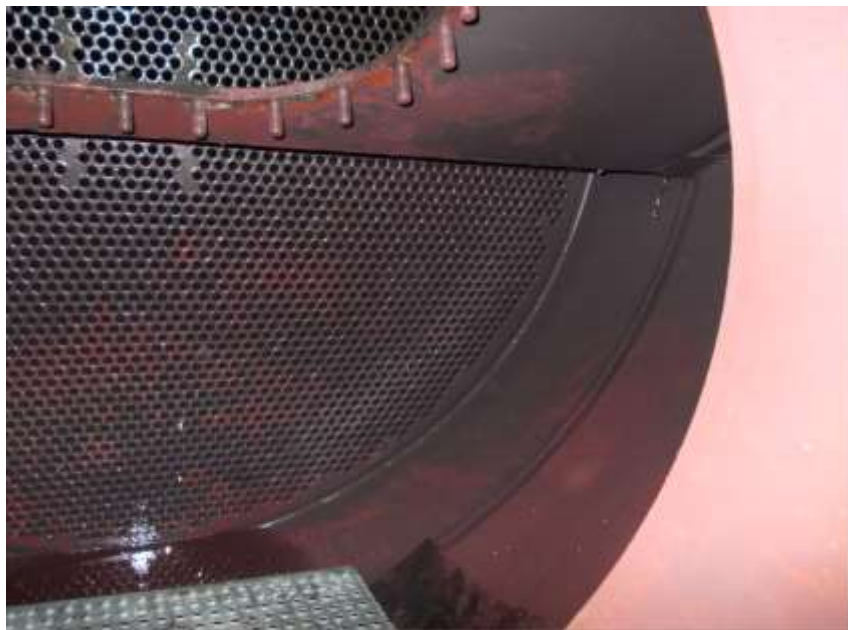
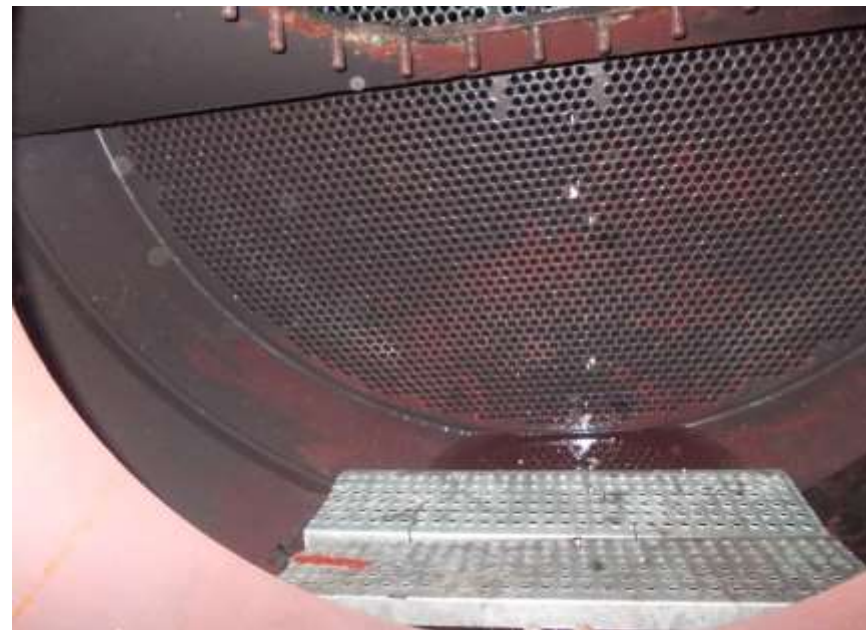
# WBN U1C12 Refueling Outage

- During WBN U1C12 Refueling Outage (Spring 2014), Eddy Current Testing was performed on the 1A2 Feedwater Heater and as a result, 4 tubes were plugged
- During the Eddy Current Testing, a black, slippery substance was found on the inside of the tubes which was a result of solidifying of the following substances:
  - Ethanolamine (ETA) – Condensate Corrosion Inhibitor
  - Iron
- No abnormalities were noted other than the ETA/Iron mixture that had plated out inside the tubes

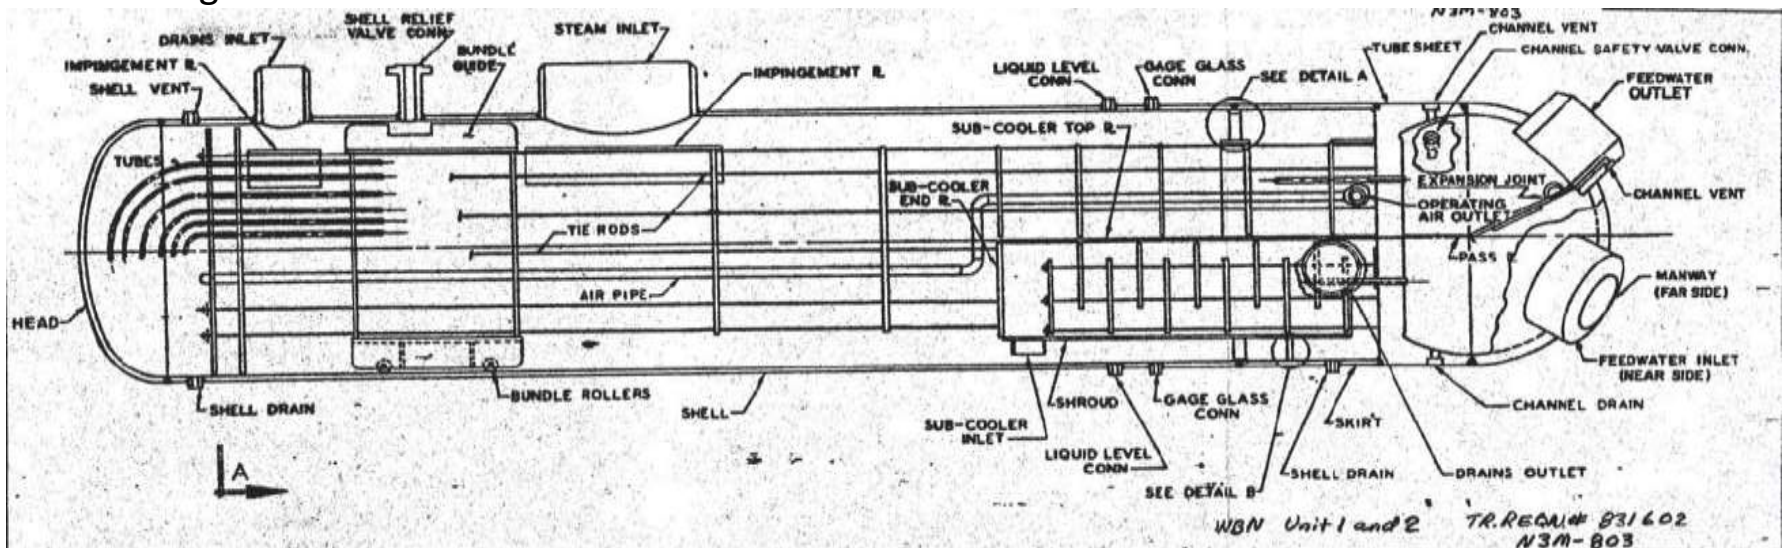
# WBN U1C13 Refueling Outage

- During Engineering Inspection with the Partition Plate Cover removed, a degraded weld was identified on the partition plate expansion joint (Found during Tube Cleaning for Eddy Current)
- 75% of the hemispherical weld on the expansion joint was eroded away which created a ¼ to ½ inch wide gap
- The degraded weld allowed a portion of the flow entering the 1A2 Feedwater Heater to pass through without gaining any heat load
- As a result, the performance/heat transfer associated with the 1A2 Feedwater Heater was accurately displayed in the TTD trends.
- The decision was made to grind out the degraded weld and re-weld back like the original design

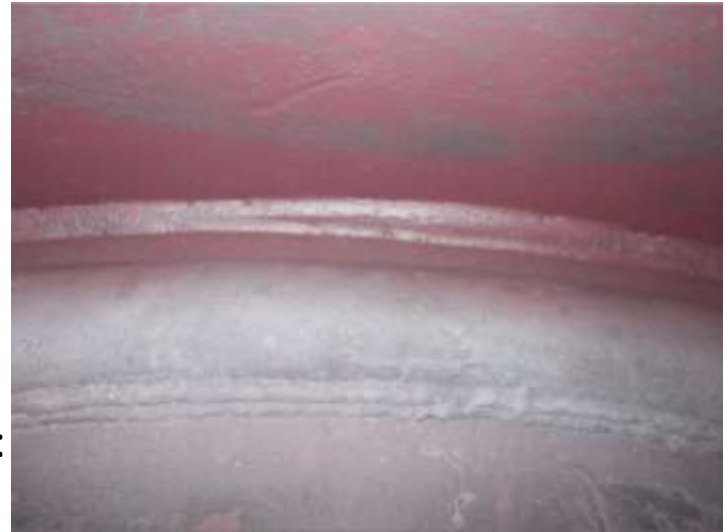
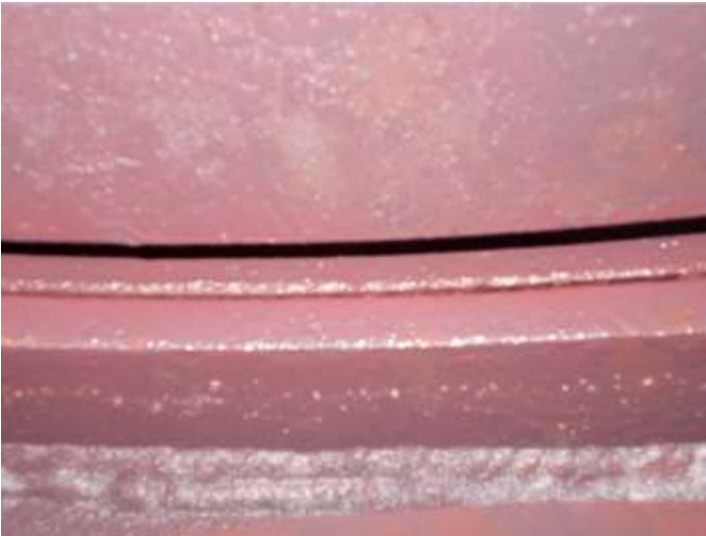
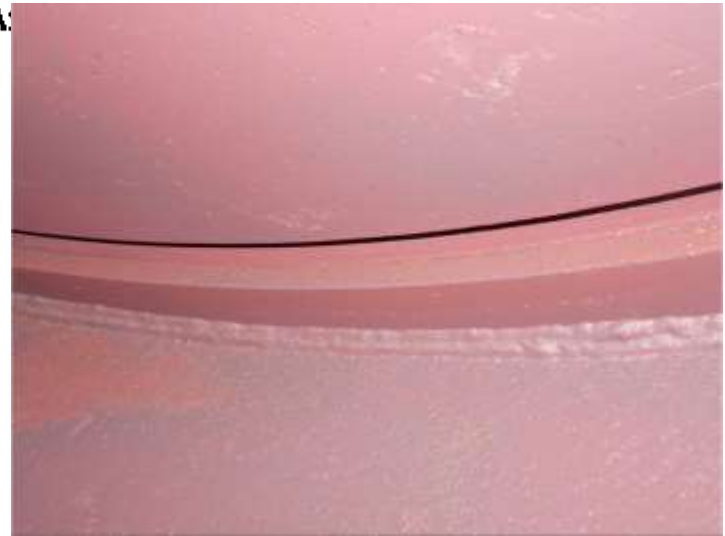
# Videos/Pictures of Weld Failure

- It is believed that the weld failed in the 1A2 Feedwater Heater due to an ineffective weld from the factory
- The 1B2 Feedwater Heater is scheduled for Eddy Current Testing during WBN U1C14 (Spring 2017) and a contingency work order will be planned to execute the same repairs if the same condition exists
- If the same condition exists in the 1B2 Feedwater Heater, a contingency will exist to also open the 1C2 Feedwater Heater instead of waiting until WBN U1C16 when it is scheduled for Eddy Current Testing
- The same condition is not believed to exist in the 1B2 or 1C2 Feedwater Heater because an adverse trend in TTD does not exist
- The current plan is to monitor the performance of the 1A2 Feedwater Heater until U1C20 (Spring 2026) when the next scheduled Eddy Current Testing will occur
- Corrective actions will be executed if the adverse TTD trend returns.
