# **Feedwater System Reliability Users Group**

# **Feedwater Heater Shell Degradation**

**Greg Tucker – True North Consulting**

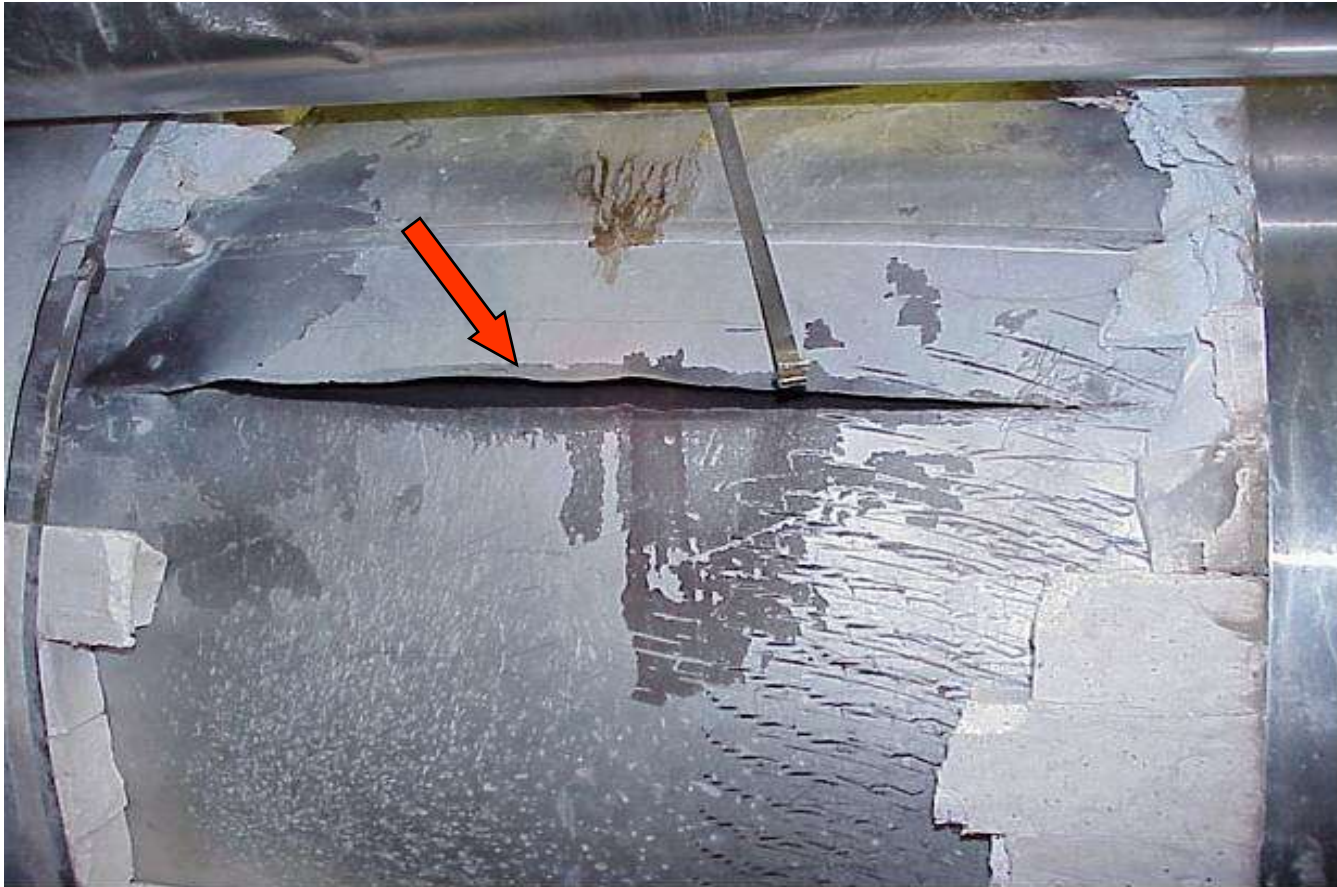
## Point Beach (Continued)

- Point Beach is a two-unit PWR, located on Lake Michigan in Wisconsin.
- Details:
  - A fish-mouth rupture (about 27” long and up to 7/8” wide) occurred in the shell of a No. 2 heater.
  - The heater is horizontal and was manufactured by Struthers Wells.
  - The shell has a nominal thickness of 0.5”.
  - Failure occurred where the entering steam (about 88% quality and 347 °F) hit an impingement plate, fanned out and struck the shell.
  - The degradation extended approximately 4 feet along the length of the heater shell.
- Similar wear was found on the parallel heater.

INPO O&MR-431, SEN-199 R1, OE-9941, OE-9958

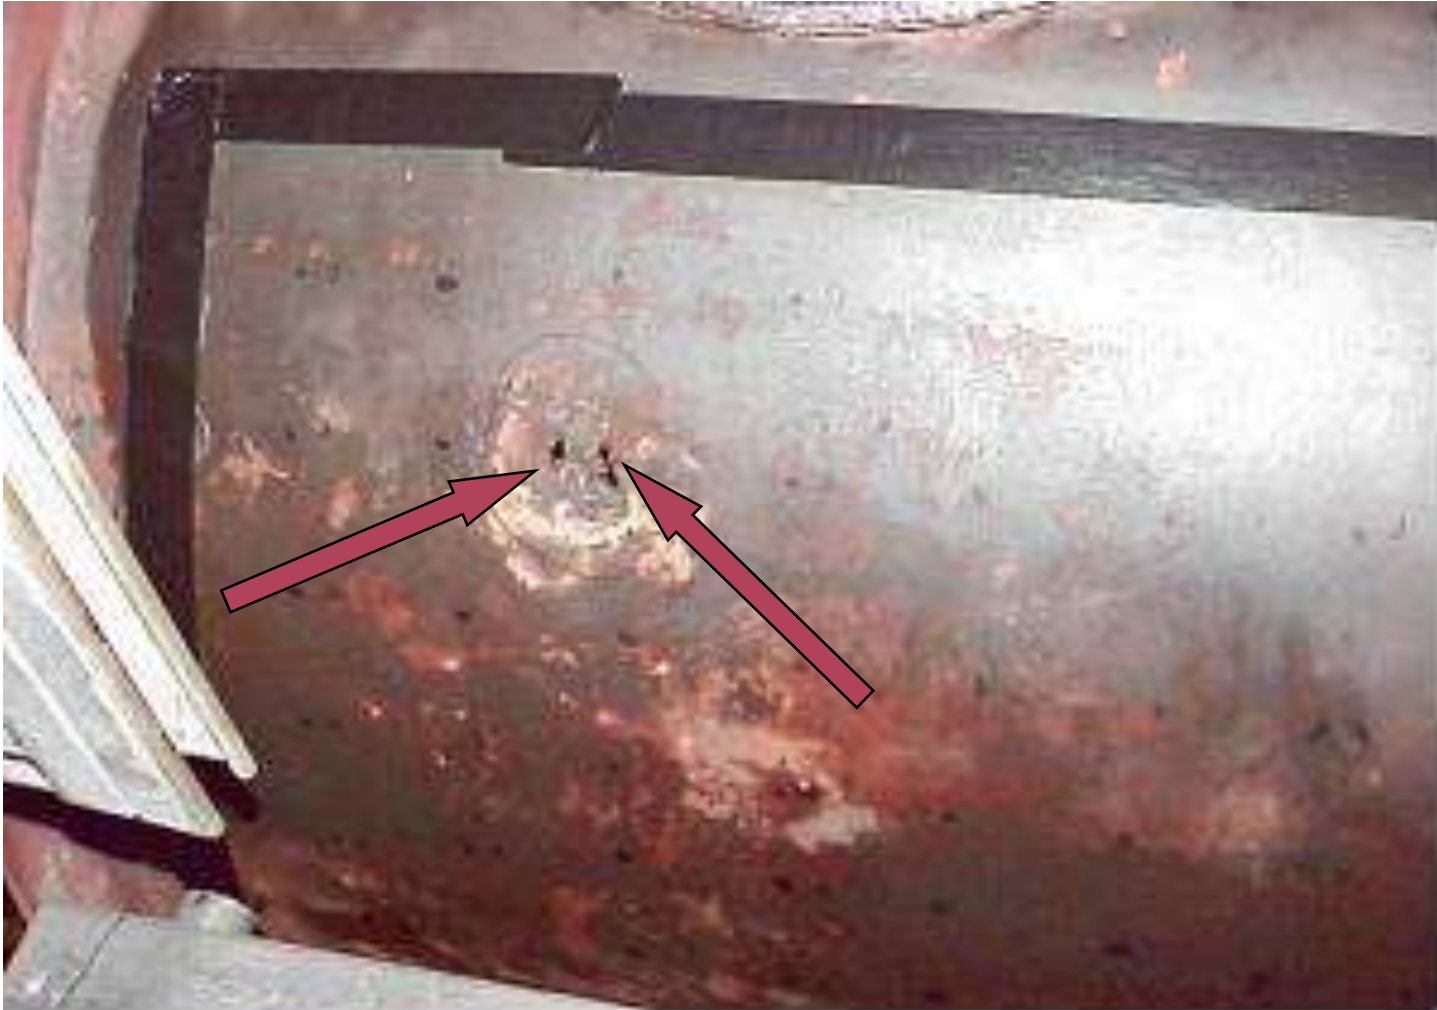
## Pilgrim (Continued)

- Pilgrim is a BWR located near Plymouth, Massachusetts
- Details:
  - Two holes (each about ½”x 1” in size) were found in the shell of a No.3 heater.
  - The heater is horizontal and was manufactured by Yuba.
  - The holes were located in-line with the extraction steam inlet, approximately 45° down the shell from the inlet.

- Details:
  - A band of high wear area ran in the longitudinal direction of the heater shell.
  - The entering steam temperature was 297 °F.
- Shell thinning on both sides of the steam inlet was found on the failed heater, as well as the on the heater of the parallel train.

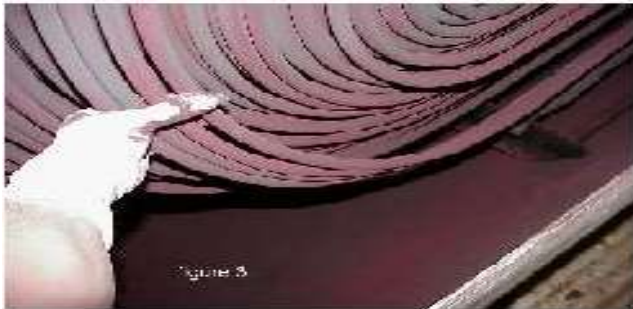
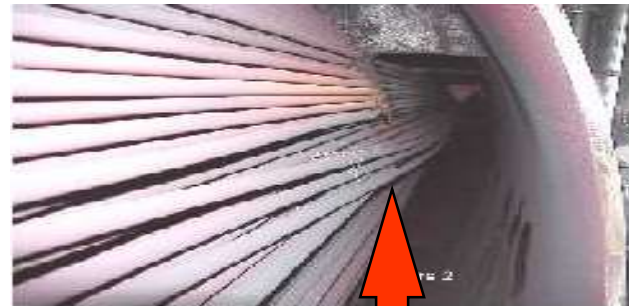
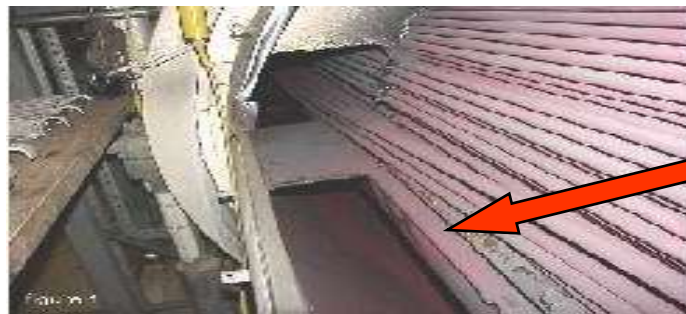
# Susquehanna Photographs (Continued)

- Upon inspecting the Susquehanna Unit 1 heaters, similar shell damage as to the Unit 2 heaters was found. Unit 1 has also reported considerable damage to the internals of one of the No. 3 heaters
- In making repairs to the shell, considerable damage to the periphery of the tube support plates was found. This damage resulted in a number of unsupported tubes
- Repairs were made by wrapping the tube bundle with stainless steel bands and by inserting cables through the tubes followed by plugging them

**Unsupported tubes**

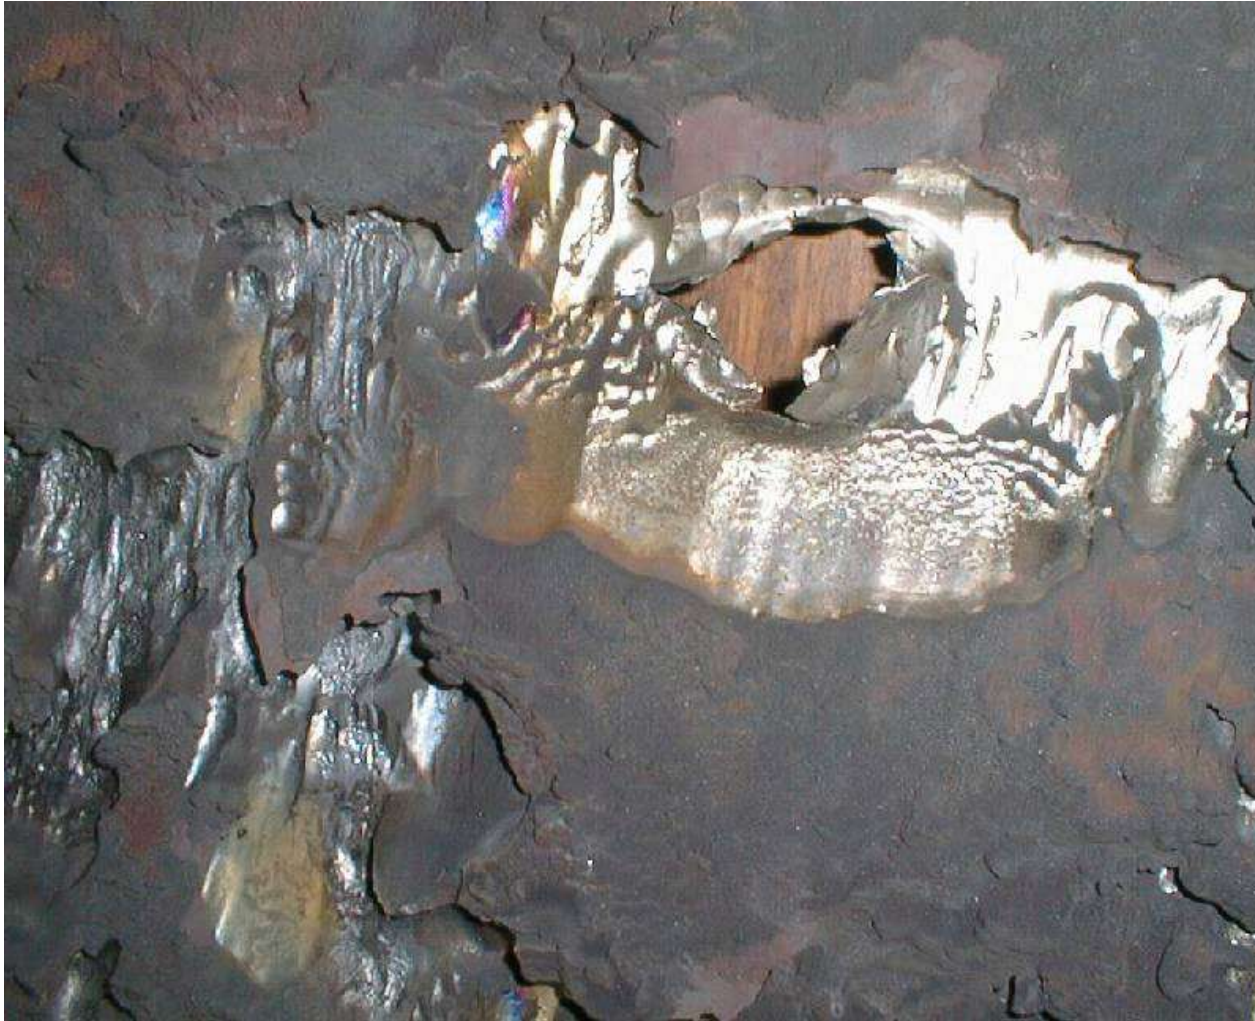
## Riverside (Continued)

- Northern States Power has reported that their Riverside Unit 8 fossil plant had experienced thinning of a feedwater heater shell
- The degradation is in a No. 2, low-pressure feedwater heater with an operating temp  $\sim 300^{\circ}$  F. It is a vertical heater, made by Alco. There was no stainless steel liner. Degradation on both sides, approximately 10:00 and 2:00 positions. Original wall thickness was  $\sim 7/16$ "
- Note the hole shown is from handling

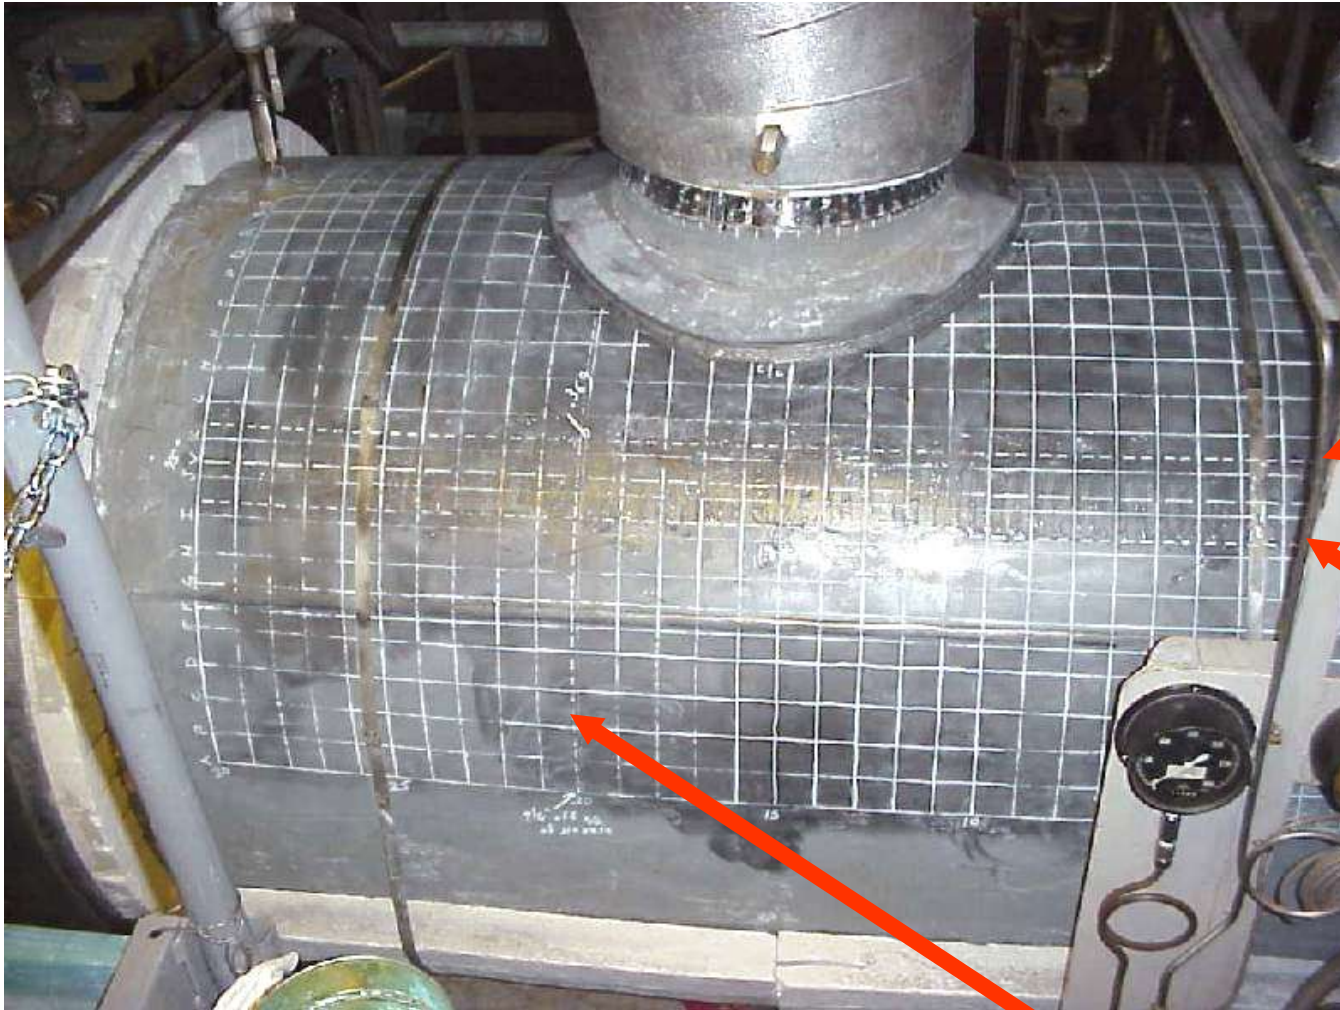
# Photograph of Good UT Practice

Internal features marked

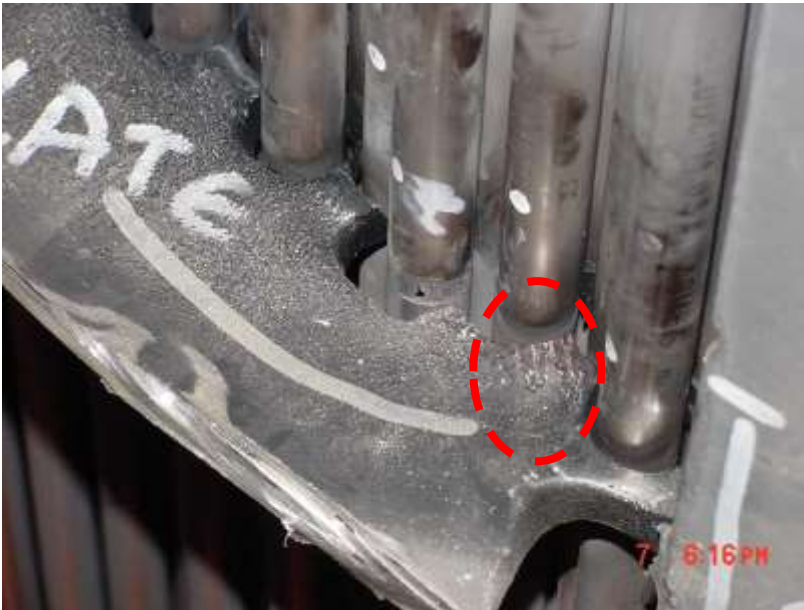
- Materials
  - Stainless steel impingement plates are not damaged, but carbon steel shells are
  - Shells with trace chromium demonstrate immunity while “pure” carbon steel shells are attacked
- Morphology
  - the characteristics of the damaged surface indicate that the damage mechanism is FAC
  - See the photos on the next slide

FAC appearance on worn tube support plate

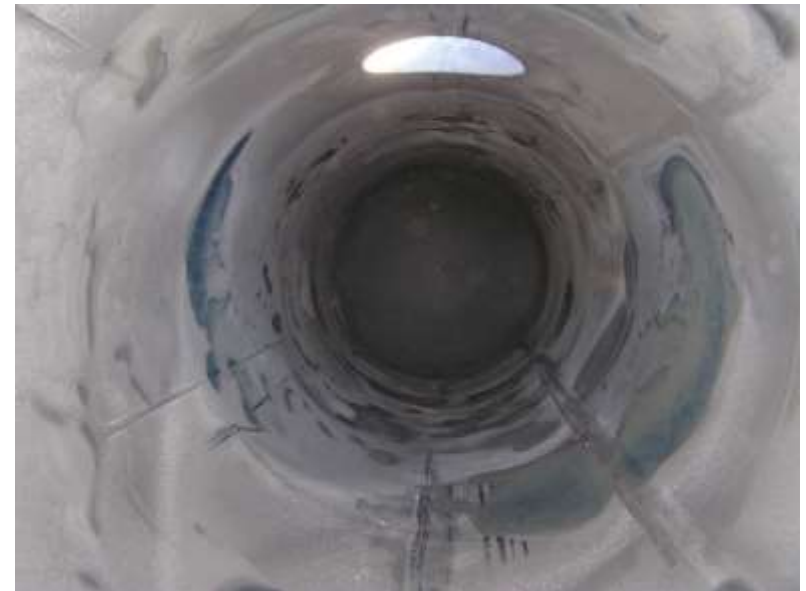
Tiger striping on worn shell
