2017 FSRUG Update

Harris Plant

Automatic Isolation of 1A/2A FWH String

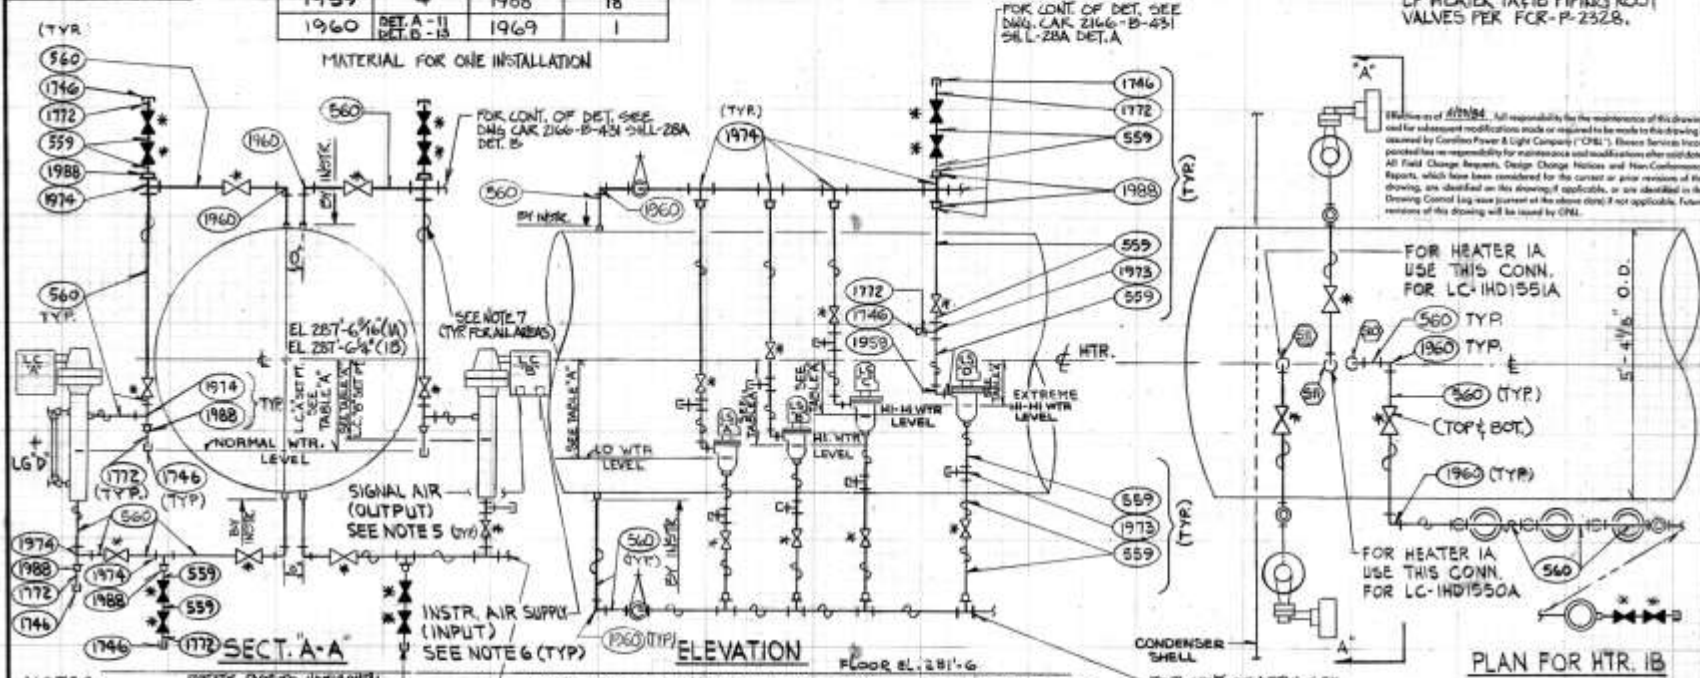
LP HEATER IA & IB LEVEL INSTRUMENT HOOK-UP

- Automatic isolation occurred on the 1A/2A FWH string due to actuation of the 1A Extreme High Level Switch.
- Plant output was reduced to 90% for several days for troubleshooting.
- Numerous high level alarms experienced the previous month.
- Level columns for the high level (1540A) and extra high level (1542A) switches were flushed.
- Preliminary investigation concluded the cause was debris in the level column(s) or common reference leg.
- No additional alarms were received until 1/27/16 (weekend before 2016 FSRUG).

- On 1/27/16, high-high alarms on the 1A FWH began to actuate every few hours.
- Each occurrence would cause the alternate drain valve to open and drain the heater, followed by the alarm clearing and level returning to normal level.
- On 1/28/16, a FIP team concluded the likely cause was debris in the associated level column or reference leg, based on earlier investigation.
- This level column had not been flushed in December based on no previous alarms.

- Debris in LS-01HD-1542A sensing column caused a false high level and inadvertent actuation.
- As described in EPRI Technical Report 1003472:
 - Condensation forms in the top equalizing leg that is connected to the upper shell of the FWH.
 - The condensate flows down into the level sensing column and then drains back into the FWH through the lower reference leg.
 - Debris partially blocking the level sensing column bottom connection to the lower reference leg reduces flow out of the lower level column
 - This can cause a false high level and inadvertent level switch actuation.

- This cause was validated in January when all of the sensing columns were flushed.
- The initial flush water included a substantial amount of corrosion products (magnetite and hematite) and some biological growth
- No foreign material was found.
- As of Jan 2017 - No additional alarms or automatic isolations have occurred.
