# 2016 FSRUG

Rotating Equipment Repair  
Mark Barber

Steam Generator  
Feed Pump  
Cyclic Vibration

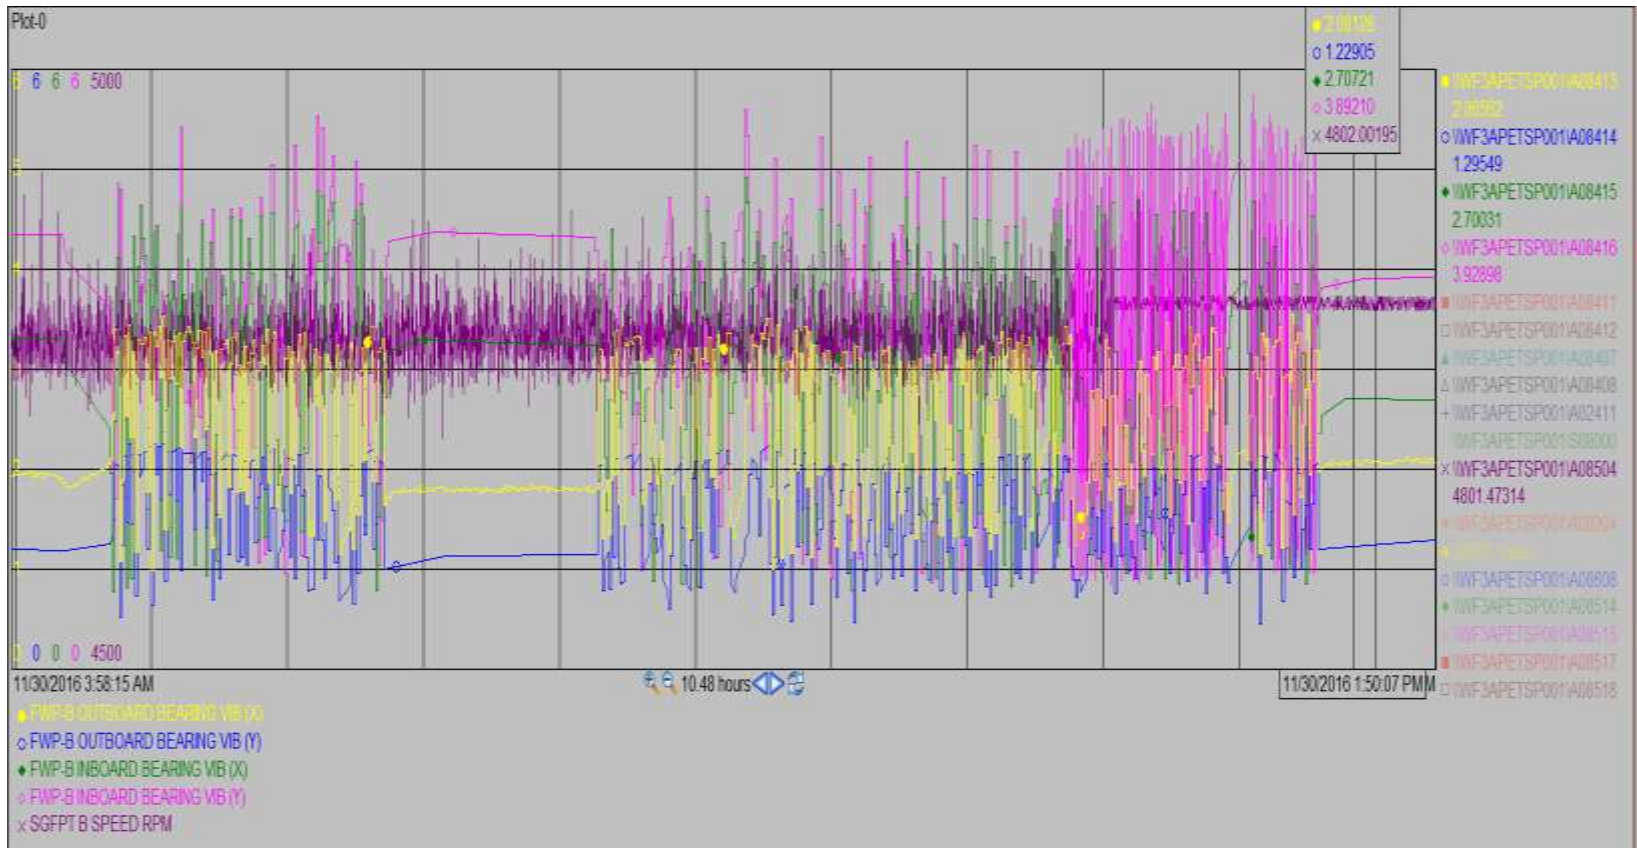
- Vibrations began to intermittently appear; highest on IB end.

- Worse on IB bearing housing

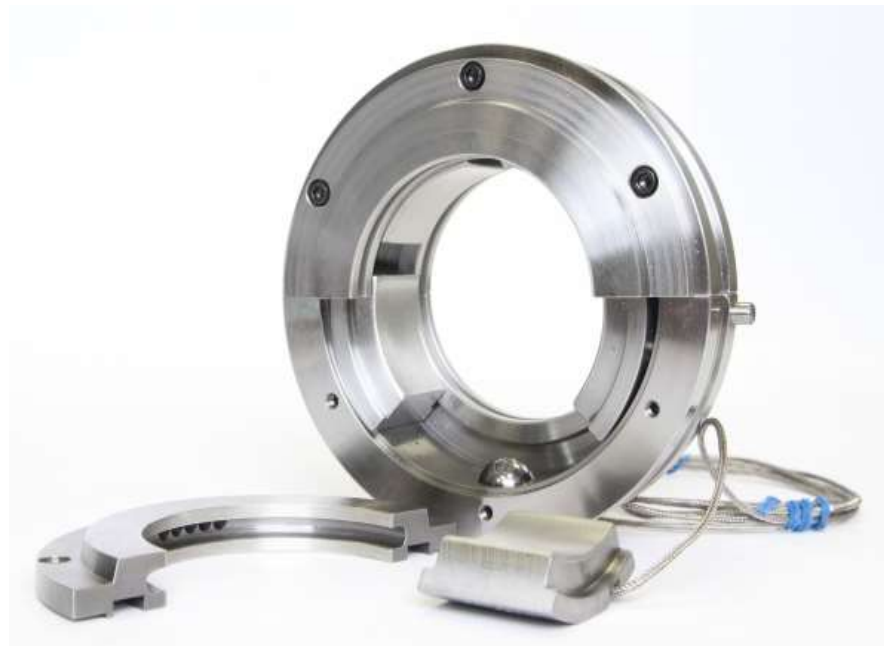
- Pump utilizes tilt-pad journal bearings
  - 5 shoes
  - Designed to minimize oil whirl problems associated with high speed machines

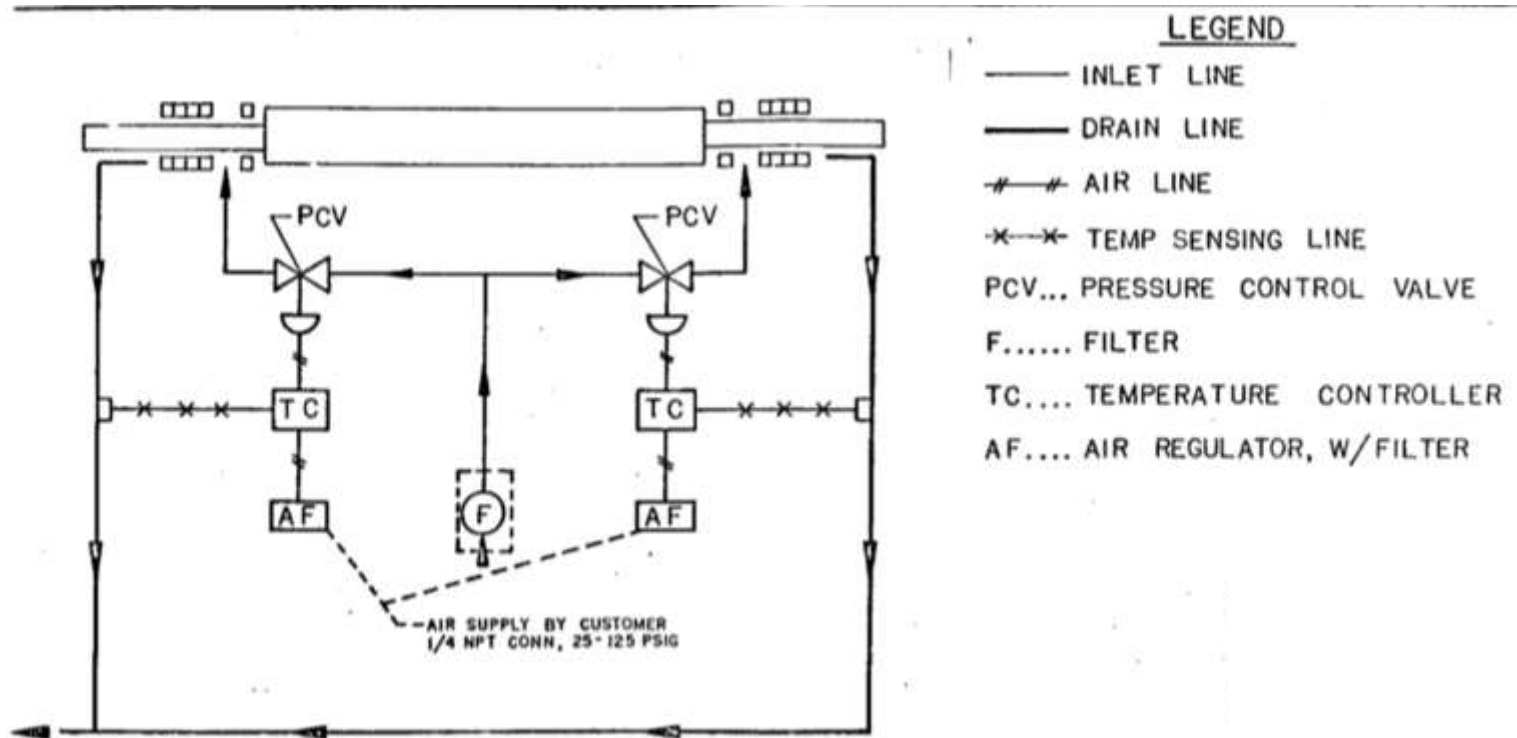
- Typical seal water injection system
  - Same temp water from condensate injected into both IB & OB stuffing box bushings
  - Seal drain temp is controlled

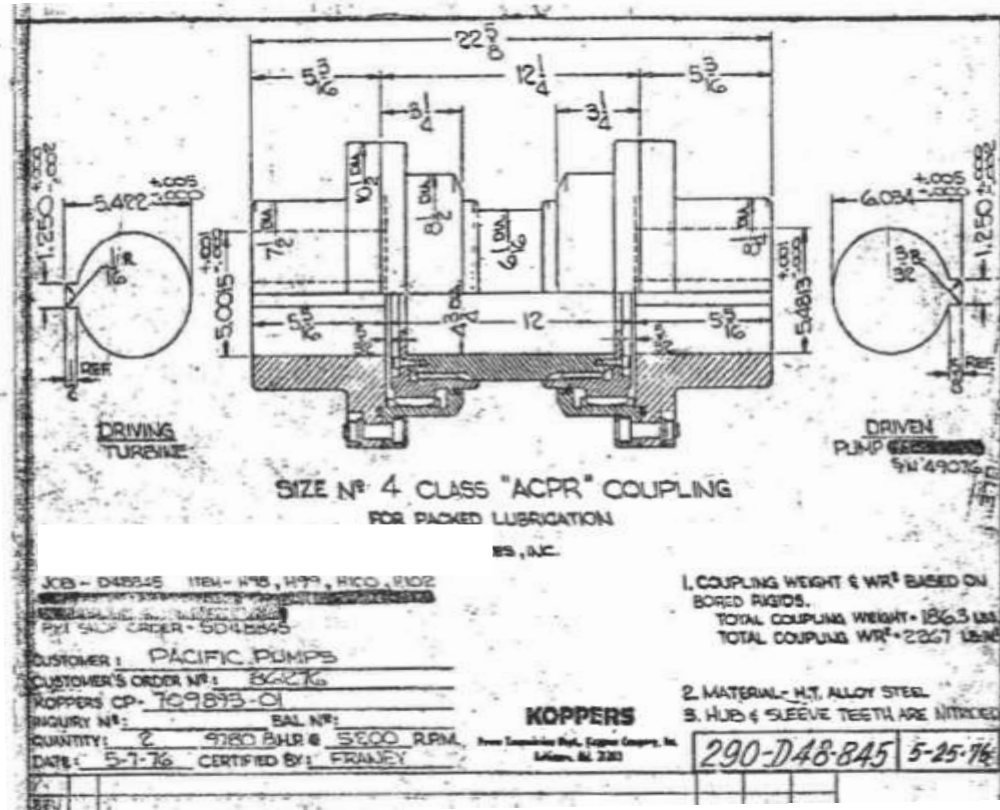
- The coupling was found to have loose fits. It was also assembled NOT per match marks.

- A new, balanced coupling was installed. No noticeable improvement. Vibration sporadically existed for no apparent reason.

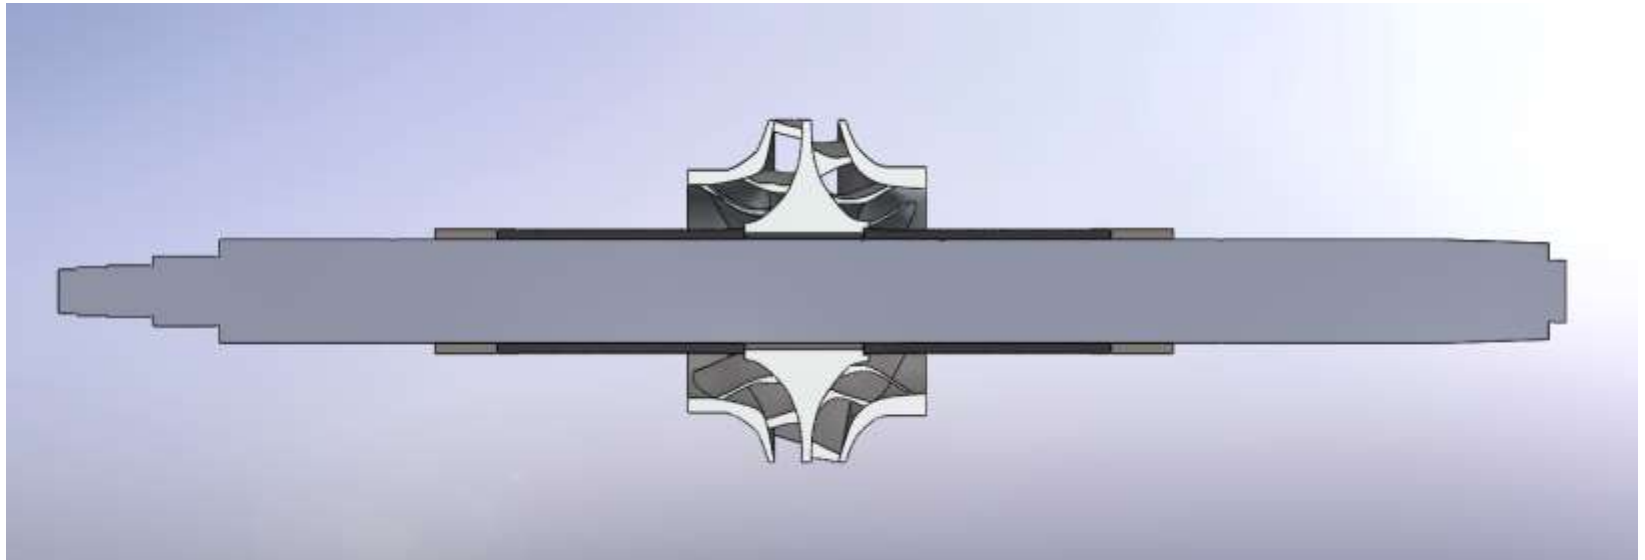
- Rotor stack is restrained via nuts.
- Sleeves have 0.001-0.0025" loose fit re the shaft.

- The sleeves, being less massive than the shaft, tend to grow in length relative to the shaft.
  - Not a problem if sleeve fit to shaft is “perfect.” If shaft and sleeve are at tolerance limits, can cause bending moment.
- Moment of inertia equation suggests that shaft deflection at impeller can easily be close to 0.003”. Sufficient to cause vibration.
