# Trending and Lessons Learned

Site Trending and Improvements

**Luminant**

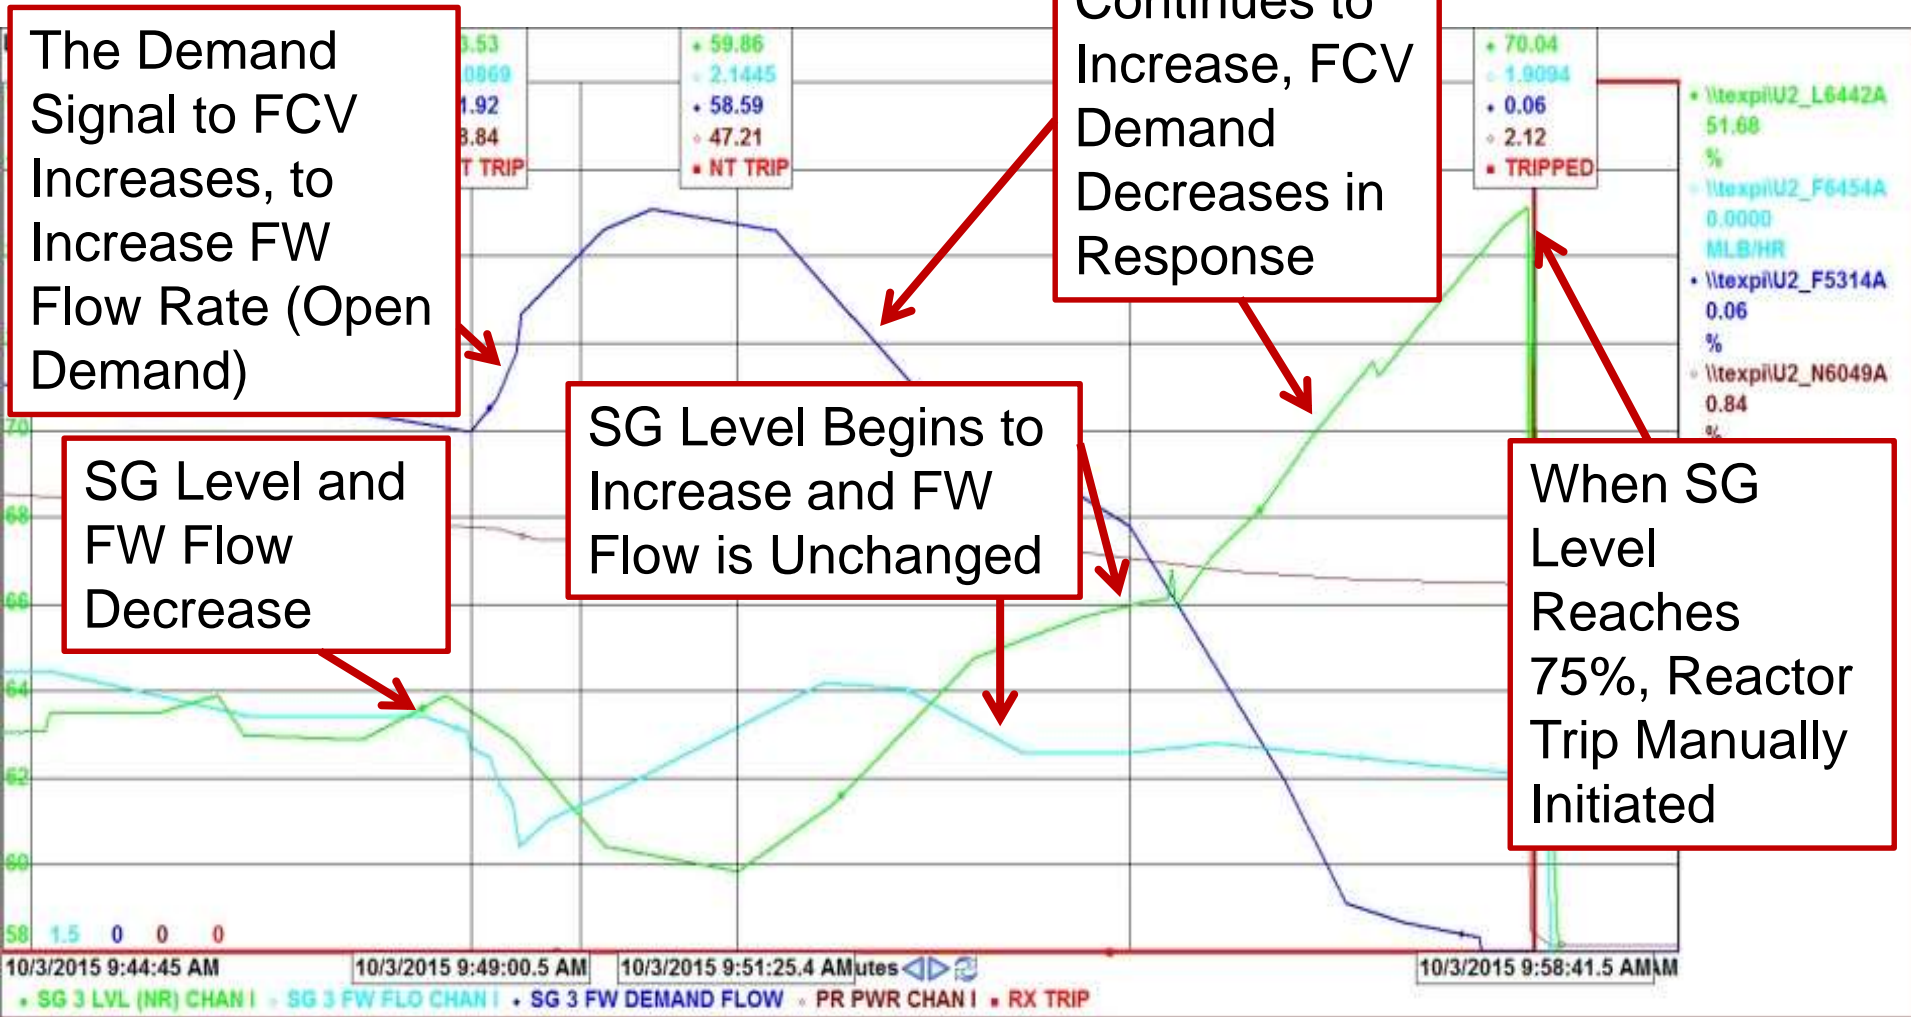
# Cause of the Trip

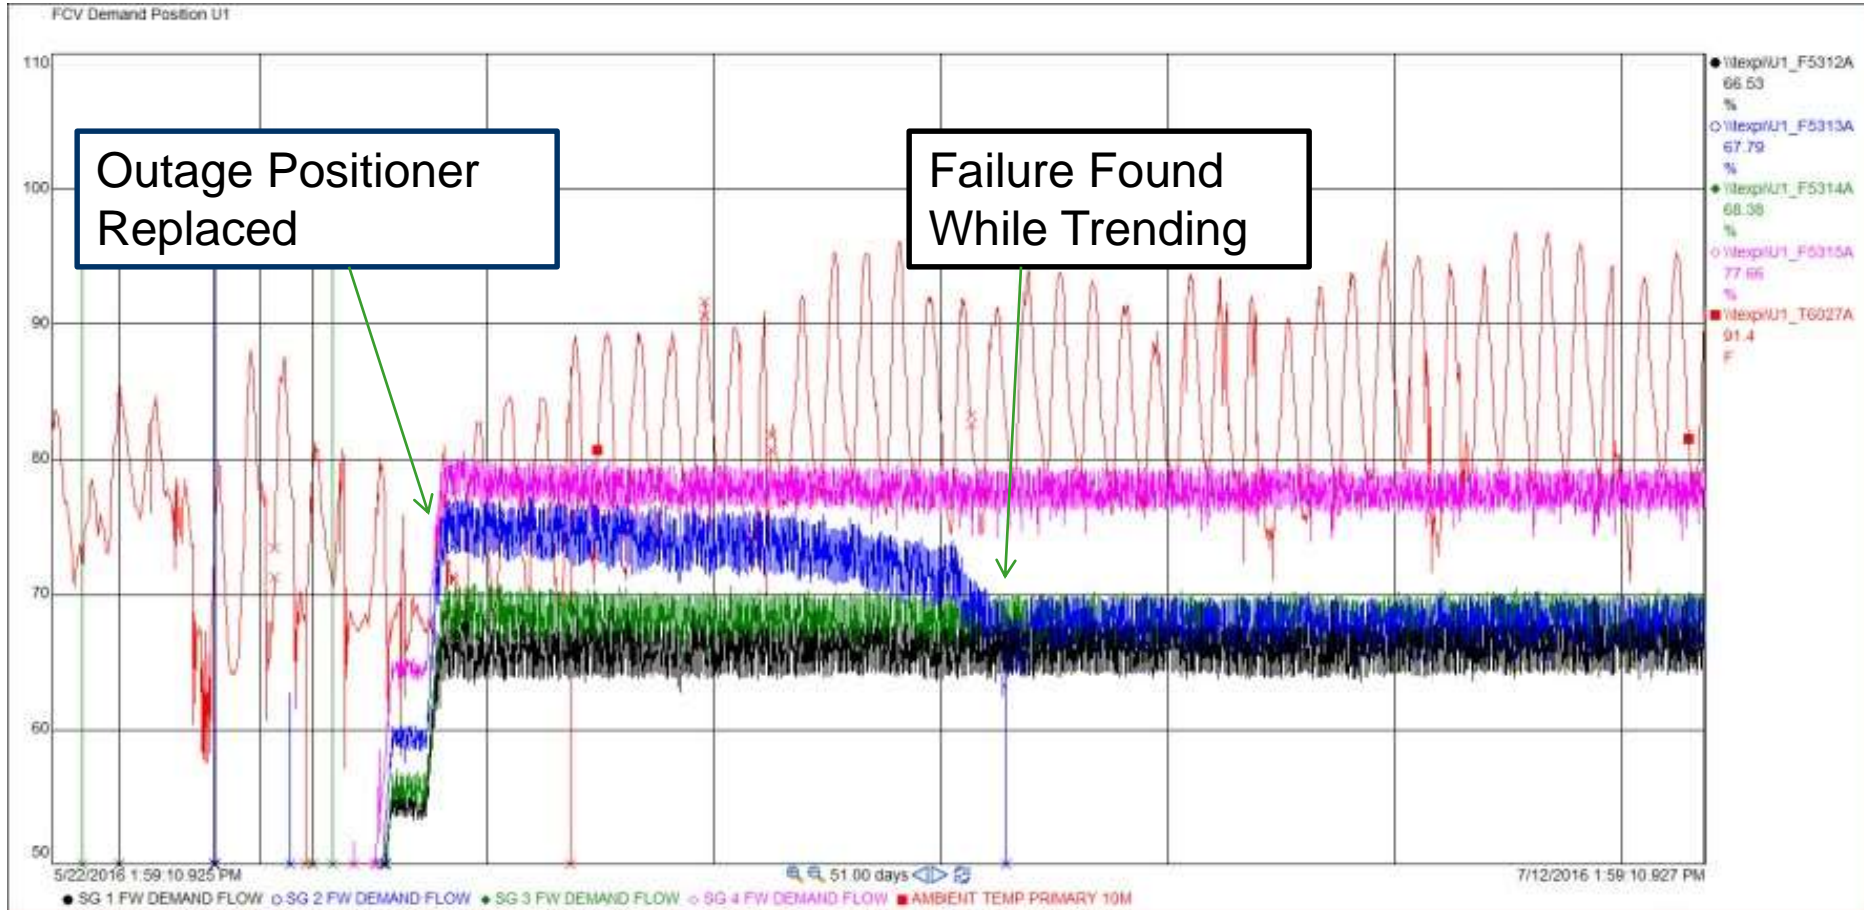
# 2016 FRV Failure

In total 6 failures have occurred during the 13 years of service in 8 locations for the Siemens Model 74SG positioner
