Case Study: “Preventing
Reactor Feed-water 1X
Vibration by the Addition
of Axial Clearance in the
Rotating Assembly”

Joseph A. Silvaggio, Jr.
Fellow Engineer
Pump Projects and
Engineering

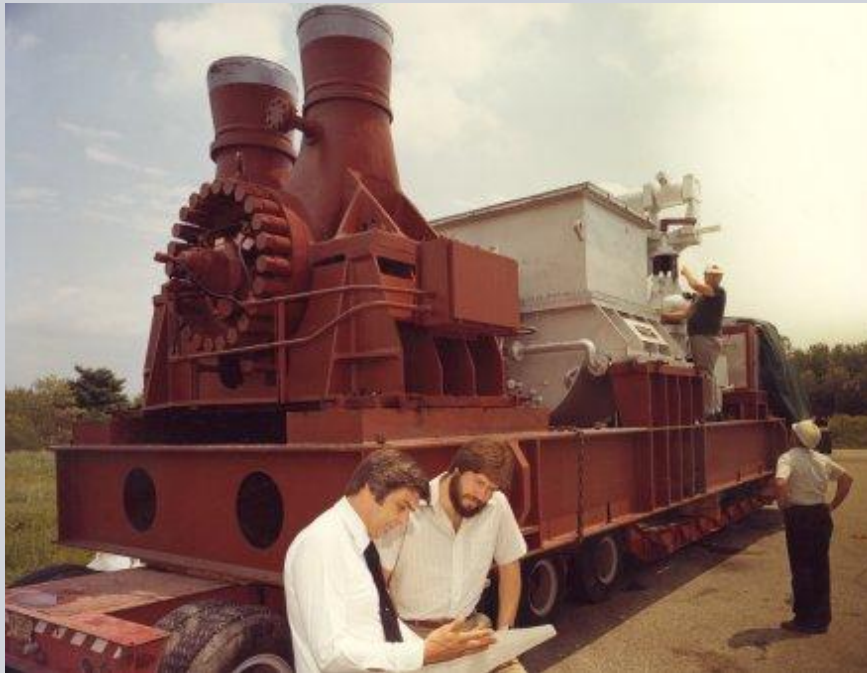
SINGLE STAGE NUCLEAR FEED WATER PUMP

Maine Yankee Atomic Power

Largest Nuclear Feed Pump Ever

24" Nozzles

28,000 GPM

14,763 HP

700 PSI SUCTION

1,800 PSI DISCHARGE

Driven By A Delaval Steam

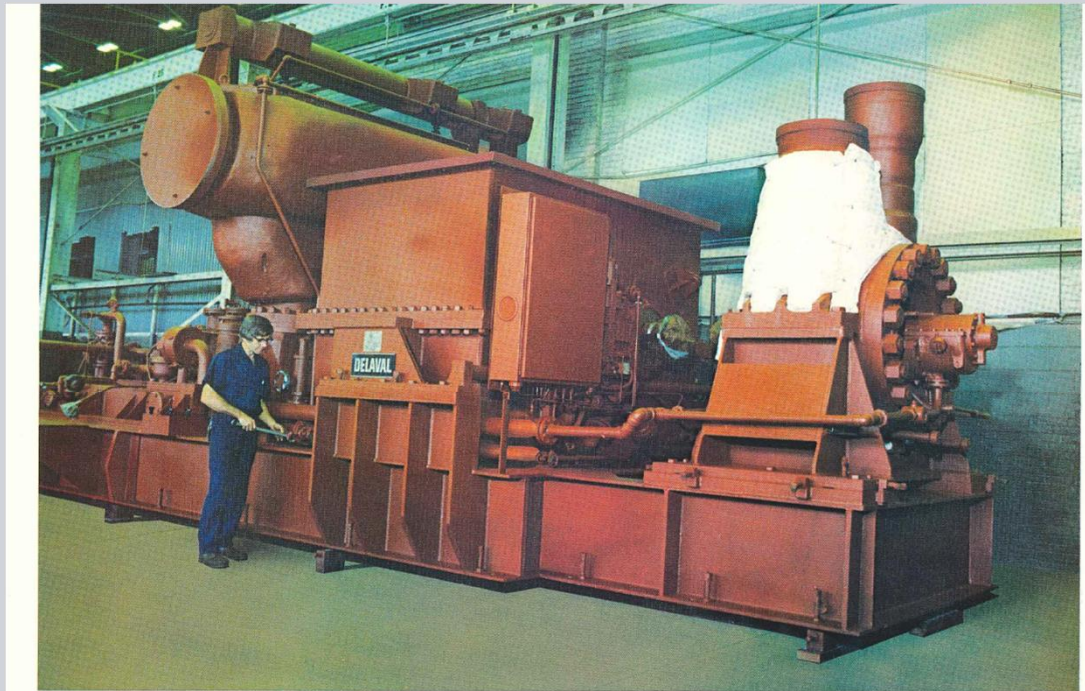
TURBINE DRIVEN REACTOR FEED PUMP

DELAVAL REACTOR FEED PUMP 16,000 HP TURBINE WITH ITS REACTOR FEEDWATER PUMP MOUNTED ON A CONTINUOUS BEDPLATE - STEAM CONDITIONS - 90 PSIA/490°F PRIMARY - 883 PSIA/550°F SECONDARY PUMP CONDITIONS - 20,000 GPM @ 2460'TDH @ 5400 RPM.

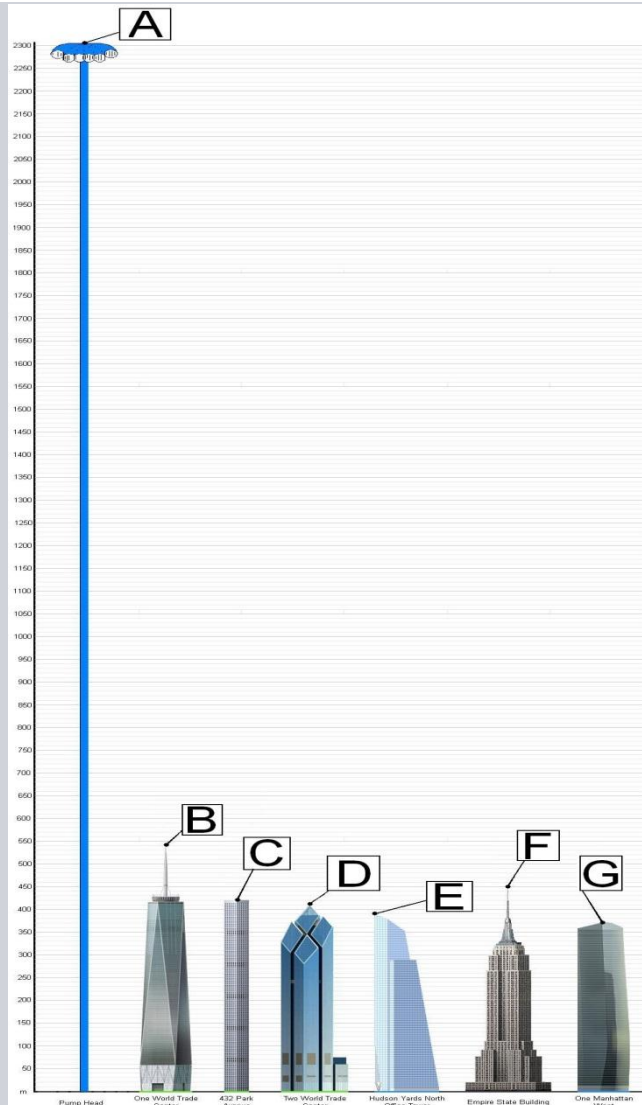
VISUALIZATION OF PUMP HEAD PRESSURE VS. NYC SKYLINE

- A. *Pump Head Pressure*
~7570 ft (2307.3 m)
- B. *One World Trade Center*
~1775.9 ft (541.3 m)
- C. *432 Park Avenue*
~1378.9 ft (420.3 m)
- D. *Two World Trade Center*
~1350.4 ft (411.6 m)
- E. *Hudson Yards North Office Tower*
~1292 ft (393.8 m)
- F. *Empire State Building*
~1454.1 ft (443.2 m)
- G. *One Manhattan West*
~1215.9 ft (370.6 m)

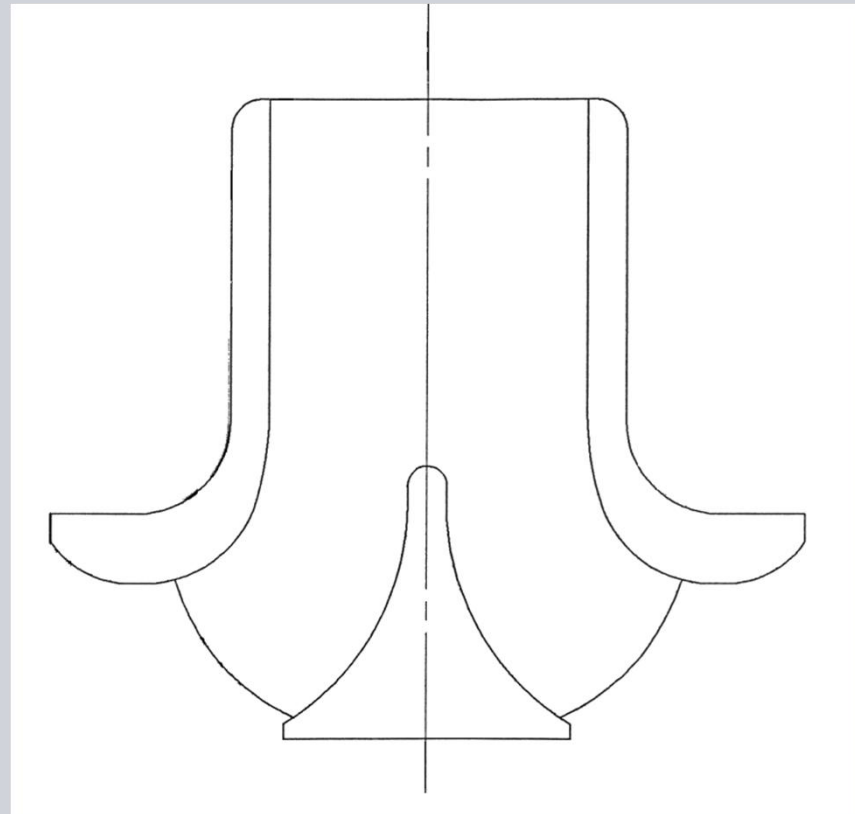
DOUBLE SUCTION

- NORMALLY REFERS TO THE DESIGN OF IMPELLER INLET
- THE IMPELLER HAS TWO (DOUBLE) INLET EYE AREAS
- $\frac{1}{2}$ OF THE TOTAL PUMP INLET FLOW ENTERS EACH SIDE OF THE IMPELLER
- PRIMARILY USED ON SINGLE STAGE PUMPS

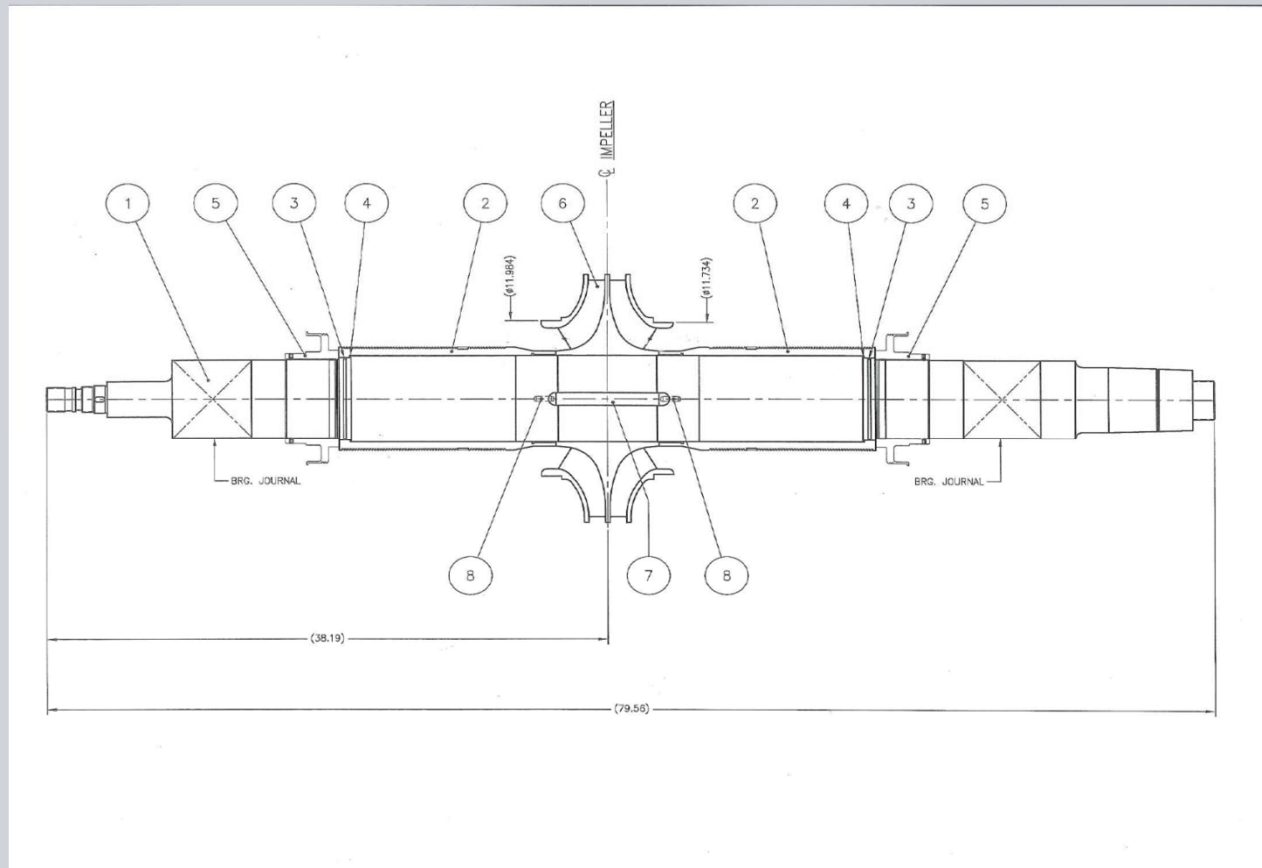
ORIGINAL ROTOR ASSEMBLY

- a. Initiated a program to determine the “root cause”.
- b. First attempts were to investigate the conventional causes. All did not seem to be the cause initially.
- c. The major pump characteristic was determined to be the elevated temperature of the running pump.
- d. A hypothesis was developed that the differential thermal expansion between the sleeves and shaft could cause the rotor to bend (kink) to cause a 1X vibration.

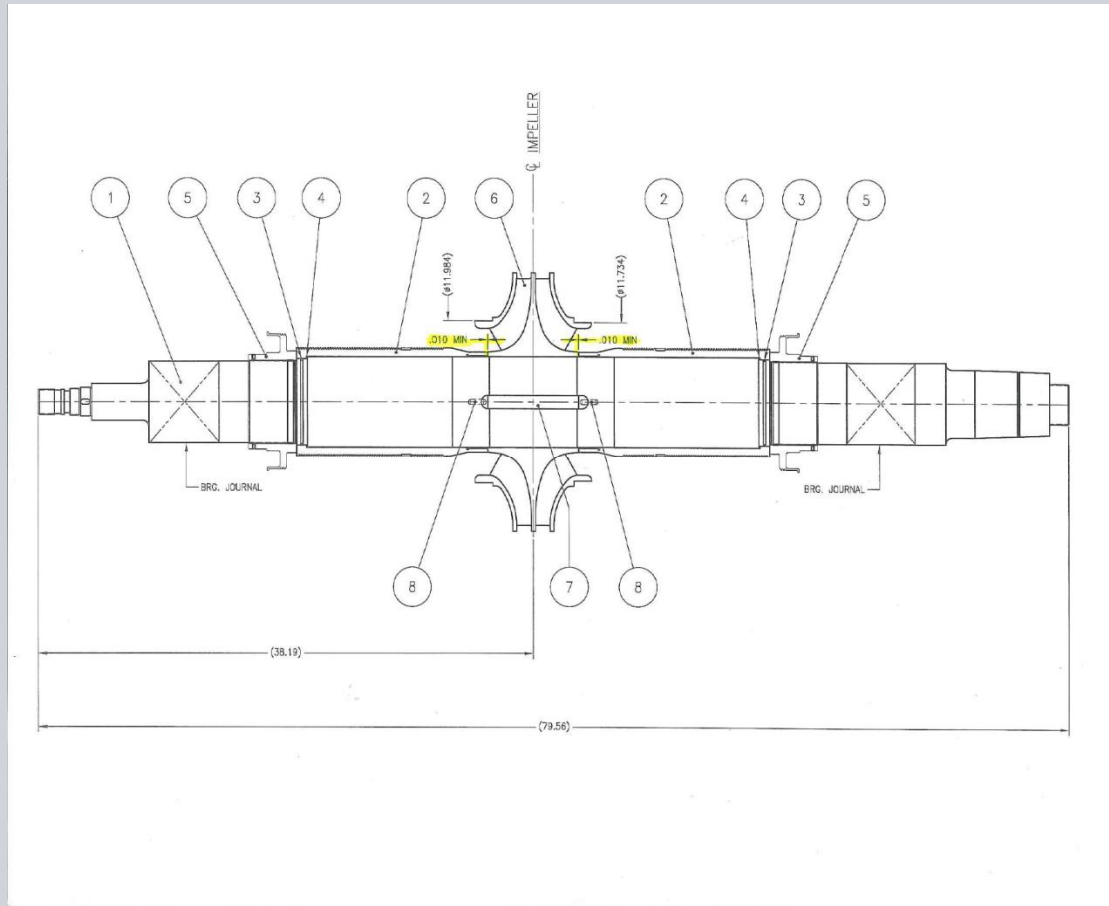
6. ELIMINATION OF THE ROOT CAUSE

- e. An axial clearance was added between both shaft sleeves and the impeller to prove or disprove the hypothesis described in d. to eliminate the 1X vibration.
- f. After implementing the axial clearances as described in e., the 1X vibration was eliminated.

The lack of the axial clearance between the shaft sleeves and impeller was determined to be the “root cause” of the 1X vibration. To eliminate this cause of 1X vibration, all reactor feed-water pumps were supplied with this axial clearance.
