# **Seabrook Station Feedwater Reg Valve Internal Erosion OR17 – Fall 2015**

**Jim Johnson**

**Feedwater System Engineer**

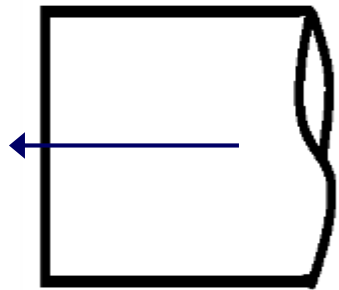
Seabrook performed FAC piping replacement in Fall of 2015.

Downstream piping cut, about 3+ ft from valve outlet.

Water pocket left in in low spot of valve body – rusty water could not see through.
