Manual Trip Entering 2RF15

Inability to Control Steam Generator
2-03 Level Due to Unresponsive
2-FCV-0530

Main Feed Pump Turbine (MFPT)

1-A Trip due to Loss of Axial Position Probes

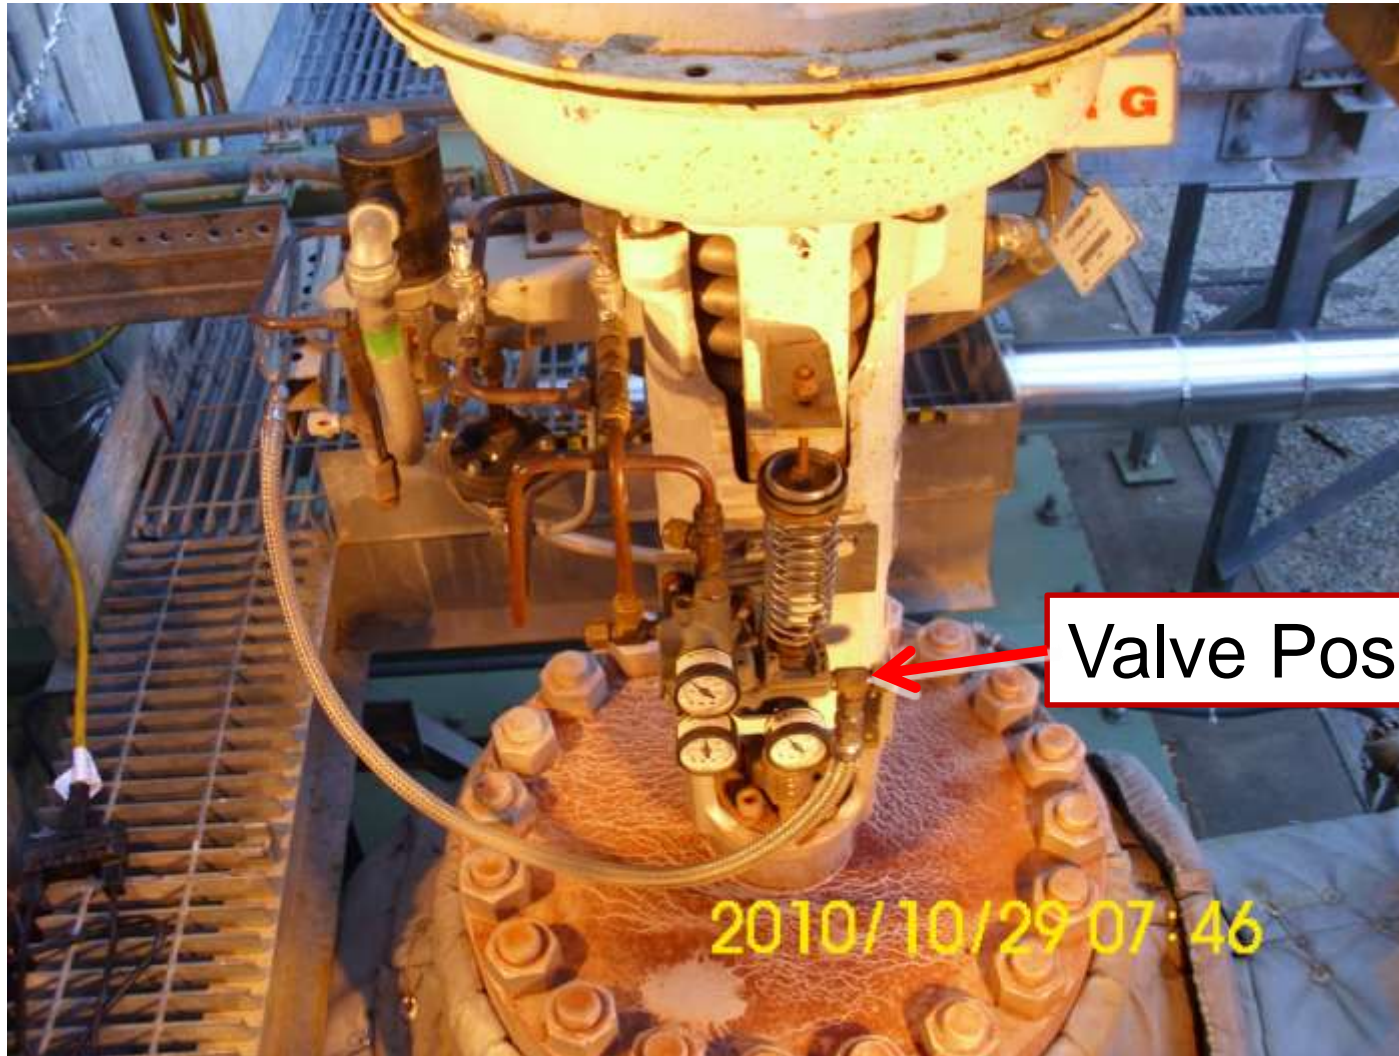
Cause of the Trip

- 2-FCV-0530 is an identified Single Point Vulnerability.
- Erratic performance of SG FW demand flow and sensitivity to ambient temperature were not detected prior to the Unit 2 trip.
- The SG FW demand flow was not being trended by Engineering(Systems, Reliability, POC)leading up to the failure of the 2-FCV-0530
- Trending of this data could have provided early indication of an issue with the positioner on 2-FCV-0530

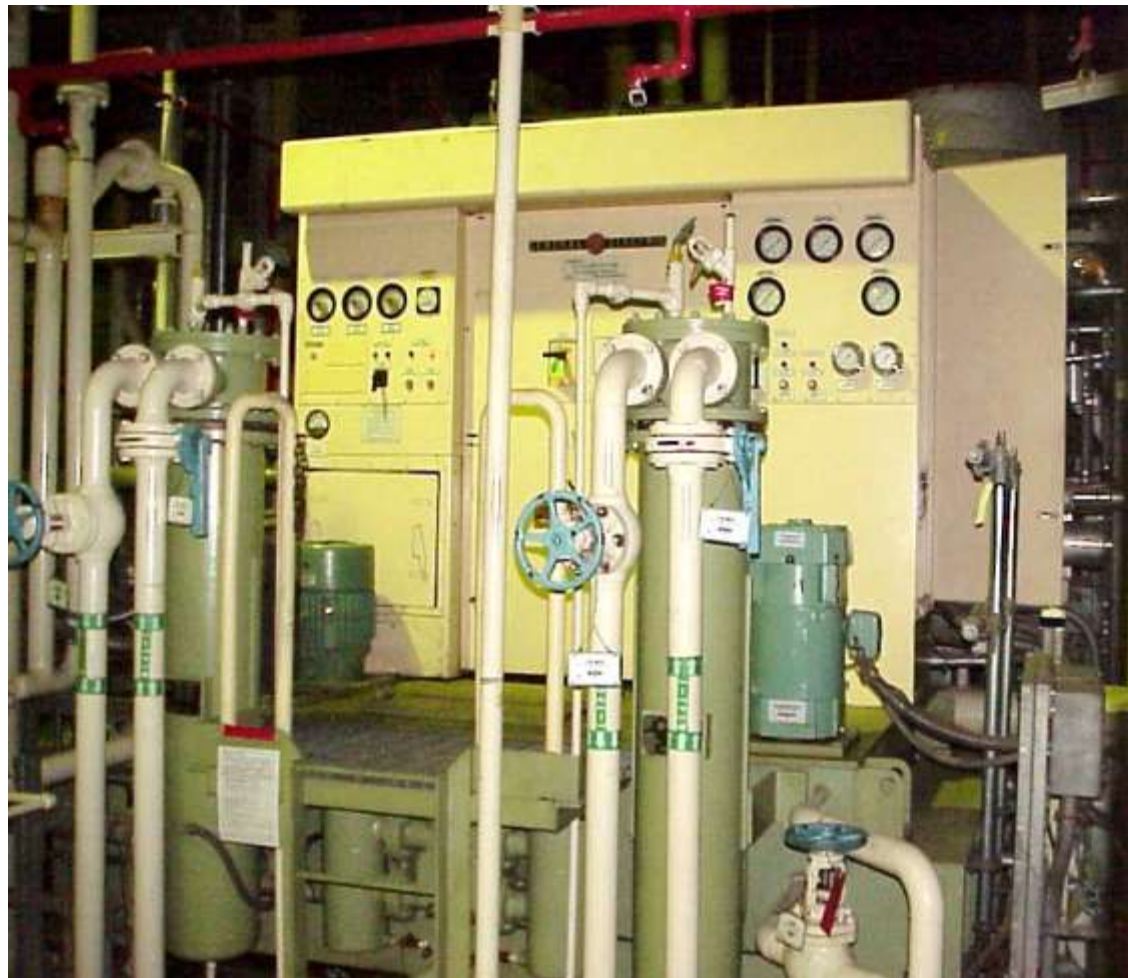
- The Emergency Governor Plunger experienced a fatigue failure of the perforated disk that holds the plunger in place by a spring. This fatigue failure caused the bolt to be no longer restrained within the trip housing, shearing off the proximity probes. The fatigue failure was enabled due to a failed solenoid that did not allow the Reset/Trip Piston to fall which allowed excessive contact to the trip trigger during overspeed testing.

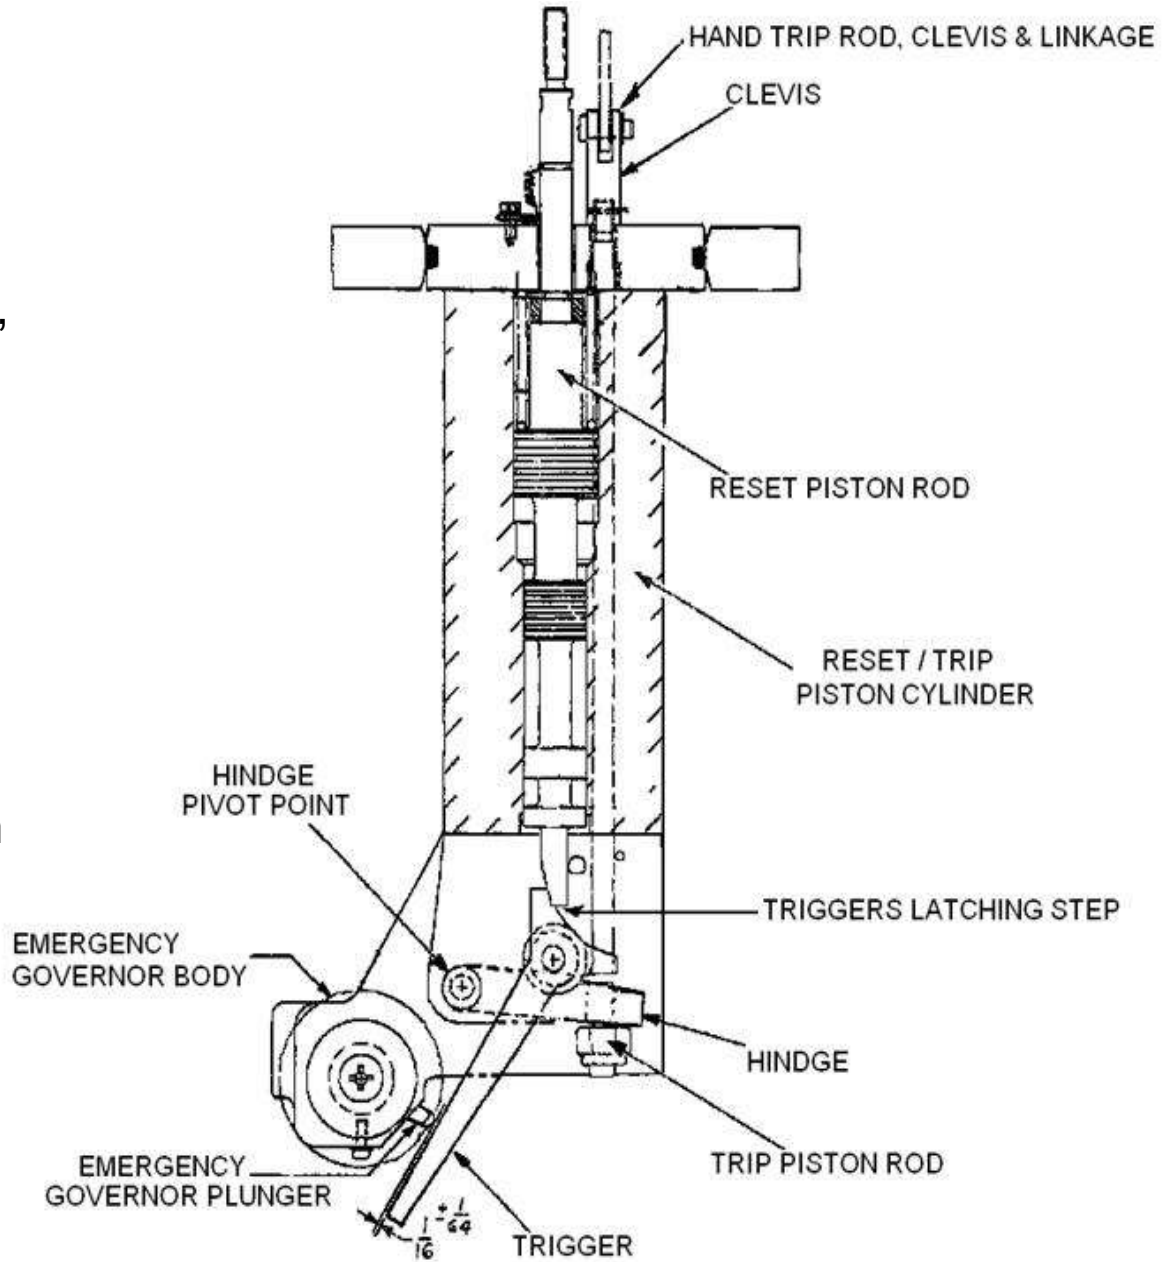
How it works

Trip Mechanism and Emergency Governor Set Up, -Shown in reset position. A Trip causes the trigger mechanism to rotate, unlatching the Reset Piston Rod from the step located on its trigger, which causes the reset piston rod to drop. Movement of the reset piston rod within the trip mechanism will open up drains within the cylinder initiating a pressure drop across the EHC system. This pressure drop is what causes the turbine stop valves to close stopping the MFPT.

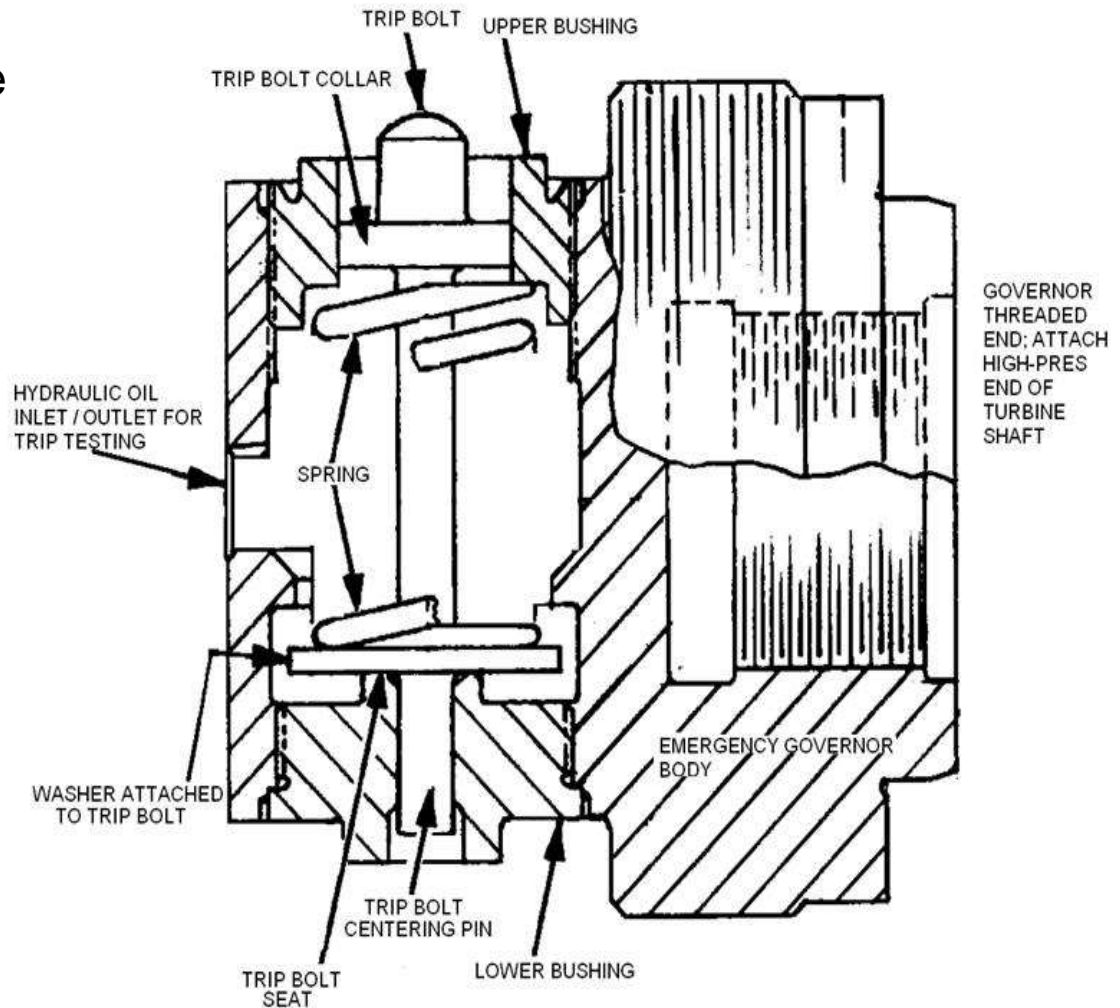
Mechanical Trip Bolt Config

The overspeed trip is located at the MFPT front standard on the high-pressure end of the turbine shaft. The governor components consist of a trip bolt that is held within its seat by a spring which is set up to move the trip bolt off its seat in an overspeed condition. The governor works on the principle of centrifugal force that moves the trip bolt off its seat. The overspeed trip bolt is set to extend from its housing at a speed of 5663-5777 rpm's, which is adjusted by its upper bushing.

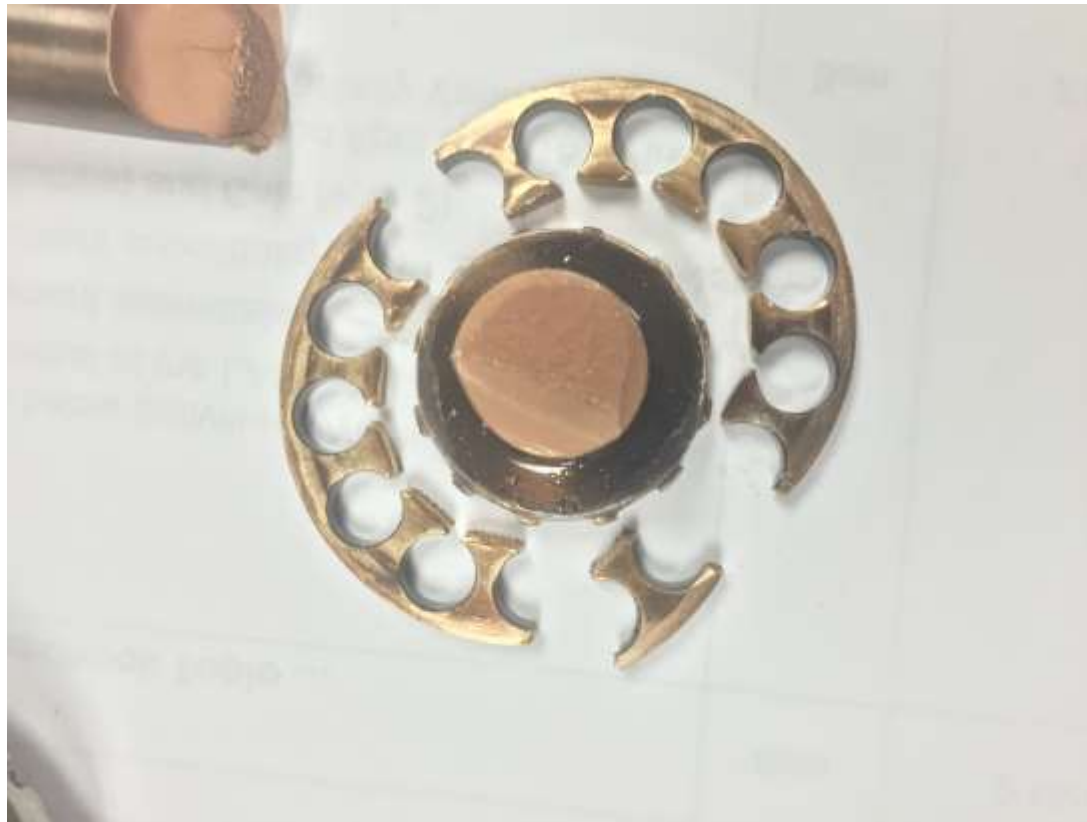
Fatigue Failure

- Failure analysis found that the trip plunger experienced fatigue failure from the tens of thousands of impacts it experienced from holding the trip exercise down for that amount of time. The cause of the MFP not tripping on demand was the reset solenoid was mechanically stuck in the reset position preventing the trip cylinder from falling

- The Reset Solenoid failed in the energized state and did not have a PM
- (Non-Crit RTF)

- CA1 (CAPR): Create PM to replace SV-8 during major teardown inspection (~7-1/2 yr) For 1/2-MSTDFP-01/02
- CA2: Revise ETP-302 series procedures to include the following:
 - 1. Add a Note or a Caution concerning the instantaneous trip of the device that should occur during this PM.
 - 2. Add abort criteria and additional monitoring instructions for conduct of the PM.
 - 3. Reinstitute the <900 MWe
