# EHC Fluid Contamination D.C. Cook – Unit 2

# EHC Fluid Contamination Background

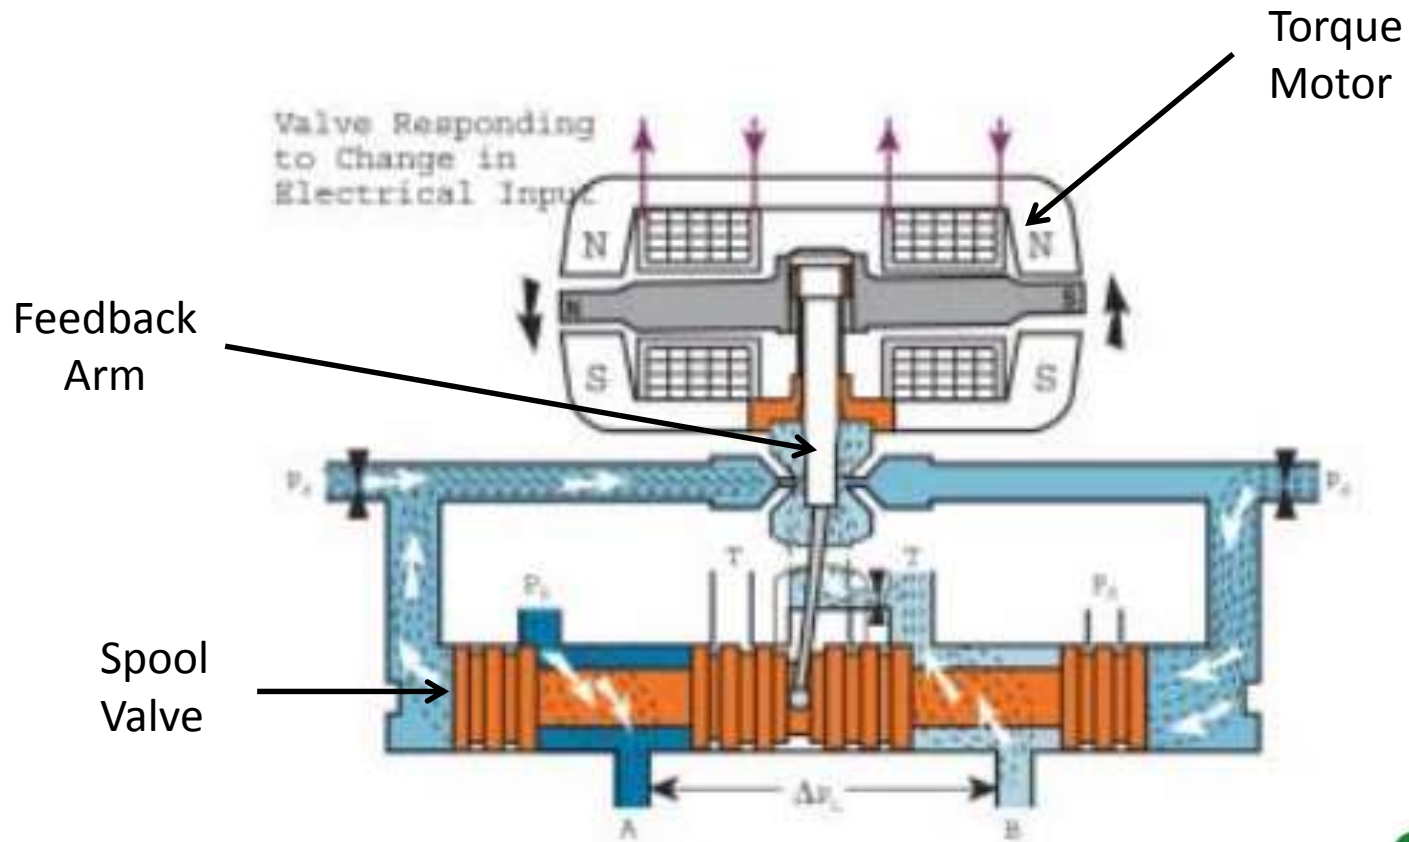
# EHC Fluid Contamination Servo Operation

- The drifting of the control valves is the sticking of the servo spool valve due to small changes in position. When the servos are in a constant position the silt accumulates in the “lands” or grooves in the spool. As EHC fluid bleeds through the spool valve the pressure difference across the spool valve will change and cause the actuator to move, but because the signal to the torque motor is small it is not sufficient to overcome sticking in the spool valve.
